# EFFECTS OF HYDROGEN SULFIDE IN GEOTHERMAL POWER PLANTS OF CALENERGY INTERNATIONAL LTD. LEYTE OPERATIONS

Crescenciano Q. Laugo

CalEnergy International Ltd. Leyte Operations, Milagro Administration Complex  
Milagro, Ormoc City, Philippines.

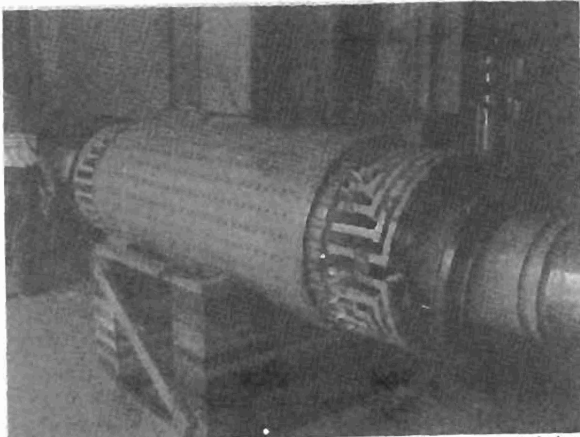
Figure 1a. STG #40 Generator Rotor retaining removed. Exciter and coupling side view, as opened.

Following a plant trip caused by activation of the generator ground fault relay, a turbine generator was found grounded due to the formation of copper sulfide corrosion products in the copper coils of the rotor. All rotor coils were replaced with new material. To prevent recurrence of the same problem, the following preventive measures were initiated:

1. Modification of the generator cooling air purification system.

Cooling air for generator coils was pressurized by installing a blower or a force draft fan upstream of the air purifying and filtering media. The filter replacement periodicity was changed from yearly to quarterly.

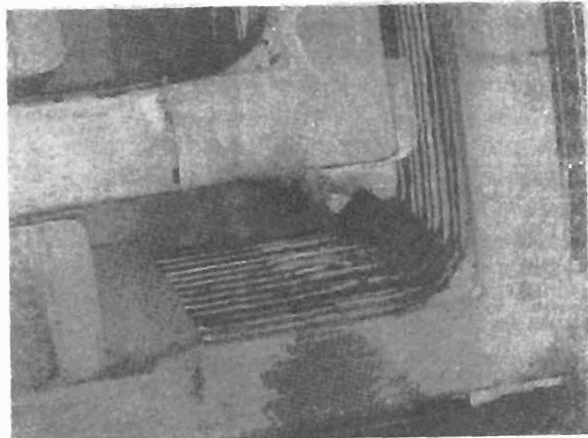
Figure 1b. STG #40 Generator Rotor winding close up of black deposits on the soldered connection, as opened.

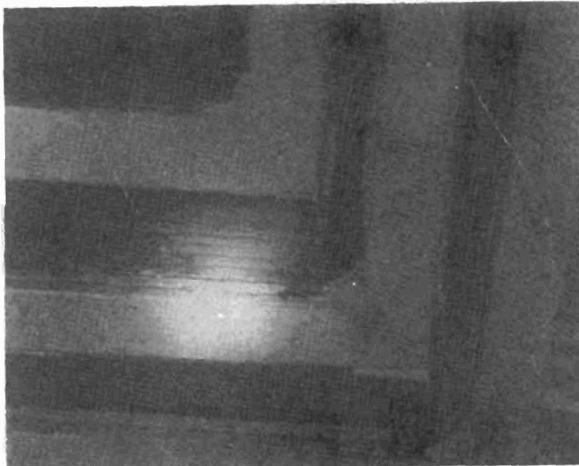
Figure 1c. STG #20 Generator Rotor winding, coupling side, positive of black deposits, as opened.

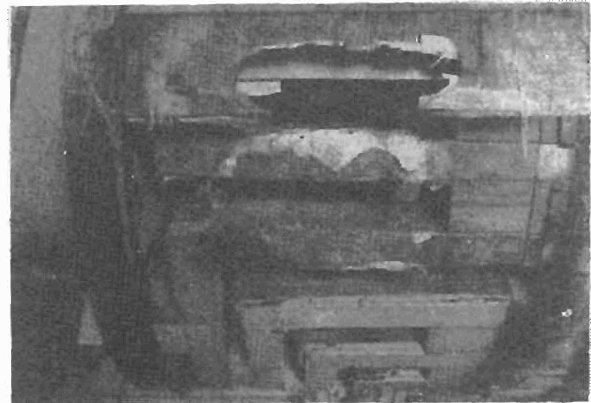
Figure 1d. STG #20 Generator Rotor winding exciter side shorted pole to pole between no.5 and 6. as opened.

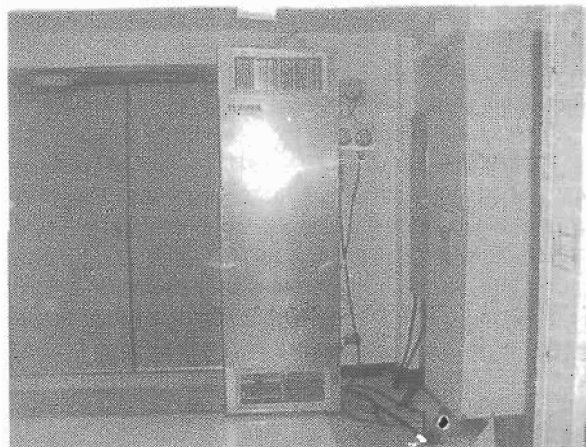
Figure 2. Two units of this 500 cfm capacity Positive Pressurization Unit (PPU) installed at GCCU 1 and 2 Control Room and GCCU 3 and 4 Control Room.

Two units are installed at GCCU 1 and 2 control room and GCCU 3 and 4 control room (Figure 2). One unit installed at Central Station Control (CSC) room (Figure 3). Make up air is filtered and purified. While air inside the room is re-circulated, thus re-filtered and re-purified.

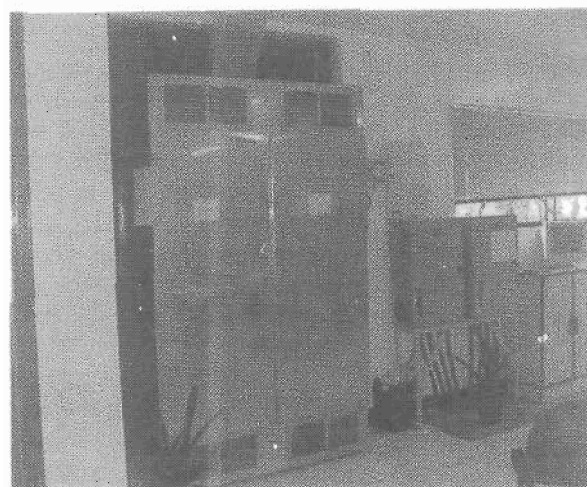
Figure 3. A 2,000 cfm capacity Positive Pressurization Unit installed at Central Station Control (CSC) Room,

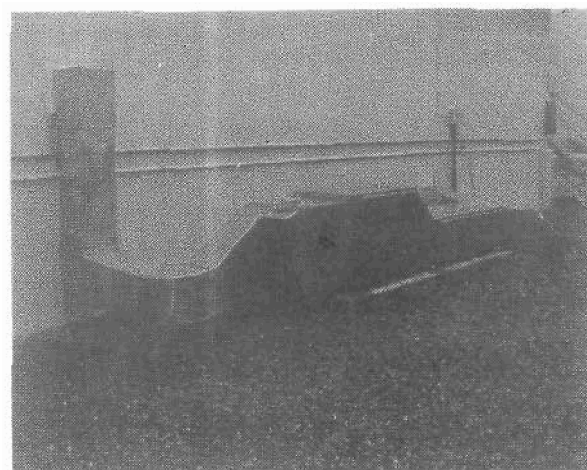
Figure 4. Twelve units of this 500 cfm capacity Industrial Side Access (ISA) Units installed in twelve Power Shelters.

These are installed at Power Shelters. Make up air is also filtered and purified. Air inside

*the room* is recirculated to the unit for refiltration and repurification (Figure 4).

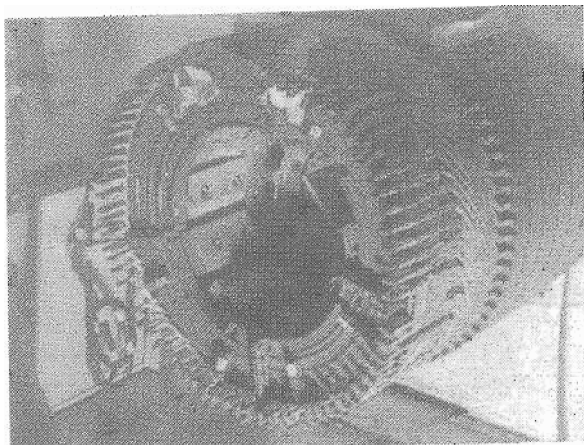
Figure 5. Exciter of turbine generator unit 3.

A major problem encountered by the plant was the failure of the exciter of turbine generator unit no. 3 due to short circuiting of the coil end connection at permanent magnet generator (PMG) side of slot no, 33 top coil and no. 34 top coil (Figure 5). Laboratory analysis of the dust collected in the area of failure showed a presence of copper sulfide (CuS). It is suspected that dust accumulated between the coils, and then the coil surface treatment peeled off due to overheating caused by ventilation interference. It is possible that CuS produced by H<sub>2</sub>S gas contributed to the failure. Inspection of unit 1 and 2 exciter coils showed also the presence of copper sulfide black deposits (Figures 6a and

Intensive repair of the damaged exciter coil was done in place to save operational downtime. The entire exciter unit was replaced with a new spare during the year 2000 scheduled plant turnaround.

As a preventive measure, the following are recommended to be done at the next periodic inspection in order to prevent the possibility of coil short circuit.

- Visual inspection
- Testing, such as megger test, etc.
- Continuous monitoring of operational data.
- Blowing fresh and a Glean dry air to rotor coil-end portions for cleaning.
- Re-treatment of anti-tracking epoxy varnish "Neo Gose #200" on the rotor coil-end surface to enhance prevention tracking ability.

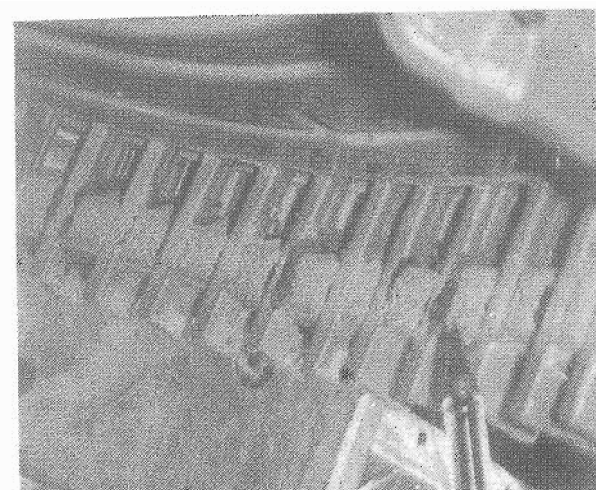
Figure 6a Unit 1 exciter mil-end showing the presence of copper sulfide (CuS) black deposits.

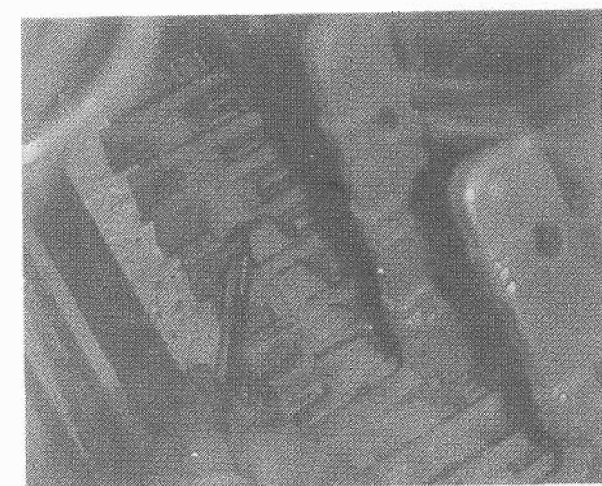
Figure 6b. Unit 1 exciter coil-end showing the presence of copper sulfide (CuS) black deposits.
