CASE STUDIES OF LANDSLIDE HAZARD OCCURRENCES IN GEOTHERMAL FIELDS: THE PNOC-EDC EXPERIENCE

R. D. Leynes, W. P. C. Pioquinto and J. A. Caranto

PNOC Energy Development Corporation, Merritt Road, Fort Bonifacio, Metro Manila 1201, Philippines

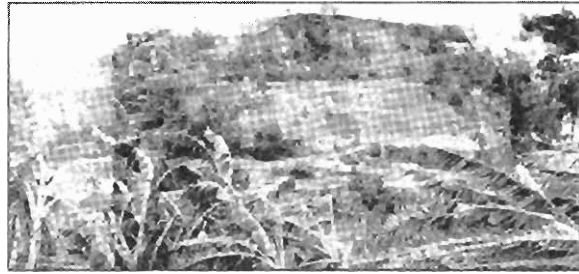
Except for the flexible support structures, the abovementioned remediation measures have been used in PNOC-EDC geothermal fields. The first remediation technique was employed in LGPF at the former Mahiao quarry area. In this area, the downward movement is occurring due to the removal of the toe support due to quarrying. Thus, the load above was reduced and the slope was benched to prevent further slippage. Photo 1 shows the removal of upper

Photo 1. View of the Upper Mahiao quarry after a reduction of the upper load and benching of the slope face has been effected.

load along the slope of the quarry face. The second scheme, control of surface water and seepage, was applied in the Malitbog quarry area where concrete water cascades were constructed water saturation of the formation. The more common remediation technique employed at PNOC-EDC is the construction of rigid structural barriers such as rubble masonry wall, concrete masonry wall, concrete lined canals, and pipe shelters. Photos 2-3 show examples of these structural barriers. Vegetation is also similarly included in this classification as a means of remediation. Vegetation is **selectively** conducted in the landslide affected area.

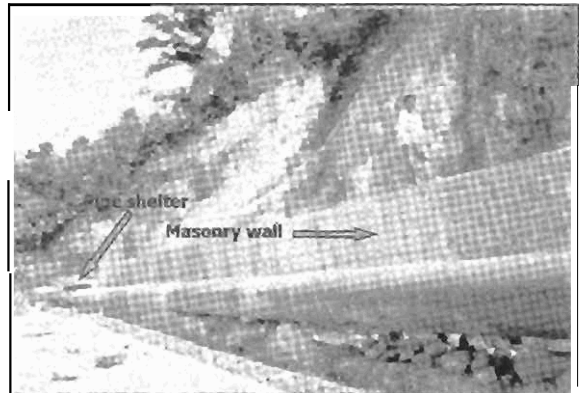
Photo 2. View along the Mahagdong-MGRD1B access road. Photo shows the newly constructed masonry wall. Also visible is the pipe shelter that was constructed to protect the pipeline from landslides.

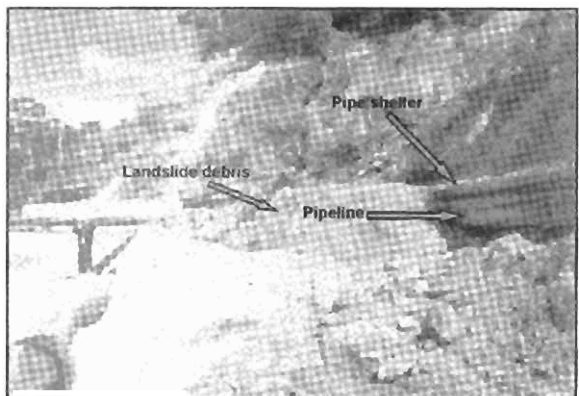
Photo 3. Taken along the Mahanagdong to MG-RD1B access road. Shown is a landslide which covered the pipeshelter and pipeline. The pipe shelter protected the pipe from damage.

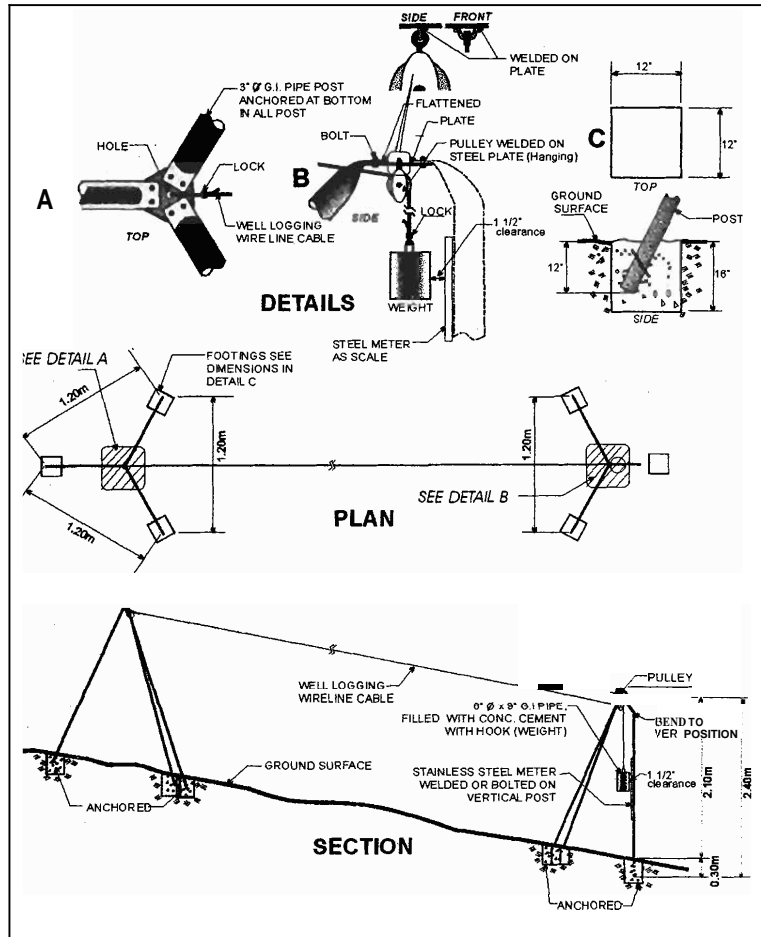
Figure 2 Design of extensometer installed in Tower No. 7 location.

Simple and cheap tools that are locally fabricated such as extensometers are also utilized in follow-up monitoring. This is currently being conducted in Tower No. 7, which is very critical in order to determine if it is still at risk of toppling.

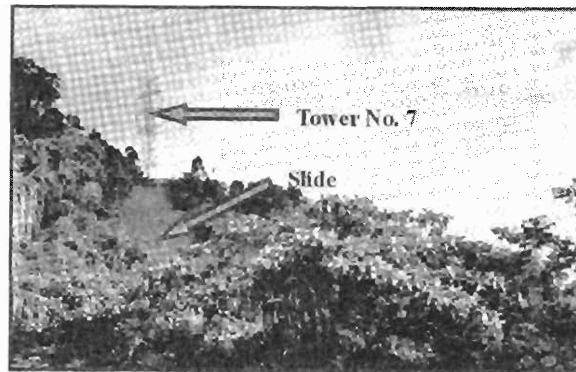
Tower No. 7 of the Leyte Geothermal Production Field is located at about 590 masl, northwest of the Malitbog power plant (Fig. 3). The tower site is flanked by steep slope on both sides about three meters away from the wall face. The rocks beneath the tower are mostly colluvium and/or debris materials, which is composed of highly- to moderately-weathered boulders of volcanics and breccias, underlain by highly weathered tuff.

During the height of Typhoon Auring last February 2001, a huge landslide occurred at the slope below the tower location. Rainwaters could have seeped through cracks near the edge of slope and along the periphery walls which were previously created by an earthquake (Arreza, pers. comm.). The concrete wall surrounding the tower is now at the edge of the landslide crown (Photo 4). Moreover, after the landslide, the cracks have widened and threatened the stability of the tower base and periphery walls (Fig. 4).

Photo 4. View of the slide at Tower 7. One side of the tower footings is now at the edge of the slide crown.

To mitigate the risk, engineering measures consisting of reinforced concrete masonry wall was built to protect and prevent the slope from further sliding (Photo 5). The site is also continuously being monitored using an extensometer that was locally fabricated (Photo 6).

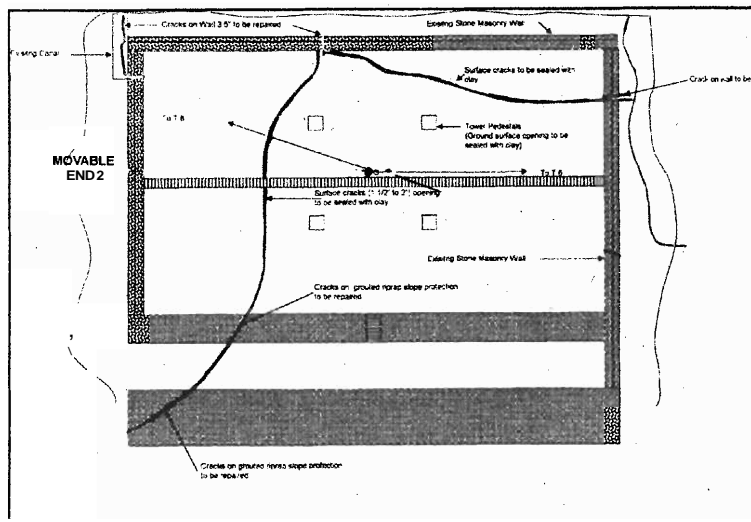
Figure 4. Top view of Tower 7 and the visible cracks opened up during May 8, 2000 earthquake.

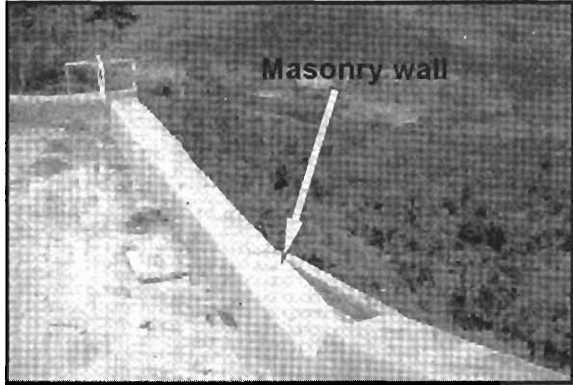
Photo 5. View of Tower 7 and the newly constructed masonry wall.

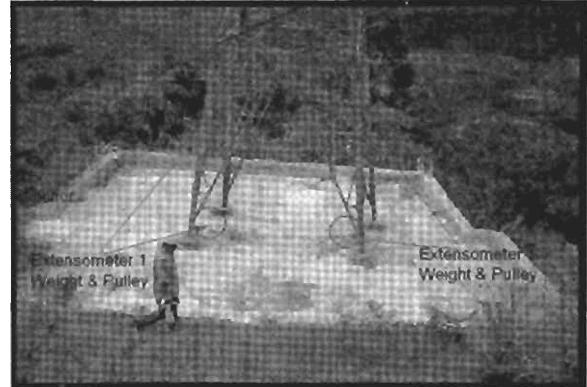
Photo 6. Location of landslide monitoring equipment at Tower 7, South Sambaloran.

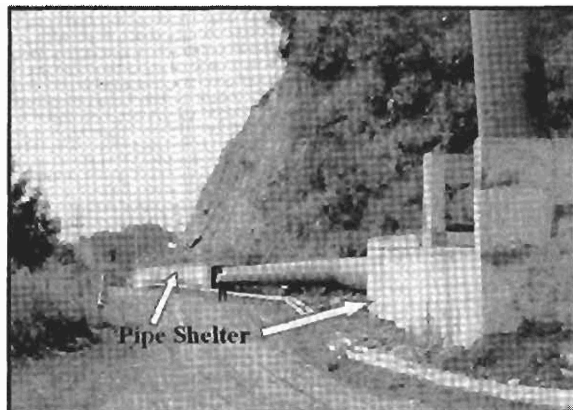
Photo 8. View of the FCDS route above pad E upper taken when the pipelines were already in place together with the pipe shelter. A landslide has occurred as evidenced by the remaining debris (most were already cleaned-up). The pipe shelter protected the pipelines.

On the basis of the above assessment, reinforced concrete pipeshelters were constructed after the pipelines were built to protect them from potential landslides. As a result, the FCDS lines in this portion were safeguarded from any damage during the 1999 and 2001 landslides. Photo 8 shows the area (now with pipeline and pipe shelter) after the Occurrence of the landslide.
