## SURFACE EQUIPMENT AND SUB-SURFACE CASING CORROSION AND EROSION - THE CASE OF BL-1D, SOUTHERN NEGROS GEOTHERMAL PRODUCTION FIELD, PHILIPPINES

Arvin R. AQUI

PNOC Energy Development Corporation, Merritt Road, Fort Bonifacio, Taguig City, Philippines

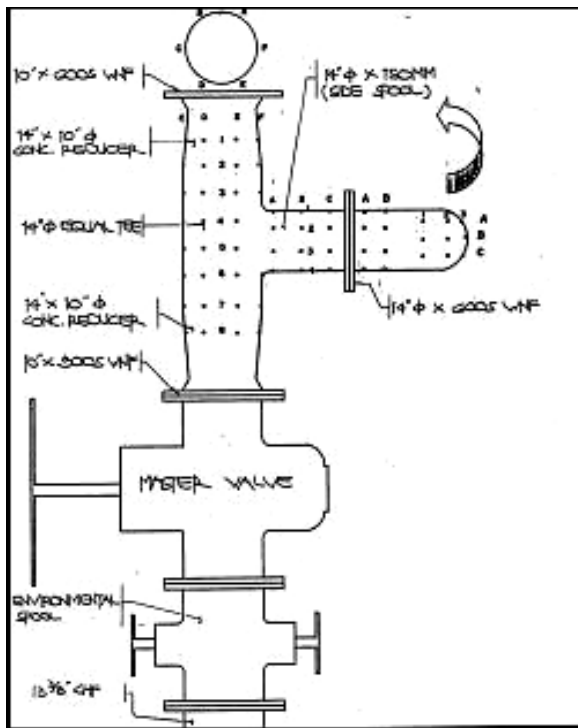
Figure 2. Wellhead tee and elbow (after Silorio, 1997).

Wall thickness measurements resumed shortly after the wellhead tee was replaced on January 13, 1997. Measurements were taken across the cross-sectional area (designated by letters, Figure 2) and along the length (designated by numbers, Figure 2) of the wellhead tee, elbow and upper section of the 13-3/8" anchor casing.

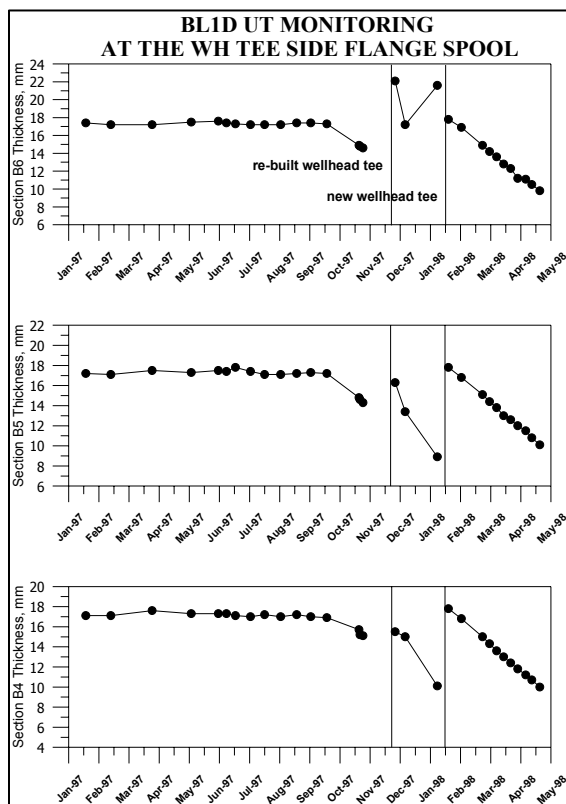
Figure 3. BL-1D thickness monitoring trend.

UT measurements of the 14"- wellhead tee within a fifteen-month period from January 1997 to March 1998 indicated that all points of section "B" (Figure 3) showed consistent and highest thinning. Exponential increase in the corrosion

rate was observed from an initial of ~1 mm/month prior to the second replacement to 5.3 mm/mo. and 2.6 mm/mo. prior to the third and fourth replacements. Replacement of the wellhead tee was based on an allowable minimum pipe wall thickness of 7.7 mm computed (using ANSI B31.1 equation) for an operating pressure of 0.76 MPag of the well. A slightly higher value of 11.5 mm was established for a shut-in pressure of ~3 MPag. The corrosion rate was highest prior to the third replacement as only a re-built wellhead tee was used. Accelerated thinning was also observed at the 14" inch elbow particularly in section "C", but unlike the wellhead tee, repairs were made to extend its service life. In both equipment, the excessive thinning generally took place where the flow direction of the discharging fluid changes from vertical to horizontal.

The accelerated thinning at section "B" of the well head tee and section "C" of the 14" elbow took place in time with the changes in the line chemistry of the well and the progression of the wellbore blockage from ~1700 mMD to ~1100 mMD. The line pH (Figure 4) dropped abruptly from an average of about 4.5 in the 1<sup>st</sup> quarter of 1997 to 3.0 – 3.5 in April 1997 that continued on to the first two months of 1998. Conversely, the total Fe concentration level (Figure 5) increased steadily from <20 ppm in March 1997, to 30 ppm - 40 ppm before it peaked to a high of almost 100 ppm in March the following year. It was earlier surmised that iron levels entrained in the discharging fluids were coming from the eroded wellhead assembly and surface pipeline. However, the elevated iron levels from October 1997 to February 1998, notwithstanding the installation of fully re-built tee on 27Nov97 and new wellhead tee in 9Jan98 suggested that these iron particles were coming from the wellbore. Also, the parallel occurrence of the accelerated thinning and the increase in iron concentration strongly implied the latter as the major cause of the former.

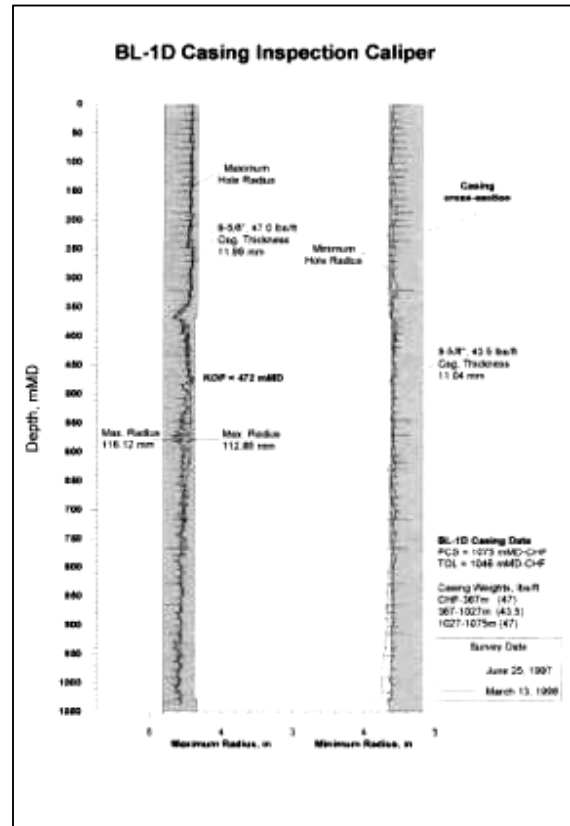
Figure 6. BL-1D composite plot of CIC results.

wellbore, a repeat casing inspection caliper survey was conducted on March 13, 1998. The objective was to check the casing wall thickness and the over-all integrity of the 9-5/8" production casing in preparation for the mechanical workover being considered at that time. The results positively identified the section between 460 mMD and 650 mMD to have appreciable yet un-circumferential thinning as evidenced by the composite plot of the June 25, 1997 and March 13, 1998 survey logs (Figure 6). The maximum radius measured at 576 mMD increased from 112.85 mm (June 1997 log) to 116.12 mm (March 1998 log) indicating a thinning rate of 3.27 mm over a 9-month period, which is consistent with the thinning trend at the wellhead tee and elbow. At a linear rate of corrosion, the well can further be utilized for about one year before the thinned-out section of the production casing would be eroded completely.

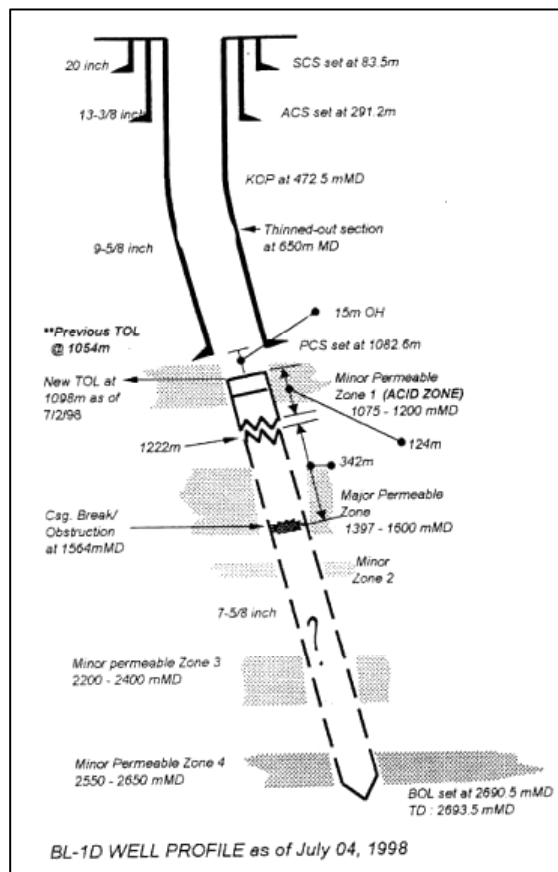
Figure 7. BL-1D casing profile after aborted mechanical workover (after Retuya, 1998)

Unfortunately, the workover objectives were not achieved due to unfavorable downhole conditions. The top of the 7-5/8" liner was tagged at 1090.5 mMD, about 44 meters below its original depth of 1046.9 mMD, creating a 15 meter gap of open hole between the production casing shoe which was set at 1075.6 mMD. In addition, a liner break existed at 1214.5 mMD leaving the upper and lower section off-centered. The rig was able to clear the slotted liner at the vicinity of the major permeable zone up to 1556.5 mMD but a hard obstruction at this depth prematurely terminated the workover operation. Relining of the thinned out section of the production casing was also foregone due to technical difficulties associated with this activity (Figure 7).

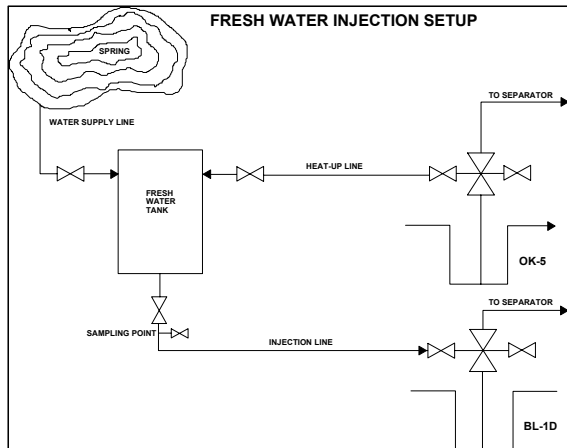
Figure 8. BL-1D fresh water injection set-up.

Steam blowing prior to the well's commissioning indicated a relatively high content of total suspended solids (TSS) entrained in the steam flow evidenced by abrasion marks on the target plate. Spring water injection at the two-phase line through the bleed line was conducted to reduce TSS carry-over in the steam flow (Figure 8). By principle of adhesion, the suspended solids were weighed down and separated from the steam going to the turbines. Heating of the spring water was also carried out to remove dissolve oxygen from the spring water, and to minimize the cooling effect on the two-phase fluid during injection. Water injection facilitated BL-1D steam acceptance to the plant in October 1995 and was continued until it was terminated in 1996 when TSS level had diminished when the well's discharge became dry.

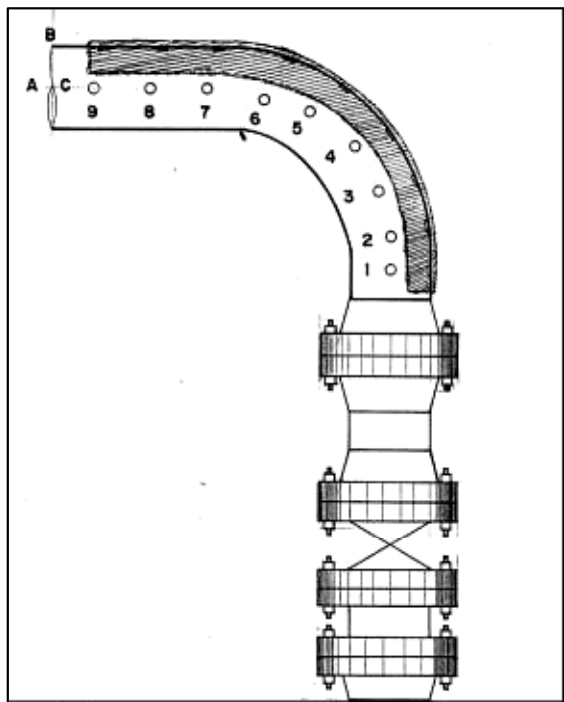
Figure 9. BL-1D Sweep "S" Bend Section (after Catacutan, 2000).

The frequent and the narrowing interval of replacement of the wellhead tee had rendered the operation of the well no longer cost effective not to mention the loss opportunity brought about by the frequent well shutdown. Thus, after the aborted mechanical workover, the wellhead configuration was revised to adopt a sweep bend atop the master valve (Figure 9). The re-configuration of the wellhead shifted the point of excessive corrosion and erosion from the expensive wellhead tee to the relatively cheaper sweep bend. Like the wellhead tee, the

section with severe erosion was found at the points where the flow direction changes. But unlike the frequent replacement of the wellhead tee, welding of a metal jacket around the thinned out section can extend the service life of the S-bend.

Other short-term interventions implemented included the replacement of the thinned out wellhead tee, welding of the outer walls of the 14" elbow and installation of metal jacket on the S bend. Re-lining of the thinned-out section of the production casing was also considered but was aborted due to unfavorable downhole conditions. However, all these served only as stopgap solutions designed to sustain the commercial operation of BL-1D but fell short in putting a complete stop to the recurring problem. Opening-up of the feed zone at the bottom would have made a lasting solution had the mechanical workover succeeded in clearing the wellbore blockage. Contribution from the neutral, liquid-dominated feed at the bottom zone could have minimized if not eliminated the problem of surface and sub-surface erosion.
