DAMAGED WELLHEAD REHABILITATION OF WELL OK-5 SOUTHERN NEGROS GEOTHERMAL PRODUCTION FIELD, NEGROS ORIENTAL, PHILIPPINES

Gino P. dela Cruz and Carlo M. R. Borromeo

PNOC Energy Development Corporation, Merritt Road, Fort Bonifacio, Taguig City, Philippines

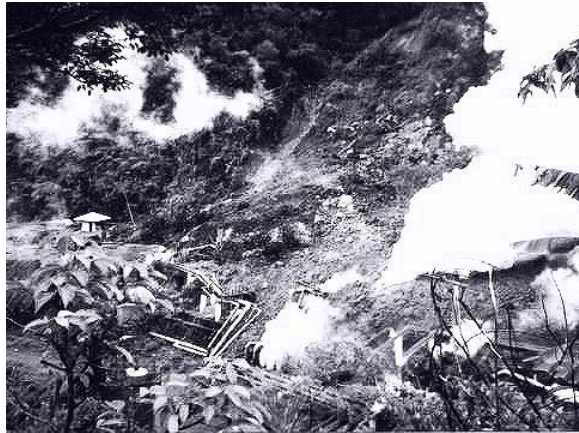
Figure 1. The landslide

and wells OK-5 and BL-2D. Well OK-5 was discharging uncontrollably through the debris (Figure 1). Access and mobility in and around the site was limited due to the muddy debris. Clearing of the debris was necessary before damage assessment could be conducted. It took 28 days to partially clear the production well pad to allow closer inspection of the damage. Slope stabilization was also necessary to ensure the safety of personnel working in the area. The plant was immediately put on shutdown and PNOC-EDC invoked Force Majeure as provided for in the Steam Sales Contract with the National Power Corporation (NPC). With this provision, overrides the 75% Guaranteed Generation provision in the Contract and PNOC-EDC was not liable to pay any charges to NPC throughout the 6 ½ month rehabilitation period.

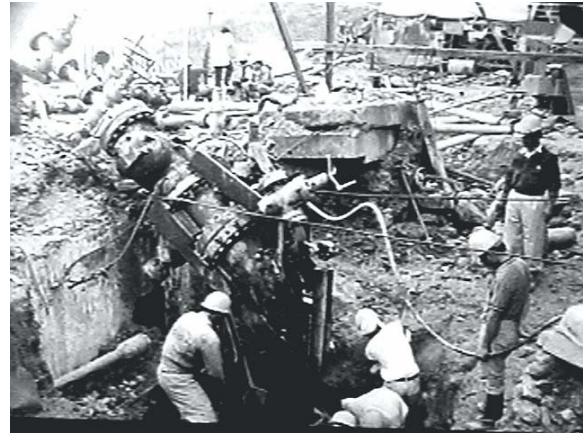
Figure 2. The damage on the wellhead of OK 5.

- The wellhead 10" tee above the master valve was completely sheared-off at the flange neck weldment (fullbore discharge to atmosphere) (Figure 2).
- The weldment between the CHF and the 13-3/8" anchor casing was partially sheared with an opening of about 1" (minimal steam leak).
- The wellhead components from the CHF up to the master valve were held in place only by the 9-5/8" production casing.

- The whole wellhead was tilted at about 37 degrees and resting on the cellar wall.
- The master valve stem was bent approximately 5 degrees (it was not possible to operate the valve).
- All associated pipelines and wellhead equipment were damaged hampering the steam supply to the Modular power plant.

from the target area to allow personnel to work at the specific part of the wellhead where there was leak. The master valve stem was straightened to allow operation of the said valve. With the master valve shut, quenching of the well commenced by pumping water through the break in the 13-3/8” anchor casing.

With continuous water injection, the master valve and expansion spool was removed. The CHF was also removed by cutting-off the anchor casing at 1.0 meter below the CHF. A leak at the anchor casing reduced the flow rate of injected water and almost initiated a blow-out. The leak was eventually stopped and repairs continued. The new CHF was installed and finally the master valve was put in place on December 31, 1998 at 9:15 p.m. Highly skilled welders were contracted to weld the casings at hot condition. Complete rehabilitation proceeded in next 5 months – replacement of production lines, wellhead supports, and other accessories. Force majeure was lifted by PNOC-EDC on May 7, 1999 (Quevenco, 1999). Total rehabilitation took 6 ½ months.

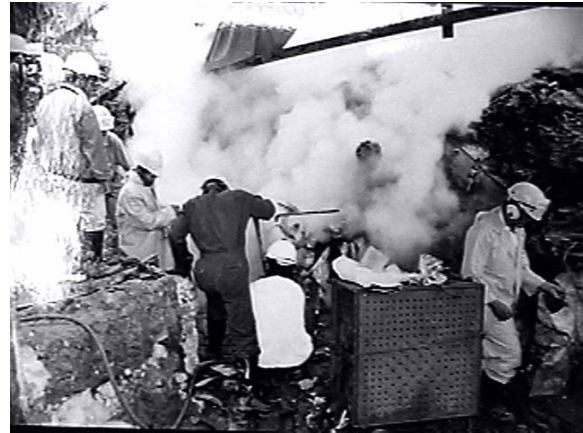
- The noise level was intense and communication was possible only through hand signal or written notes (Figure 3).
- Rainy weather made the surrounding soil muddy slowing down mobility around the wellhead.
- There was poor visibility due to the presence of escaping steam in the wellhead cellar making welding difficult.
- Movement of the 9-5/8” casing when the well was quenched.

Figure 3. Physical factors that increased the risk and slowed down the task: noise, heat, mud, and steam.
