FAILURE INVESTIGATION OF CAPILLARY TUBING (ASTM 316L) USED FOR CALCITE INHIBITION

Mayflor N. Ramos-Candelaria¹ and Keith A. Lichti²

¹PNOG Energy Development Corporation, Merritt Road, Fort Bonifacio, Taguig City, Philippines
²MPT Ltd., Gracefield Research Center, Gracefield Rd., Lower Hutt, New Zealand

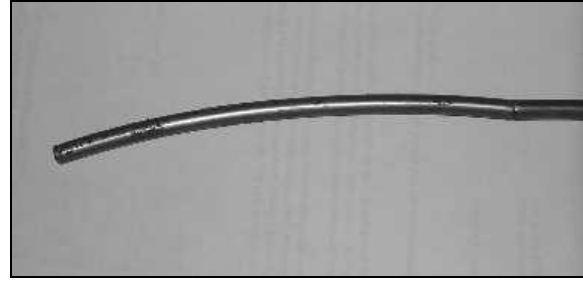
Visual examination using an optical microscope showed pits and cracks concentrated on the inner curvature of the tubing (Fig. 1). This is typical of a tubing which has been run through a pulley. The pits are shallow spherical holes in random clusters occupying ~3% of the total surface area of the tubing (Zaide-Delfin, 2001). The pits have an average diameter of ~0.8mm and a depth of ~0.14mm (Zaide-Delfin, 2001). They are mostly concentrated on the inner curvature of the tubing, although a few cracks and pits are also found on the outer curvature.

Figure 1. Damaged portion of the capillary tubing showing the pits cracks and corrosion products concentrated on the curved side.

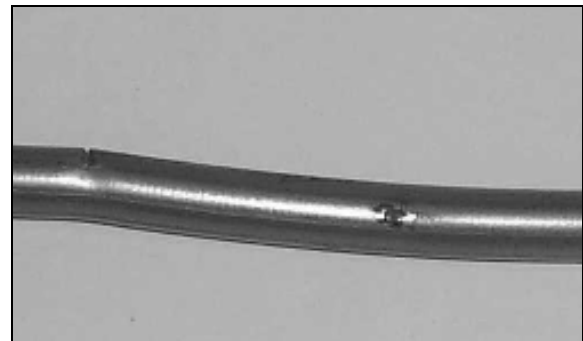
The cracks are crevices oriented perpendicular to the length of the coil tubing (Fig. 2A), associated with corrosion pits. The cracks propagate from the pitting corrosion. Some cracks are wide open and show that they have penetrated or breached the tubing wall. The length of the wide cracks is from ~4.0 to 5.0 mm, with width of about ~0.5 mm (Zaide-Delfin, 2001). Most of these open cracks are located in the inner curvature as the tubing is pulled in a pulley. This is the area of compressional stress.

Gray to black corrosion products with whitish scales are found within the pits. Adherent reddish brown corrosion stains are very visible in the uncorroded areas close to pits and cracks (Fig. 2).

Figure 2. Closer view of the opened cracks which penetrated the tubing and the pits with associated corrosion products.

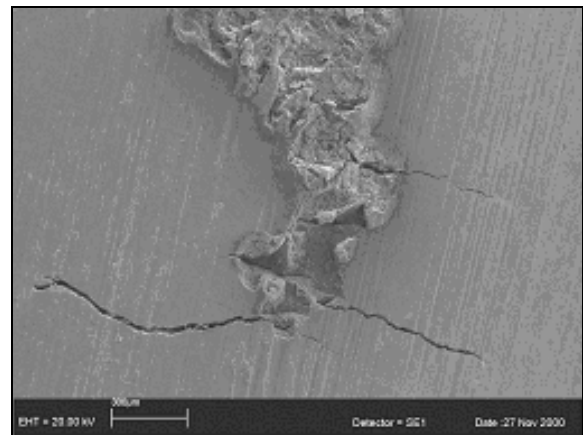
Thin section analysis of the parted tubing show that cracks are propagating from outside the tubing. Cracks were always associated with localized pitting corrosion (Fig. 3). Cracks seen on the surface of the tube form a branching pattern typical of stress corrosion cracking

Figure 3. Localized corrosion pit with cracking originating in the pit and first stages of propagation into the un-corroded material.

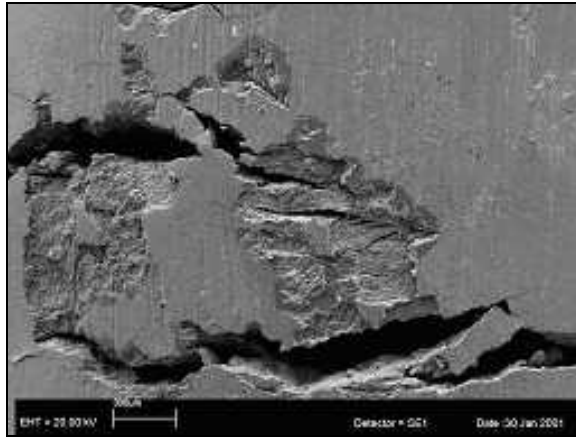
(SCC). Multiple cracks were seen from most pits but some pits had not yet caused cracking (Fig. 4). Crack opening was primarily by plastic deformation. Finer cracks emanating from the inside of the tubing are just starting to show. However, these finer cracks have not

Figure 4. Multiple cracking in localized corrosion pit, with cracks opened by plastic deformation.

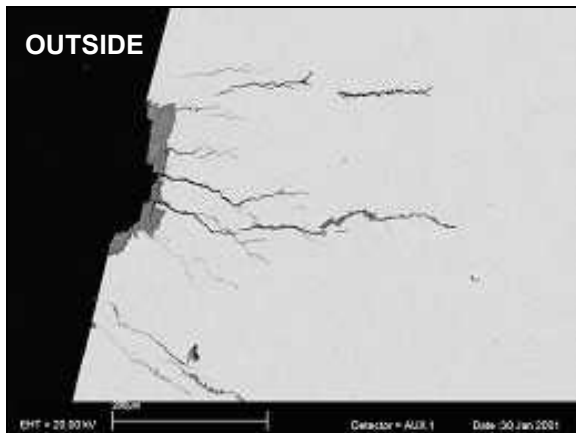
Figure 5. Cross section showing multiple branched cracks originating from corrosion pit.

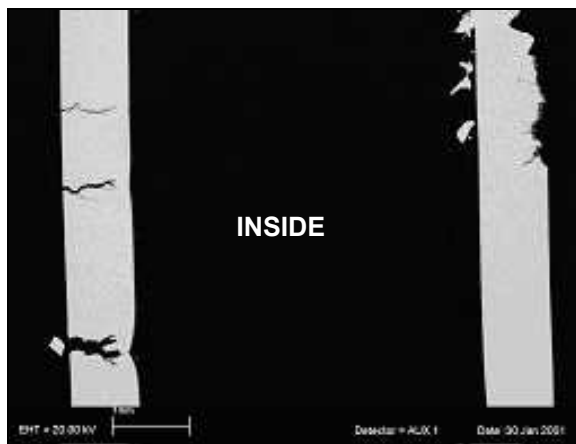
Figure 6. Cross section showing opening crack with plastic deformation on the internal surface.

Scanning Electron Microscope (SEM) examination and Energy Dispersive X-Ray Analysis (EDAX) of the corrosion products present was conducted at the MPT Laboratory. Optical examination revealed that there is minimal corrosion on the inside surface. The cracking was initiated from the outside surface, with multiple cracking occurring from single pits (Fig. 5). Crack opening was primarily by internal plastic deformation at the time of final failure (Fig. 6) indicative of high temperature conditions.

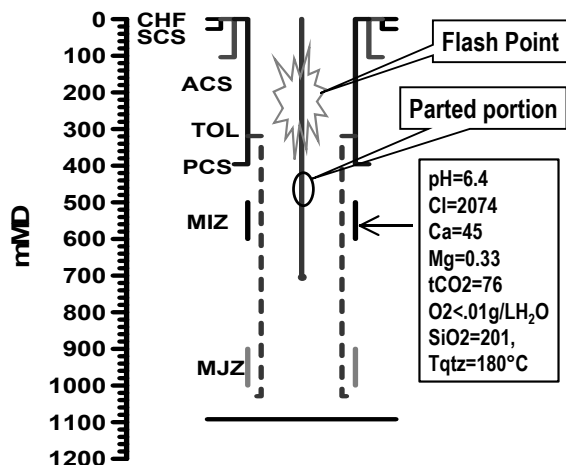
Review of the downhole well profile of MO-2 shows two feed zones at 500-600 mMD,- with major feed zone at 900-1000 mMD (Fig. 8). Both zones have close to neutral reservoir pH (6.4) waters, calculated DO levels of 0.01g/L H_2O , Ca of 200-400ppm, Cl levels of 2,000-6,000 ppm, SO_4 levels of 50-70 ppm, $\text{H}_2\text{S}_{\text{TD}}$ and CO_2_{TD} levels of at 0.57 (or 10.8 ppm) and 41 (or 729 ppm) mmols/100 moles steam, respectively.

Figure 8. MO-2 well profile showing the location of feed zones, flash point depths, injection tubing and relative position of the parted portion of tubing inside the well.

However, under full bore conditions, the flash point is expected at a shallower level of 100 mMD. Tubing breakage is coincident with ~470 mMD, located deeper than the flash point region in well MO-2 (Fig. 8). It is believed that physical and chemical conditions requisite for the stress corrosion cracking phenomenon leading to the tubing failure were not initially encountered in well MO-2. In fact, a replacement capillary tubing (also of SS 316), which was run-in last October, 2000 is still in service at well MO-2. It was pulled out and recovered intact last April, 2001.

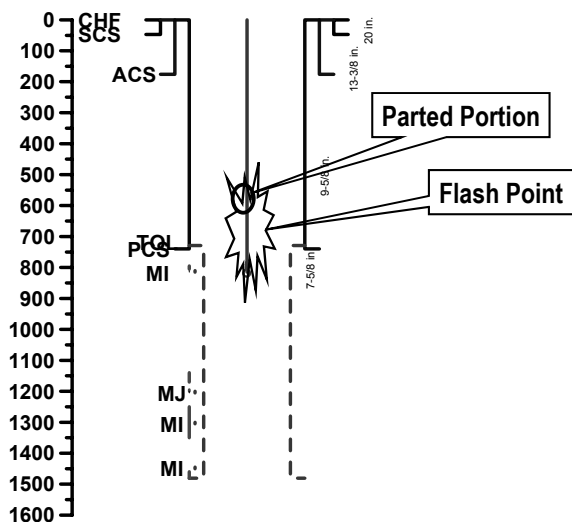
Figure 9. SP-4D well profile showing locations of permeable zones, flash point depths and injection tubing with relative position of parted section inside the well bore.
