SCALING AND CORROSION IN SEPARATOR VESSEL 303, BACMAN GEOTHERMAL PRODUCTION FIELD, PHILIPPINES

Sylvia G. Ramos¹, Josephine B. Rosell¹, Keith Lichti², Fidel S. See¹,
Jimmy J. Fragata¹, Danilo B. Rubin¹, and Raul Evangelista¹

¹PNOG Energy Development Corporation, Merritt Road, Fort Bonifacio, Taguig City, Philippines

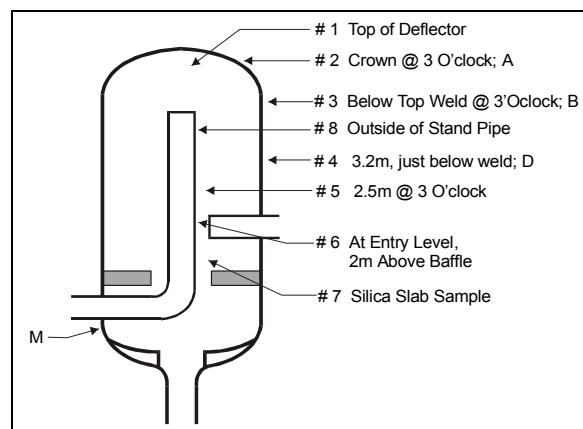
Figure 2. Location of samples and UT measurements in SV-303.

- The original thickness of the dome and upper and lower side walls was 20 mm while the central region of the separator wall is thicker at 25 mm.
- The corrosion allowance is 3 mm or greater giving a minimum allowable wall thickness of 17 mm.
- The dome of the vessel is over the design wall thickness of 20 mm (Position A, Sample 2 Location, Fig. 2).
- The wall thickness measurement at the upper side wall (Fig. 3) was the lowest measured but was only 0.67 mm less than original design thickness (Position B, Sample 3, Location, Fig. 2).

- Wall loss in the central and lower areas where corrosion products are formed with entrained clay was low at 0.2 mm (Position D, Sample 4 Location, Fig. 2)
- Wall loss in areas where silica scales were deposited was low (Position M, Fig. 2).
- The exposure time was taken as 8 years assuming the vessel was in more or less continuous service and this gave a maximum corrosion rate of 0.8 mm/year at Position B (Fig. 2)
- Assuming corrosion continues at the same rate, the time to reach the corrosion allowance is 28 years for Position B where thin corrosion product scales form; and 100 to 300 years for areas where thicker corrosion products are formed or silica films deposited.

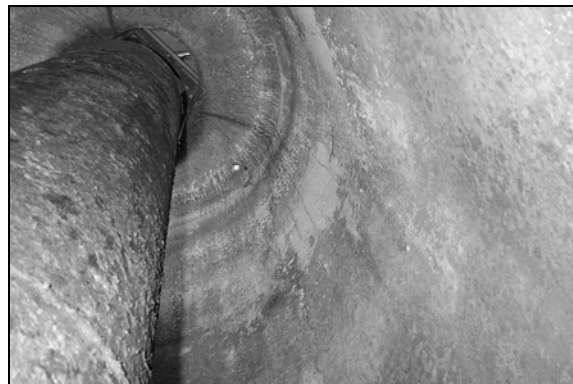
The initial visual inspection suggested scale and corrosion product deposition over the majority of exposed surfaces with no obvious areas of localized corrosion. The surfaces were generally smooth in appearance with no significant local growths as might be expected if pitting corrosion were occurring. Of note was the apparent thin corrosion product films in the upper wall area just below the dome to wall weld (Fig. 3).

Figure 3. View of inside of separator showing steam stand pipe, upper side wall and dome with seemingly thin corrosion products in the area of the upper side wall below the dome weld.

- The area was a slightly different colour than other areas with thick corrosion products (Fig. 3).
- Scraping yielded minimal corrosion products.
- The chipping activity used to remove material from this area yielded metal pieces with thin layers of corrosion product (Figs. 5 and 6).
- The material lost in this area was greater than in areas where thicker corrosion product films are formed or where silica scales are deposited.

These observations suggest that the metal pieces were standing proud of the surface with thin corrosion product layers over the top. The base material of the surface may also be covered in thin corrosion product. The lack of thick films and roughened metal surface is consistent with the area being subject to erosion-corrosion. This hypothesis is reinforced by the Ultrasonic Thickness measurements that show a readily detectable wall loss of 0.67 mm and suggest an erosion-corrosion rate of 0.08 mm/year (Table 3).

An extended operating period before the next shutdown for repeated Risk Based Inspection and PMS is suggested by the initial PMS results and reinforced by this first Risk Based Inspection. Monitoring of operating conditions and chemistry is proposed as a means of ensuring that the physical and chemical conditions remain the same in the interim and that the predicted low scaling rate is maintained. Monitoring of wall thickness by external Ultrasonic Thickness measurement is also recommended to ensure erosion-corrosion rates are within the predicted range.

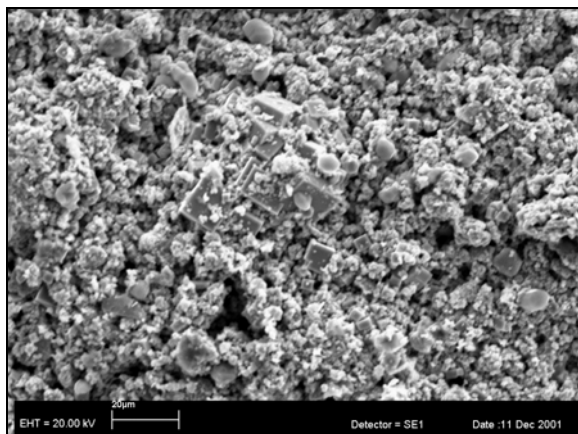
Sample #2. Crown area above the level of the baffle at the 3 o'clock position. Fine flaky banded hematized corrosion products were removed from the crown area of the separator vessels. These banded corrosion products were composed of 75% pyrite and 25% hematized magnetite. Pyrite normally banded with or coated or lined hematized magnetite. It had an average band thickness of 0.22 mm. It also occurred as fine anhedral to euhedral cubes floating within hematized magnetite. The occurrence of magnetite in this sample was similar to that in Sample # 1. Its band thickness ranged from 0.08-0.2 mm. It also occurred as "islands" within or coated by pyrite. Some anhedral to euhedral magnetite laths embedded in pyrite were also leached out.

SEM EDX analysis on this sample yielded major sulfur and iron and minor oxygen. Figure 4 shows SEM view of crystals of iron sulfides (FeS_2).

Figure 4. SEM view of top of corrosion product removed as Sample 2, crystals appear to be FeS_2 .

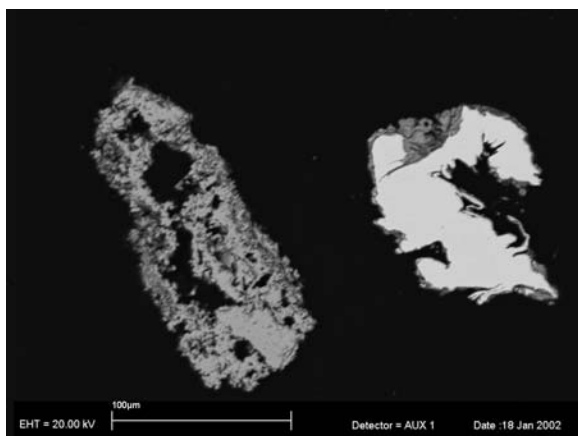
Sample #3. Below top weld at 3 o'clock position. Very tiny flakes of corrosion products were collected from this location (Fig. 3). Scanning Electron Microscope (SEM) X-Ray Analysis (EDX) was done on the small samples collected. Figure 5 shows an SEM view of a cross section of metal particle and corrosion product analyzed by SEM EDX as iron and oxygen only. The corrosion product on the sample on the right had iron, sulfur and oxygen while the white area was metallic iron. Another SEM EDX analysis on a cross section of

Figure 5. SEM view of cross sections of particles collected as Sample 3, note corrosion product on left contains only Fe/O while white metallic chip on right is Fe with corrosion product containing Fe/O/S.

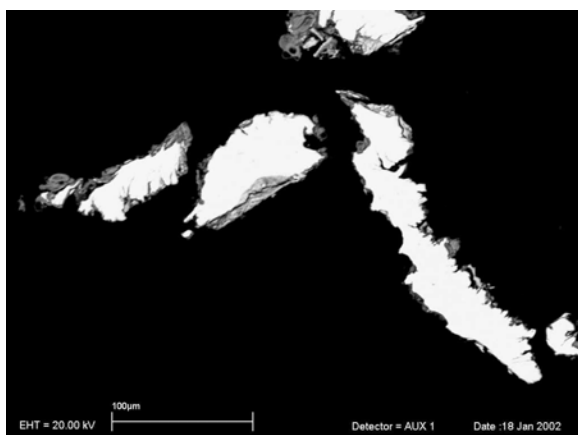
Figure 6. SEM view of metallic flakes of Fe with corrosion products of Fe/O/S and areas not Fe/O.

corrosion products (Fig. 6) yielded mostly iron/oxygen/sulfur and areas of iron/sulfur over metallic iron particles. Figure 6 also shows SEM crosssection view of multilayered metal particles and corrosion products. EDX analysis of this cross section suggests the top layer of corrosion products is mostly magnetite with no sulfur while the lower layer is rich in sulfur, possible pyrite. The middle layer is a mass of iron/oxygen and sulfur, possibly interlayers of magnetite and pyrite.

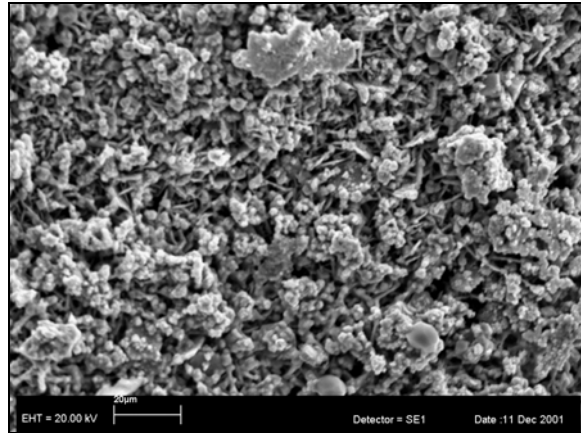
Sample #8. Outside of stand pipe. Thick flakes of gray, black and brown corrosion products were taken from outside of stand pipe, inside curvature next to the surface. The sample yielded multilayered hematized magnetite (60%), pyrrhotite (20%) and 20% pyrite (20%). The hematized magnetite occurred as either thick bands (0.04-0.4 mm thick) with internal concentric layerings, or was locally pitted, finely acicular or globular aggregates. Pyrrhotite minerals were acicular aggregates, anhedral to subhedral rimming or fine disseminations within hematized magnetite. They also occurred as isolated clusters. Pyrite was seen either as stringers, rimming or as cubic aggregates within hematized magnetite. Veinlets of cubic

Figure 7. SEM view of inside surface of corrosion products collected from the steam stand pipe.

SEM EDX analysis of crystals from the outside surface indicates the presence of iron sulfides, while analysis of the inside surface suggests iron sulfides and oxygen are present. Figure 7 shows an SEM view of samples from the inside surface of collected product.
