A GEOSCIENTIFIC APPROACH IN THE DESIGN AND SUCCESS OF THE FIRST RELIEF WELL AT THE LEYTE GEOTHERMAL PRODUCTION FIELD

Edwin B. Herras¹, Joeffrey A. Caranto¹ and Ricardo R. Palma²

¹PNOC Energy Development Corporation, Merritt Road, Fort Bonifacio, Taguig, Philippines

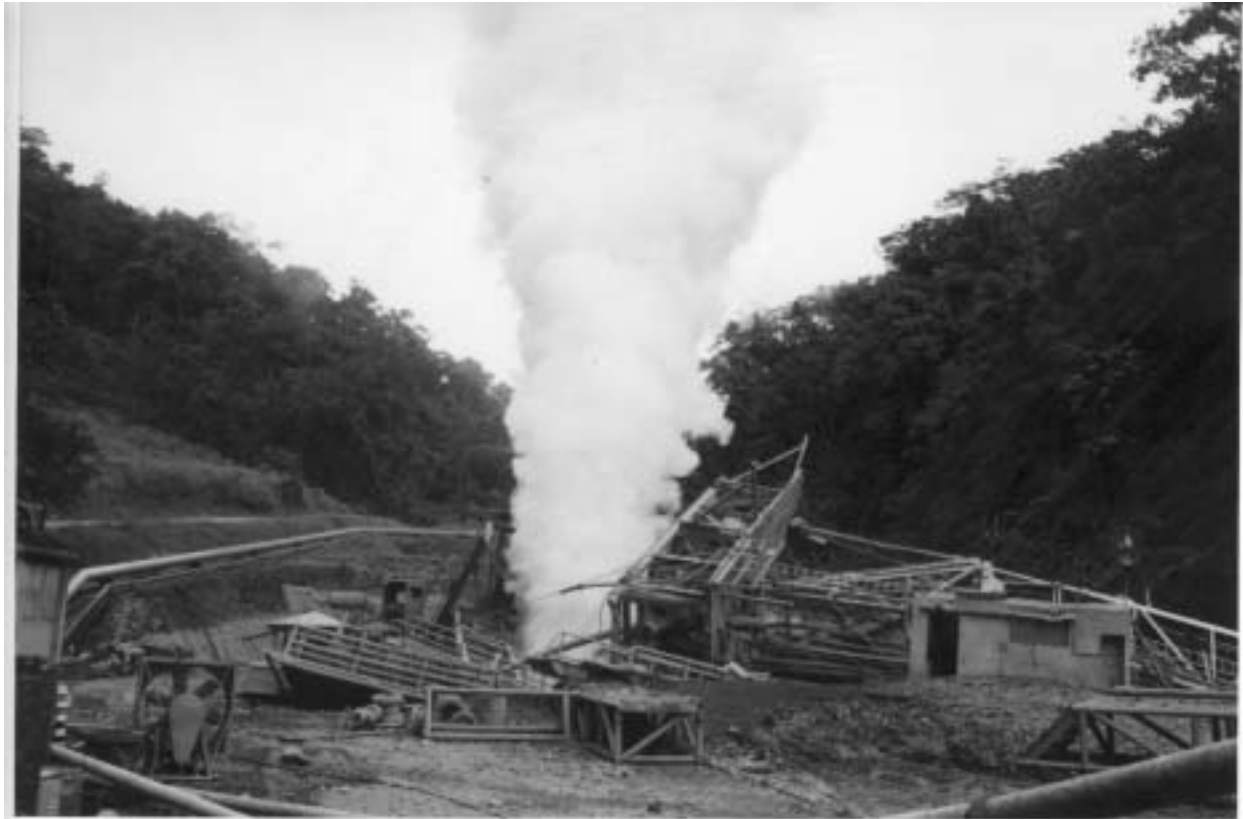
Well 5R12D was drilled as a reinjection well in pad 5R4 of the Malitbog sector to augment the injection capacity of the 231 MW Malitbog VGPC power plant. The well was spudded last July 19, 2003 and its 610 mm surface casing was set at 110m. Drilling of the 533 mm hole proceeded normally and was being drilled to 430 m (-74 mRSL) last August 2, 2003 when it encountered partial loss circulation (0.5-1.0 l/s) until 436m and persistent total loss circulation (TLC) from 436 m to 441 m. After conducting two cement plugs to seal the loss zone, drilling proceeded at 3.0 mph prior encountering again intermittent TLC's from 441 to 447 m. The drill string was momentarily pulled back to 157 m to build up additional mud volume. Blind drilling using water commenced from 447 m to 450 m (-94 m reduced sea level, mRSL) until the mud was used up and so the string was again pulled back to 106 m (shoe of 20" casing) to build enough mud volume. After pullout of the string to 106 m, the well kicked. The annular preventer was closed while the excess pressure was bled off through the bleed line. Water was then pumped through the string at 37 li/s but apparently this was insufficient to quench the well. After a few minutes, steam was noticed coming up in the cellar area. Additional water was pumped in the annulus through the connected cementing lines at 26 li/s. The steam discharge intensified, forming a mushroom-like cloud that rose some 50 m above the well, and thereafter, spewing mud, soil and rocks. A crater structure soon developed around the concrete cellar area that made the whole rig fall on its side after 8 hours of continuous and uncontrolled discharge (Fig. 1).

Figure 1. The uncontrolled discharge in well 5R12D that sent steam rising some 50 m above the well. On its side is the fallen rig and debris from the well.

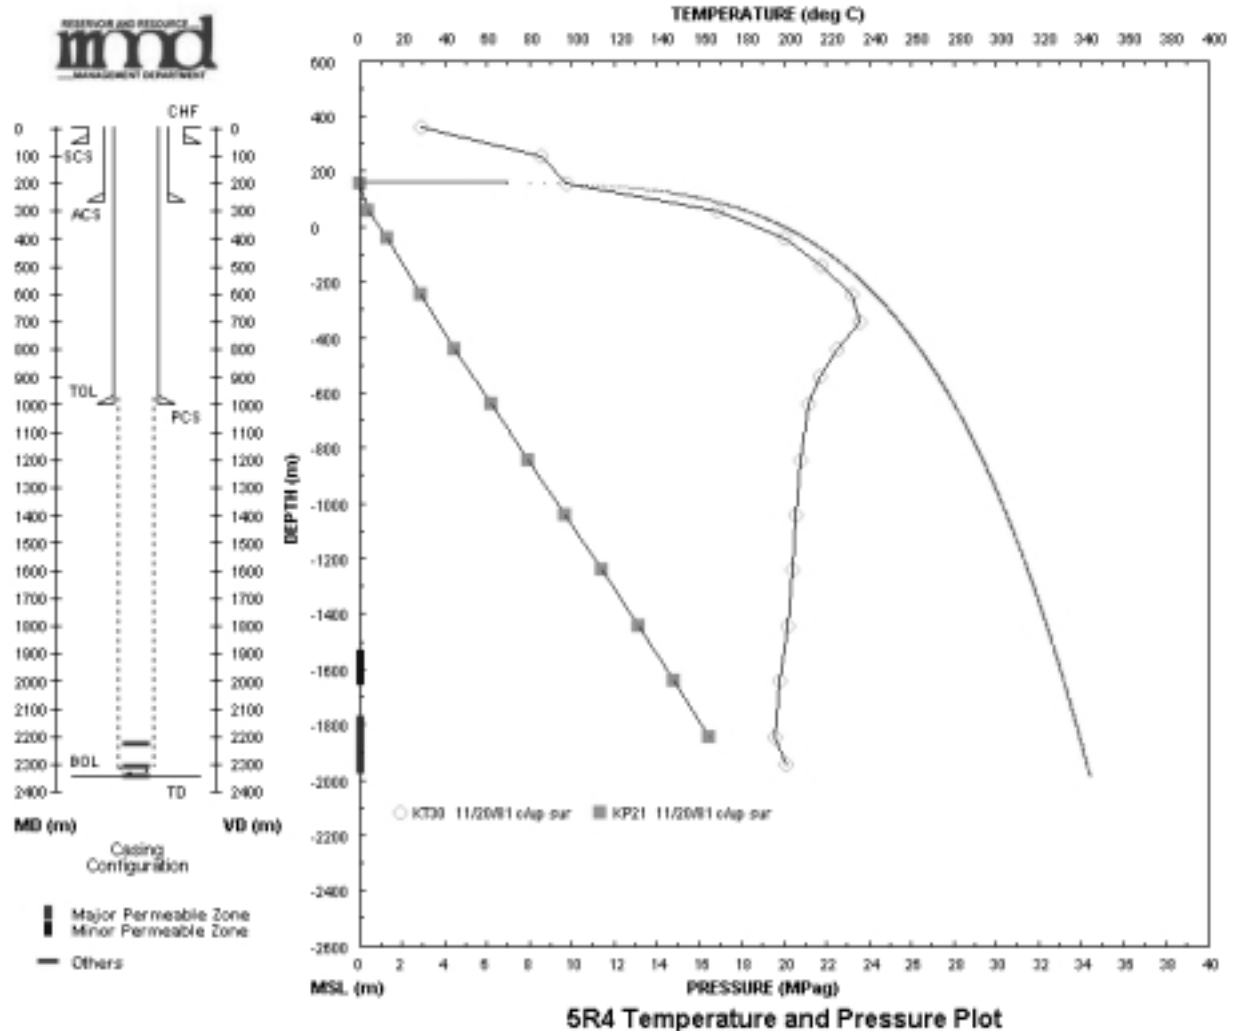
Figure 2. Plot of temperature profile of adjacent well 5R4 with the BPD curve.

temperature of 165°C down to the wells' bottom. In the adjacent well 5R4, relatively high temperatures of 240°C exist at 600 to 700 mMD. A comparison of 5R4 temperatures and pressure with the Boiling Point with Depth (BPD) curve for pure water suggests two-phase (water + steam) conditions present at these depths (Fig. 2). It should be noted that well 5R1D was previously displaying two-phase conditions prior to 1996 but after the initial large-scale injection in the area late 1996, the well reverted to single-phase conditions. Well 5R4, however, has remained two-phase to the present and develops a WHP of 3.5 to 4.0 MPag during shut conditions.

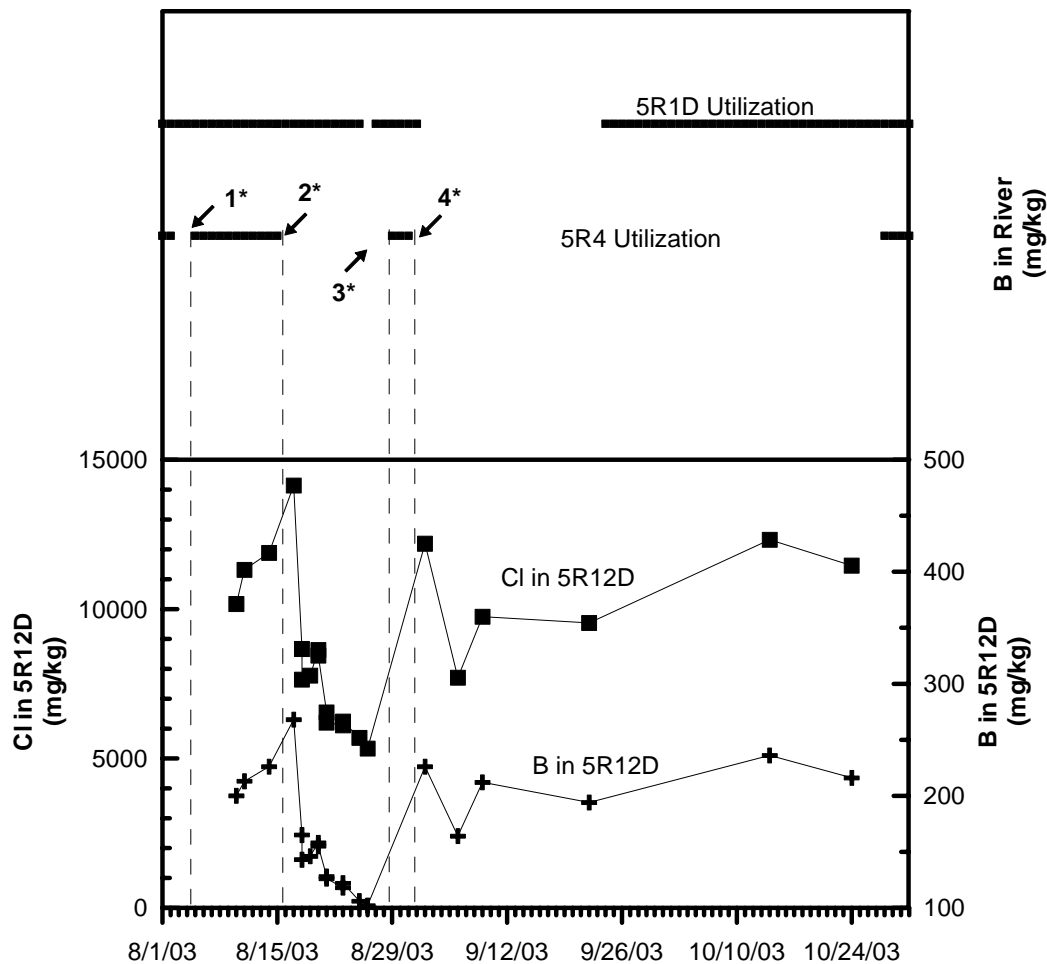
Figure 3. Well 5R12D chloride and boron trends versus 5R4 utilization.

After nearby injection wells 5R1D and 5R4 were put back on-line at a load of 57 kg/s and 110 kg/s, respectively, the formerly dry steam discharge of well 5R12D started to have some water component as evidenced by the light mist falling on the pad. Subsequent water samples taken from the 5R12D cellar/pad had a chloride content of 11880 ppm and boron of 226 ppm, almost similar to the chemistry of the RI fluids injected into 5R4/5R1D (Fig. 3). Calculations confirmed that the chloride concentration of the injected brine in 5R4/5R1D of 10000 mg/kg, when boiled to the atmospheric pressure of Pad 5R4, would correspond to a ~12000 mg/kg concentration of the blowout in 5R12D. The communication of 5R4 to the 5R12D discharge was possibly through the casing breaks at 369 mMD (-5 mRSL) and 560 to 563 mMD (-196 mRSL) associated with the Bayabas Fault intercepts. These casing breaks at 369 mMD (milled during workover) and at 560 mMD was confirmed by spinner survey in 1997 with a

measured inflow of 20 kg/s (7.6 BPM). Nevertheless, there were periods (mostly in October 2003), wherein the chloride and boron of 5R12D remained relatively high even though 5R4D was not online. It is postulated that 5R12D could also be drawing-in the injected brine from 5R1D but through the existing formational permeability of the MF.

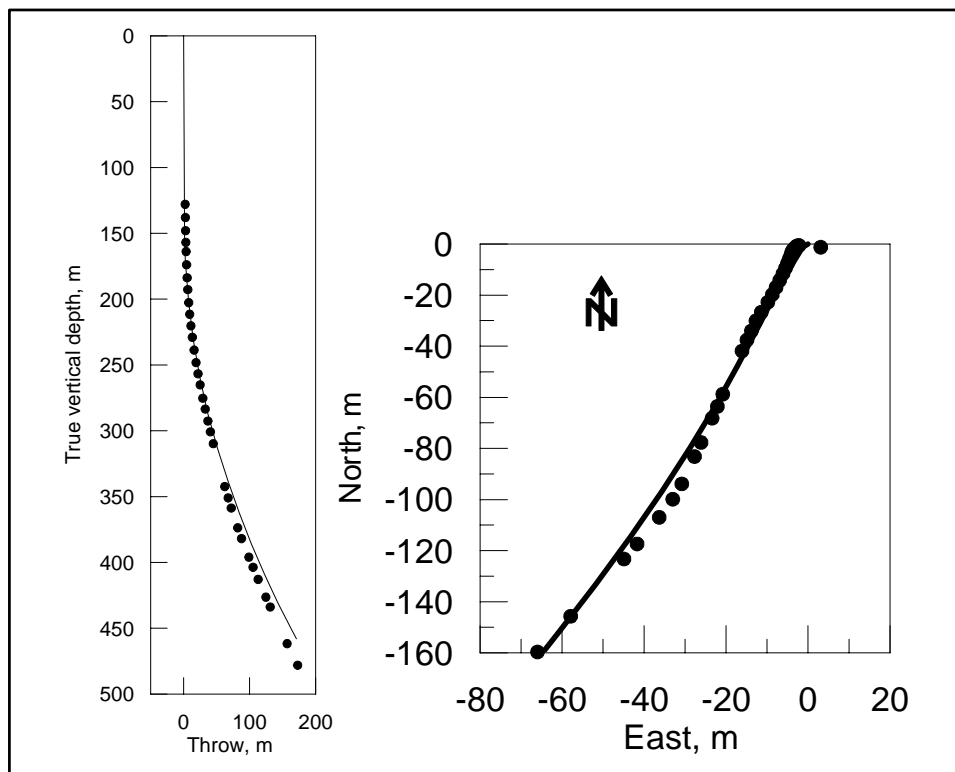
Figure 4. Directional plot of the relief well showing its semi-arcuate configuration. Build rates of $5^{\circ}/30\text{m}$ were needed to hit the target.

the slide, which was worsened by the continuous drizzle from the discharge of 5R12D, the next obstacle was carrying out the stringent well design that involved a shallow kick-off point at 120 m, a high build-up rate of $5^{\circ}/30\text{m}$ and a steep drift angle of 39° to target the shallow bottom hole of 5R12D at the equivalent depth of 427 mMD, correlatable to the 87° dip of the Bayabas fault and the permeable volcanic horizon. More so, the new pad laid alongside the Bayabas Fault, the main conduit of the two phase fluids of 5R12D, so the welltrack have to be initially veered away from the structure to avoid premature intersection and then turning it back near the bottom, forming a semi-arcuate configuration (Fig. 4).

The well was drilled according to plan but the required 39° drift angle was achieved only after sidetracking the hole using a 3.5° bent orienting sub (BOS). The 244 mm production casing was set and cemented at 446 m. The final hole section was drilled to intersect the target. A steep rise in flow line temperature and drilling breaks at 477 m preceded a TLC at 485 m

(-54 mRSL). To assure direct communication and ease in kill pumping of the discharge, drilling continued without returns from 485 m to its target TD of 530m (-86 mRSL). Note that the bottomhole location is 11m below the target and these losses are correlatable to the 84-85° dip of the Bayabas Fault. Meanwhile during the whole kill operation, the chemistry of 5R12D discharge was monitored for chloride and boron concentrations to observe any dilution effect from fluids pumped through the relief well. After almost an hour after drilling ahead from 485 m to 490 m and pumping water at a rate of 53 li/s, the chloride concentration in the 5R12D discharge decreased from its baseline level of 11300 mg/kg to 9500 mg/kg. The two-phase discharge also was seen to have changed its color to dark gray probably due to the drilling mud injected from 5R13D. Drilling proceeded to its programmed TD with the same pump rate and upon reaching TD, the chloride concentration dropped to 5300 mg/kg. The chemical and physical parameters were clear indicators of the communication between the wells. During this time, well 5R12D continued its two-phase discharge. Upon reaching TD, the drill string was pulled back to shoe and the pipe ram closed. About 39,000 li of 11 ppg weighted mud was pumped thru the string and quenching at 7,200 li of water commenced. The discharge was reduced to a “geysering” state after an hour of continuous pumping. Quenching of the well continued at 6,200 to 7,500 li through the next day while chloride monitoring indicated a concentration down to 700 mg/kg. An additional 119,500 li of weighted mud and quenching at 7,000 li was injected the next day until after two hours, the discharging well finally collapsed. The well was cemented immediately after the kill was completed.
