WATER ENTRY BELOW STEAM PRODUCTION:
A CASE HISTORY AT THE GEYSERS

George Frye
Burmah Oil and Gas Company
Santa Rosa, CA. 95406

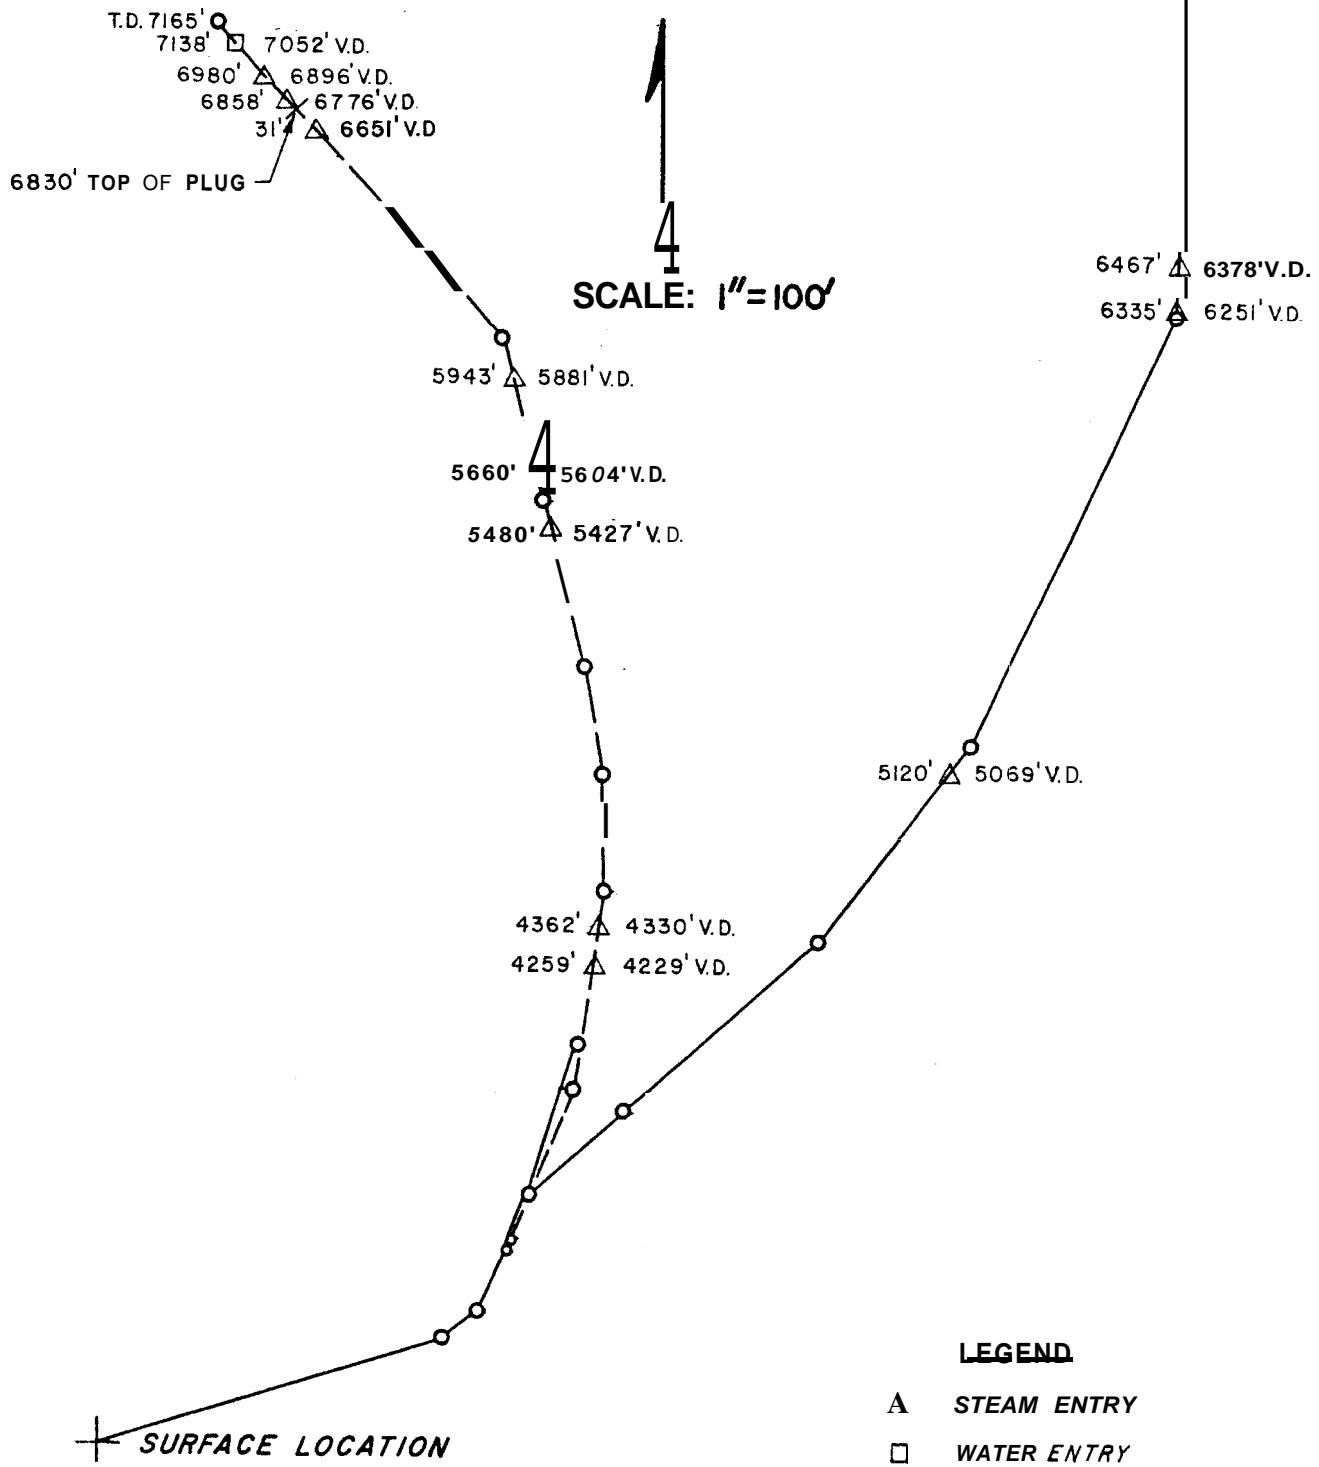
FIGURE 1

A 12-1/4" hole was drilled to 3000' and 9-5/8" OD casing was cemented to the surface. Burmah then directionally drilled an 8-3/4" hole with air and encountered minor steam entries at 5120', 6335', and 6457', as shown on Fig. 1. No additional steam entries were found below these depths. Total steam flow measured less than 20,000 pounds per hour.

Since the hole produced a sub-commercial rate of steam, Burmah decided to plug the hole and directionally redrill the hole in a more westerly location. Steam entries were encountered at 4259', 4362', 5480', 5660', 5943', 6731', 6858', and 6980'. Fig. 1 shows the location of these steam entries. The hole produced approximately 120,000 pounds of steam per hour after the last steam entry. Again the hole produced water, but at a lower rate of approximately 80 barrels an hour. The analysis of this water is shown on Column 2 on Fig. 2. The water entry indicated by the increase of standpipe air pressure was at 7138'. No pressure or temperature survey was run. The hole was plugged with 43 sacks of cement. The drill pipe stuck while pulling out of the hole. The best estimate of the top of the plug is 6830' measured by the free point indicator on the stuck pipe. The stuck drill pipe was partially recovered to 6062'. Further recovery attempts proved unsuccessful.

ORIGINAL HOLE ^{T.D.}
7665' 7459' V.D.
7580' □

REDRILL
