Preliminary Corrosion Testing of Nickel Alloys in Simulated High Temperature Geothermal Environment

Tindur Jónsson¹, Andri Í. Thórhallsson¹, Andri Stefánsson², Sigrún N. Karlsdóttir¹

¹University of Iceland, Faculty of Industrial Eng., Mechanical Eng., and Computer Science, Hjardarhagi 2-6, Reykjavík, Iceland.

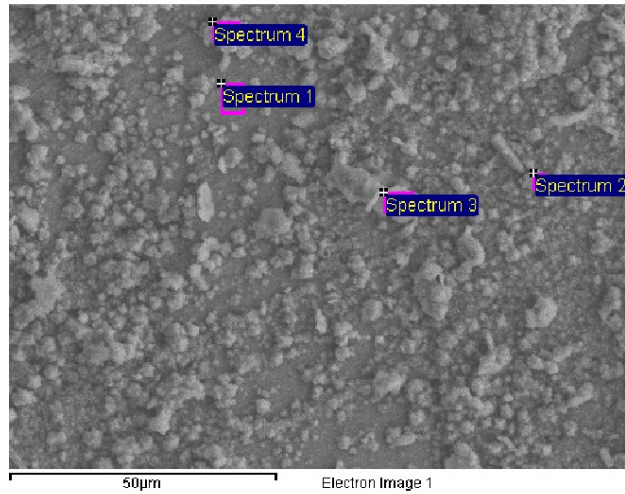
Figure 3: Surface of UNS N06625 after 3 weeks at 180°C.

Examination of the materials surface in the SEM shows a crystalline deposit rather uniformly distributed over the sample surface. The elemental analysis shows it consists of a mix of sulfides and oxides of indicated by the detected O, Ni, Fe and Cr. Viewing the sample in cross section very little could be seen even at rather high magnifications. Almost no corrosion layer could be seen and no indication of cracking.

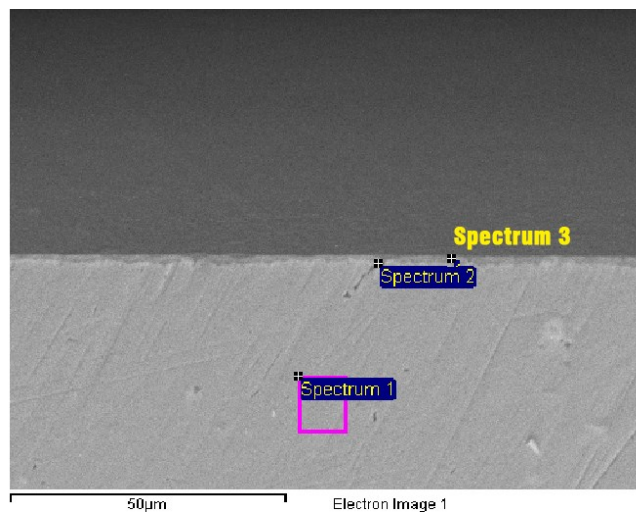
Figure 4: SEM micrograph of UNS N06625 after 3-weeks exposure at 180°C. Very thin corrosion layer is observed

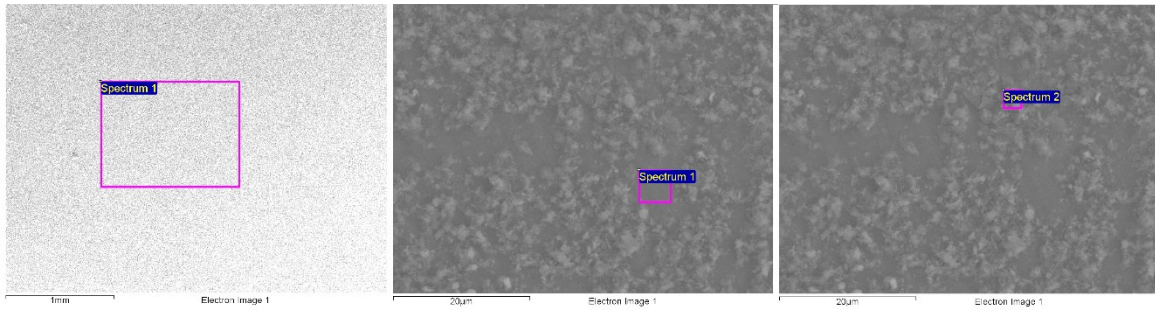
Figure 5: Areas selected for XEDS analysis a) low magnification of surface b) smooth surface at high magnification c) surface deposits at high magnification.

At low magnification, the surface of the sample looks quite uniform as is seen in Figure 5 a). On closer view an unclear deposit is visible which can be seen in Figure 5 b) and c). High amount of aluminum was analyzed at the smooth surface but less aluminum deposits seems to be on the fuzzy deposits on the surface. Small amount of sulfur and higher amount of oxygen was analyzed in the deposits comparing to the smooth surface. The chemical analysis indicates that the surface deposits are most likely corrosion products rich in sulfur (S) and oxygen (O).

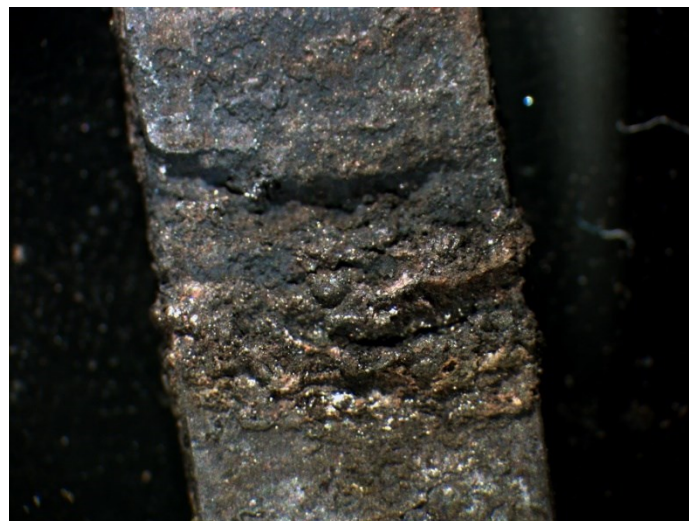
For the 3-week exposure at 350°C there was visible damage the sample at the exit of the reactor. A large crack had developed through the center of the upper sample and is shown in Figure . Some scaling was present on all of the samples but only the top sample showed visible corrosion damage.

Figure 6: Crack on the surface of UNS N06625 sample

The average corrosion rate was 0.15 mm/yr for the UNS N06625 sample tested for 3 weeks at 350°C. The presence of a deep crack on the surface of the UNS N06625 sample was not expected after 3-week exposure as the material is known to be very corrosion resistant. The crack was analyzed with XEDS to identify the corrosion products.

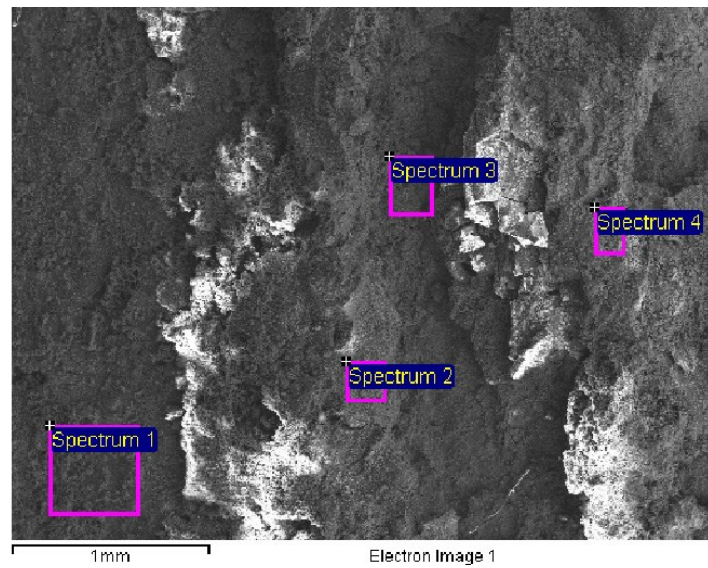
Figure 7: Surface of the area around the crack

The surface deposit along the crack seen in Figure 7 shows traces of Cl in all areas except one, and all areas contain large amounts of Cr and O as seen in Table 5 indicating these are corrosion products. Some Al is also present around the crack indicating deposits of dissolved MACOR ceramic washer. The MACOR material includes alumina but the UNS N06625 includes only maximum 0.4% Al. relatively higher Al content than 0.4% was analyzed adjacent to the crack

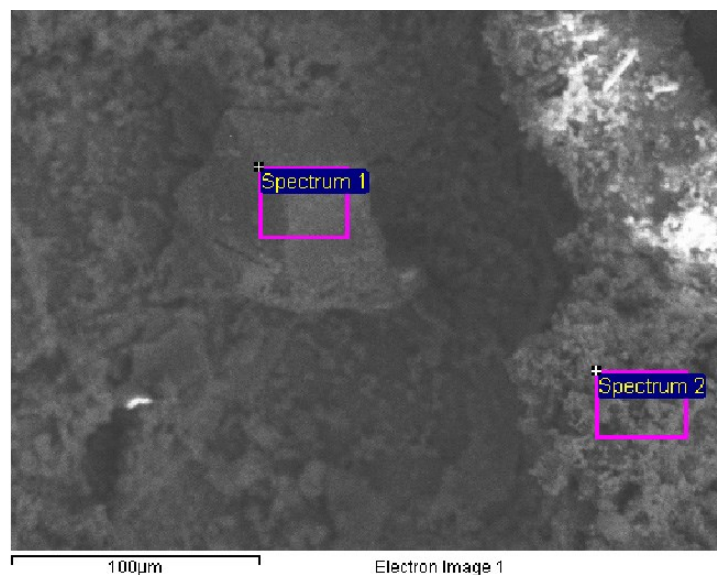
Figure 8: Area inside crack on UNS N06625 after 3-week exposure in 350°C

Looking into the area at the center of the crack in Figure 8 a crystal-like deposit was seen and analysis in Table 6 shows this deposit contains a rather high amount of Cl and S.

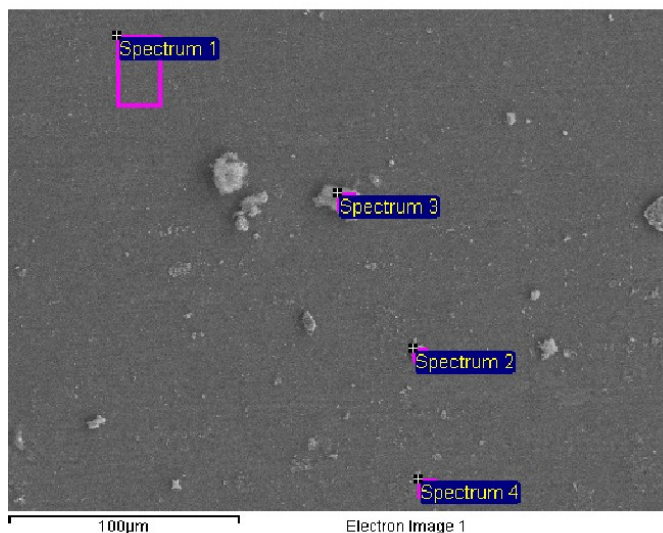
Surface examination of the center sample showed no significant damage.

Figure 9: Surface of undamaged center sample of UNS N06625 after 3-week exposure

The deposits analyzed by XEDS appear to be loosely adherent to the surface one is high in Ni and S while the other two are mainly Cr and O. An unusually high level of Ti and Nb was detected in the area marked as Spectrum 4 in Figure 9 as shown in Table 7.

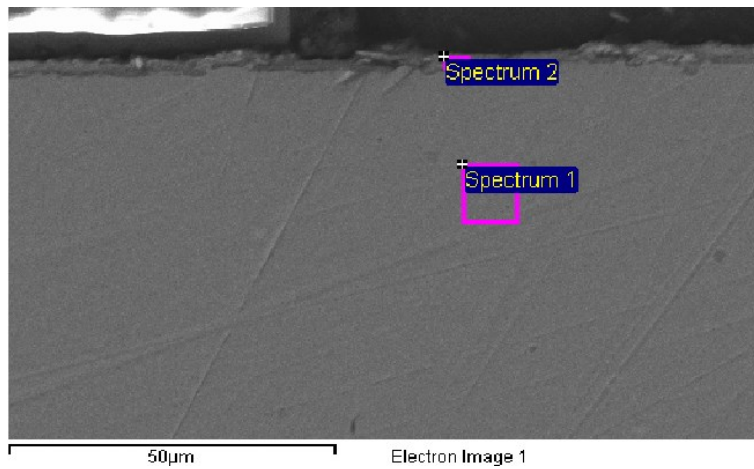
Little damage or corrosion products were visible in the cross section of the sample. Only a thin layer of corrosion product was available for chemical analysis using XEDS. No evidence of pitting or cracking was visible on this sample. However it should be kept in mind that one of the weight loss samples from this exposure experienced severe cracking as mentioned before at the outlet of the reactor, possibly due to condensation of steam and liquid droplets falling down from the exhaust pipe down to the outlet of the reactor.

Figure 10: Cross section of UNS N06625 after 3 weeks at 350°C.

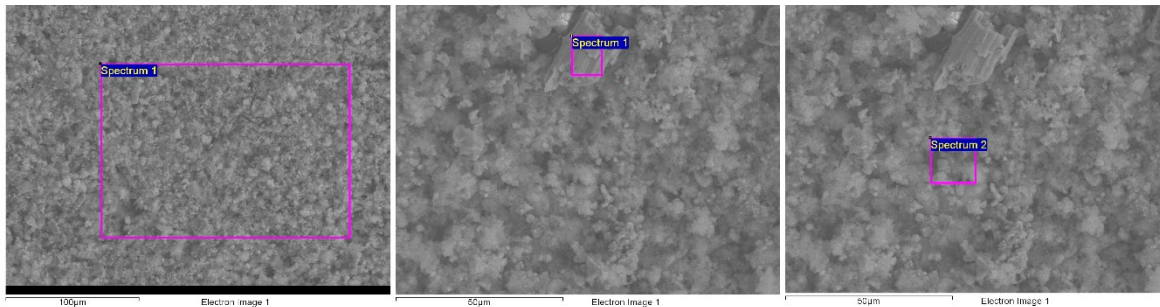
Figure 11: Micrographs from the SEM showing surface areas selected for XEDS analysis a) bulk surface at low magnification and b) surface deposit crystal at higher magnification and c) surface deposit at higher magnification.

Analysis of the surface deposits seen in Figure 11 shows a large amount of S and significant but smaller quantity of O indicating sulfur rich corrosion products covering the surface. Also the presence of Al and O can indicate the presence of deposits from the MACOR washers. An interesting feature is the crystal shown in b), where high concentration of S and Ni (see Table 8) and the morphology indicates that it is NiS crystals have formed.

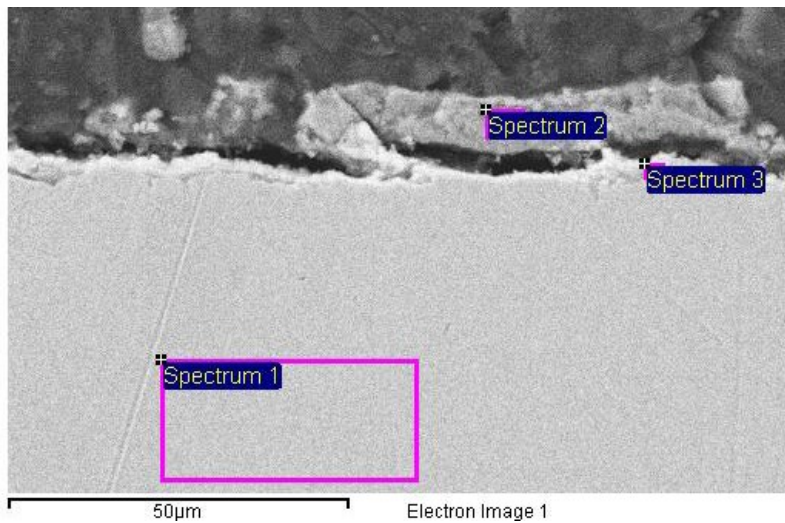
Figure 12: SEM Micrograph of the cross-section of UNS N10276 after 1 week at 350°C

Cross section of the surface showed no indication of localized damage on UNS N10276. Film has though formed on the surface that is evident in Figure 15 on the surface. The XEDS analysis of the film shows the presence of mainly, Ni, O, Mo, Cr, and S, indicating it being rich in corrosion products consisting of metal oxides and sulfides.

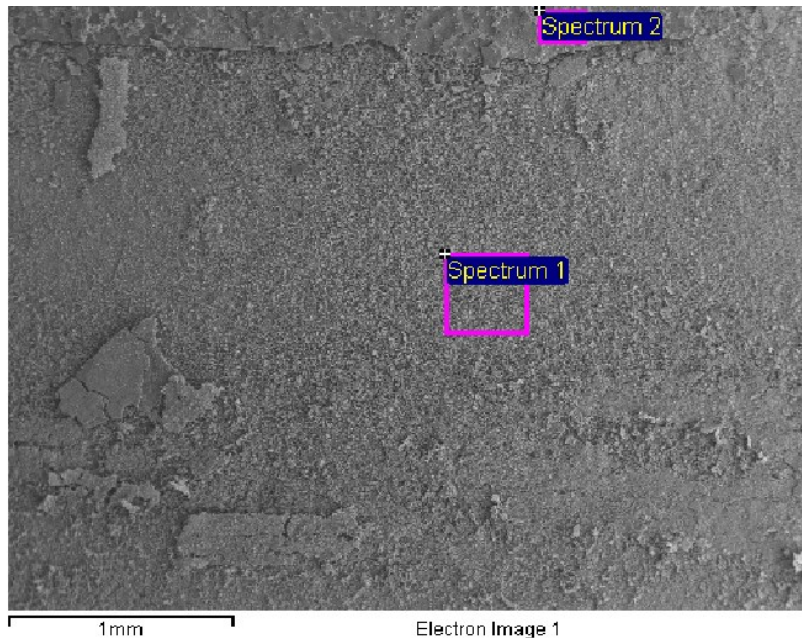
Figure 13: Surface deposits on UNS N10276 after 3 weeks at 350°C at low magnification in the SEM

SEM analysis of the surface of sample shows both flakes and fuzzy deposit. Both the flake like deposit and the fuzzy deposit were analyzed using XEDS and the composition is given in Table 10. Both deposits contain large amounts of corrosion products including either Ni, Cr and Mo while the fuzzy deposit in Spectrum 1 is more sulfur based. The flake like deposit has a higher amount of oxygen and Cr comparing the fuzzy one. The Al detected suggests precipitated material due to the dissolution of the MACOR ceramic washer material.

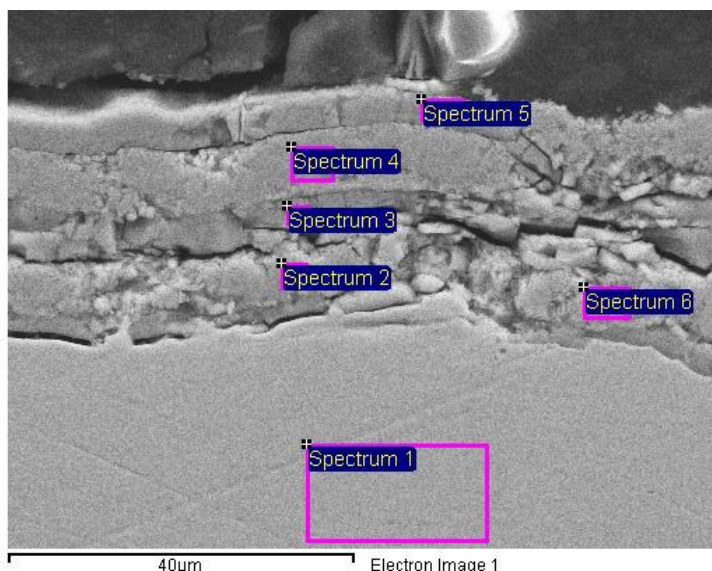
SEM analysis of the cross section of the UNS N10276 alloy after 3 weeks at 350°C showed a corrosion film at the surface. No signs of significant localized damage were seen on the UNS N10276 sample despite the fact that uniform corrosion was significant and obvious on the surface of the sample, as can be seen in Figure 14.

Figure 14: Cross section analysis of UNS N10276 after 3 weeks at 350°C

The surface layer is multi layered as can be seen in Figure 14. The layers are separated and have diversified amount of Ni, Cr, O and S in the layers as can be seen in Table 11.

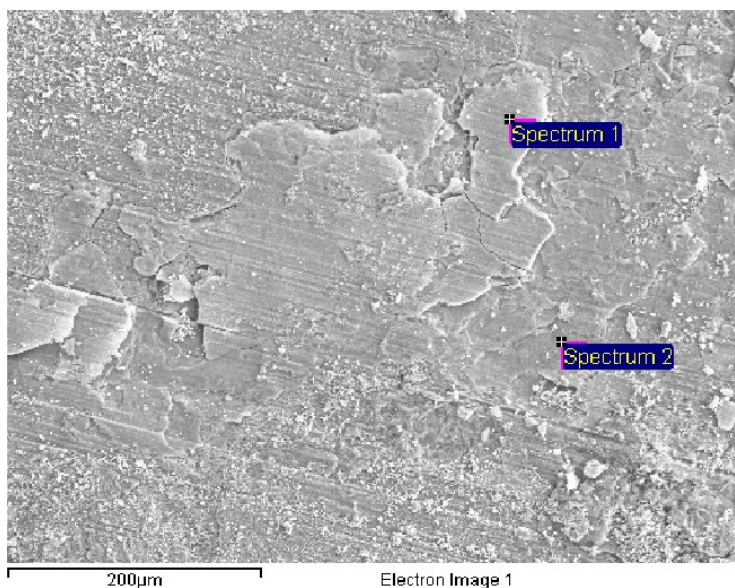
Figure 15: Surface deposits on UNS N06625 after 1 week at 350°C with no MACOR washers

The deposits seen in Figure 15 are a mix of mainly O and some S based corrosion products as seen by the high Cr, Mo, Nb and Ni as can be seen in Table 12. A small amount of Cl was detected in deposit along with some Na suggesting maybe some NaCl formation. High levels of Nb are present in both Spectrums especially number 1. Why there is local enrichment of Nb in some areas is not known, and will be examined further in future corrosion experiments that are planned with updated version of the reactor setup. Less aluminum was observed on surface than on samples connected with MACOR ceramic washers
