Lesson Learned: Well Logging Analysis to Interpret Shallow Connection Between Two Wells in Dieng Geothermal Field, Indonesia

Ichwan Agusta Elfajrie¹, Reza Jamil Fajri¹, Elfina¹, Muhammad Istiawan Nurpratama¹, Nurkholis Hariyadi¹ and Alan Muhadjir²

¹PT Geo Dipa Energi (Persero), Aldevco Octagon 2nd Floor, Jl. Warung Jati Barat No. 75, South Jakarta 12740 - Indonesia

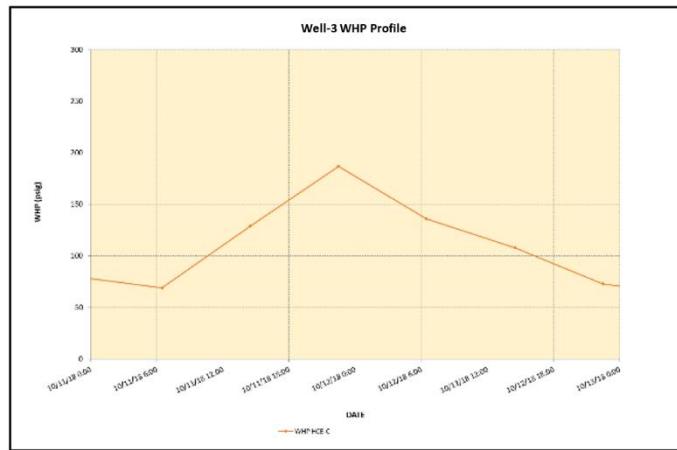
Figure 3: Well-3 WHP profile during air compression stimulation on 11-12 October 2018.

Since September 2018, several air compression stimulation programs have been performed to improve production. On 11-12 October 2018, WHP slowly dropped from 187 psig to 136 psig during air compression (Figure 3). The indication of a production casing issue was confirmed after air compression stimulation on 22 October 2018, when WHP experienced a drastic decline from 480 psig to 350 psig (Figure 4).

Based on all the phenomena of WHP hereinabove, fluid channeling or networking at production casing is suspected. The compressed air was lost to the formation through the leakage depth. Geochemistry data need to be reviewed to strengthen the possibility of casing leakage.

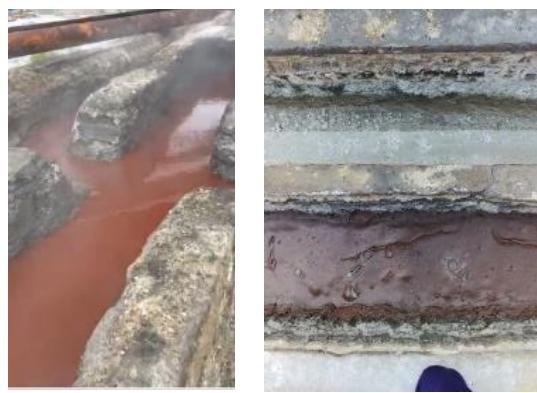
Figure 5: Brine color after horizontal discharge.

Visually, there is also an anomaly in the brine color after air cap stimulation on October 22, 2018. The brine is reddish (Figure 5-a) and different from the brine color in normal conditions (Figure 5-b).

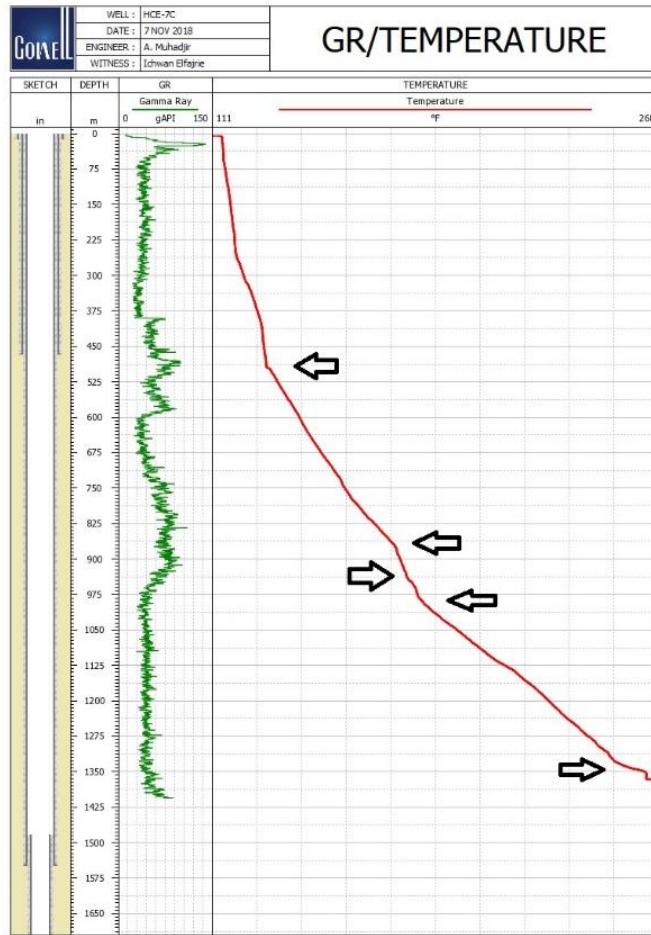
Figure 8: Temperature and gamma ray profile vs. depth.

The arrows in Figure 8 show the temperature change points that indicate changes in water flow. Drastic temperature slope changes occur at a depth of around 1,300-1,375 mMD where the temperature jumps from 250°F to 420°F. It is suspected that water injection loss into the formation occurred. The following are the results of the analysis in question:

- Anomaly at about 500 mMD
- Anomaly at between 850 and 1,000 mMD
- Anomaly at 1,350 mMD
- With OD of 1-11/16", MCD at 1,389 mMD

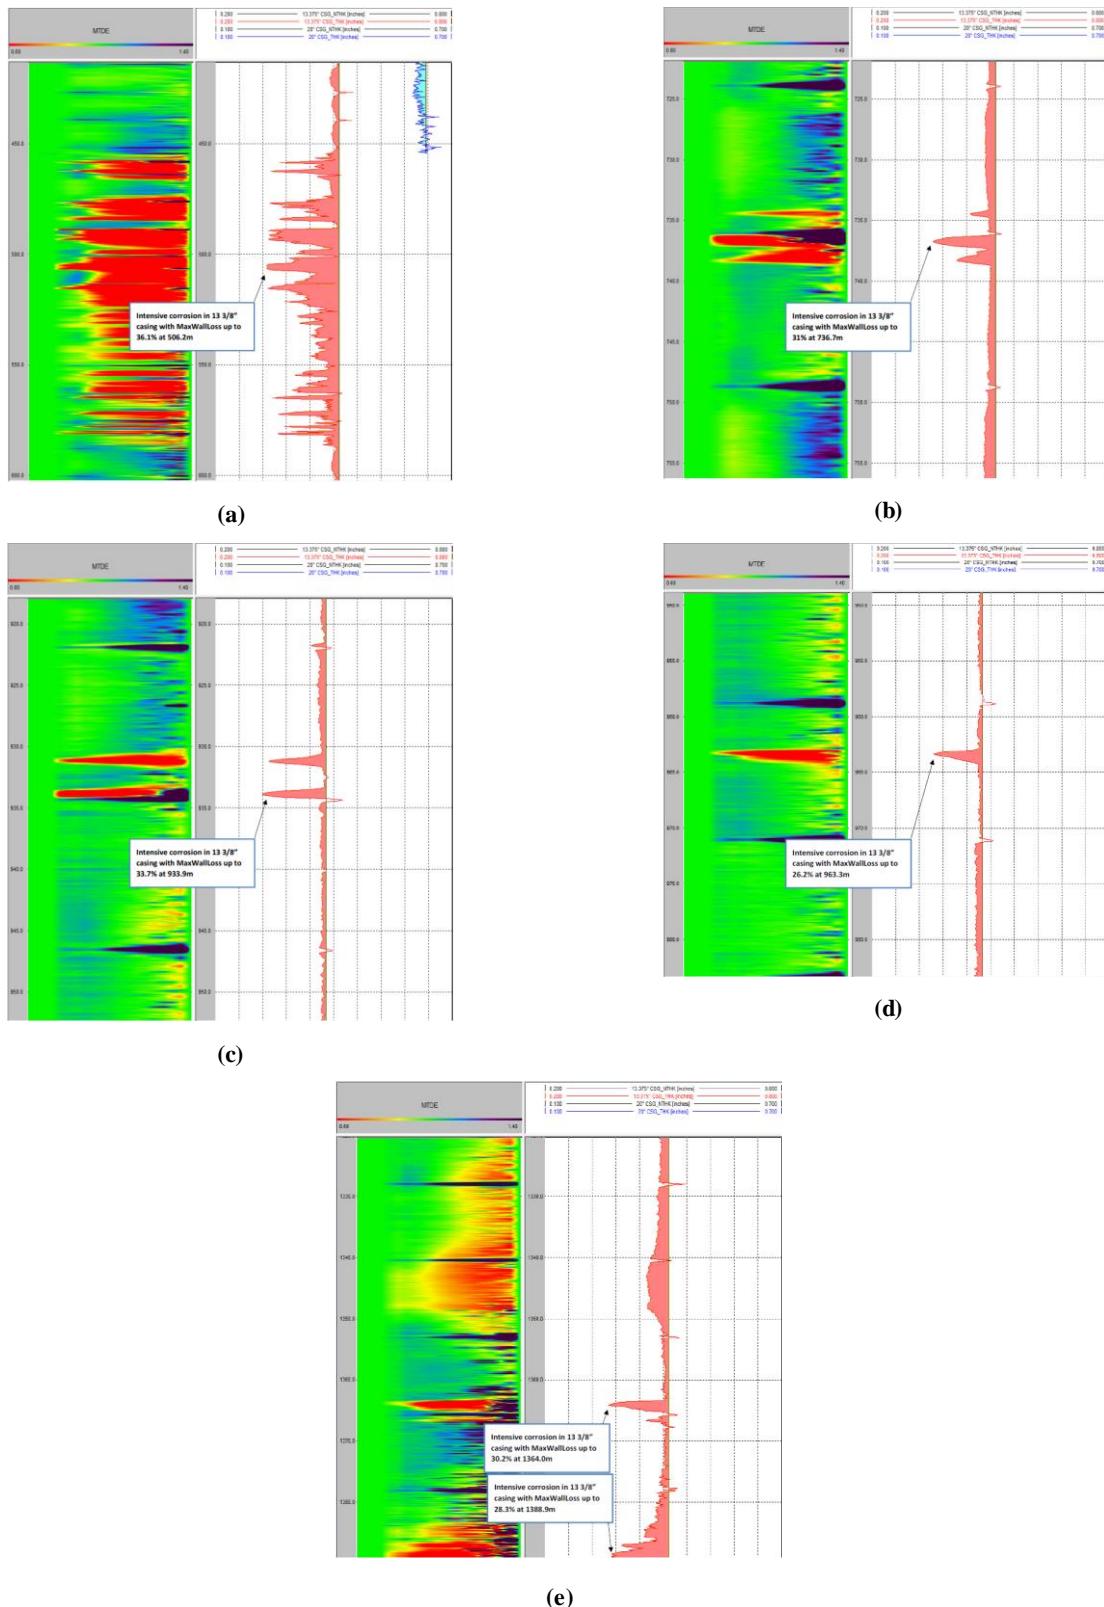
Figure 9: MTD results.

After reaching maximum depth, the MTD tool starts recording metal losses data to the surface at a speed of 2 mpm. Figure 9 (a-e) show the several locations where indicate intensive corrosion in the 13-3/8" casing. Table 4 gives a metal losses grade definition.

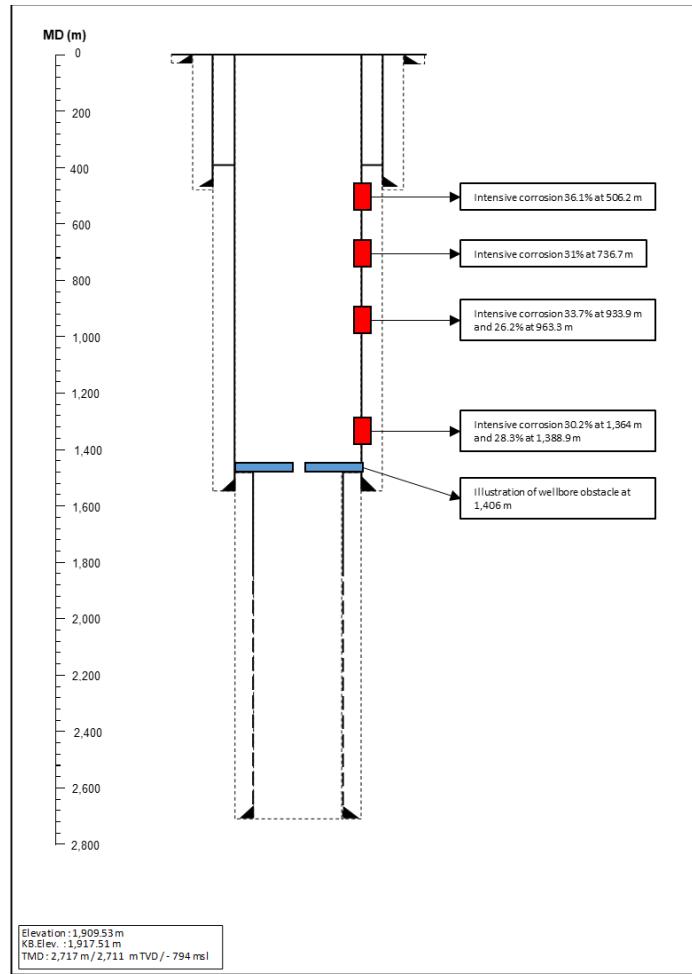
Figure 10: Well-3 wellbore condition.

Figure 10 shows a resume of wellbore condition after several investigations.

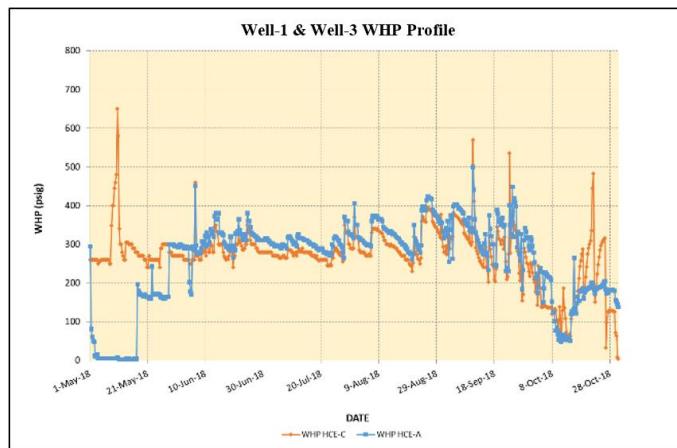
Figure 11: WHP profile of Well-1 (static condition) and Well-3 (flowing condition).

Well-3 WHP changes following maneuver in throttle valve opening. In the meantime, the WHP of Well-1 also changes while its throttle valve opening remains unchanged. Well-1 WHP profile, which "mimics" the WHP of Well-3, continues even though the well is in a shut-in condition. Figure 11 shows the profiles of both wells since May 2018, where the Well-1 is in shut-in condition, and Well-3 is in flowing condition.

The quick response of WHP changes between both wells shows that the connection between them does not represent feed zone interference. This condition strongly indicates that Well-1 and Well-3 are connected at shallow depths.

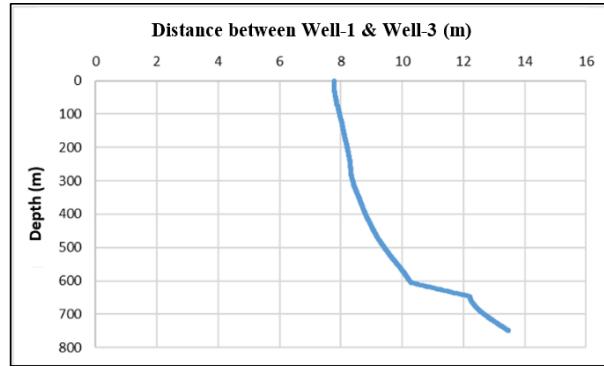
Figure 12: Distance between Well-1 and Well-3 vs. depth.

Based on history, there were three workovers after the completion of Well-1. The objective of the first workover was to overcome the leak in production casing 13-3/8" at 227 mMD. TLC (Total Loss Circulation) at 129 mMD of depth during drilling indicates an aquifer at a shallow depth. The distance between these two wells is quite close, where the wellhead space is 8 m. Figure 12 shows its magnitude to a depth of 750 mMD. It is suspected to be a leakage position that results in a connection between Well-1 and Well-3.

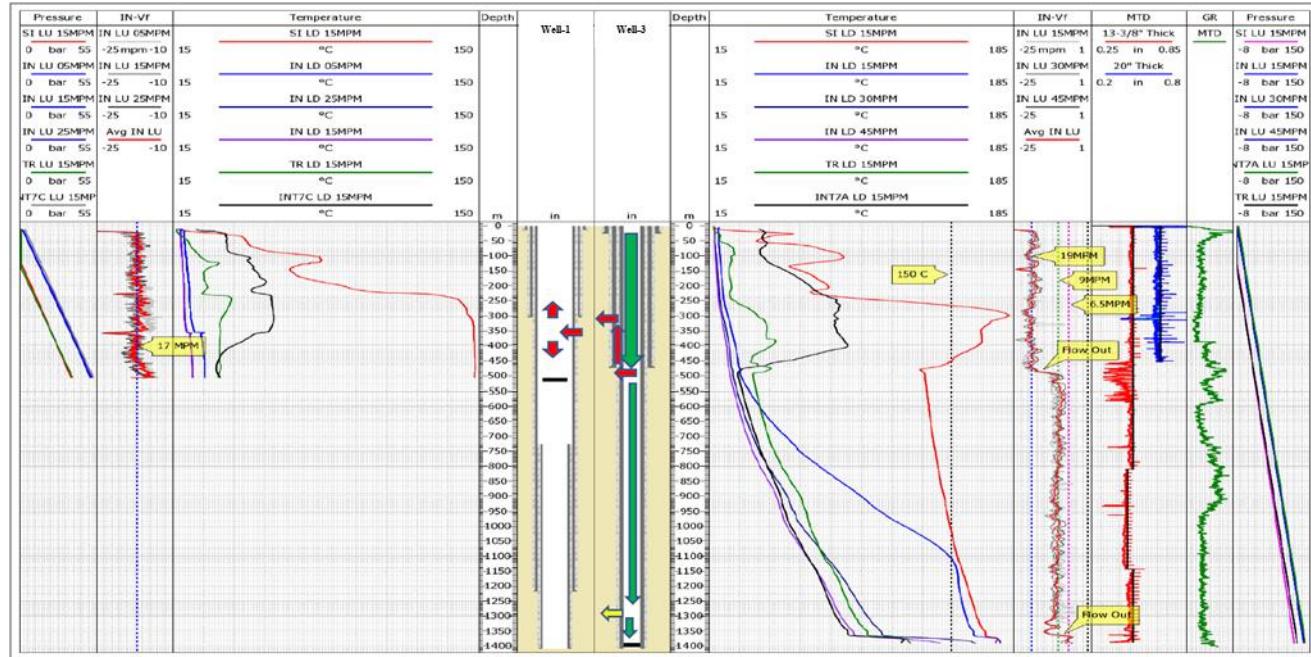
Figure 15: Well-1 and Well-3 PTS log conclusion (Well-1 shut-in and Well-3 injection).

The results of the PTS analysis on the Well-1 show that there is a hole in the 13-3/8" casing with the following details:

- Depth 122 m
 - Temperature reading: There is a significant increase in temperature at a depth of 100 – 122 m. This zone may be a permeable layer that becomes hot because there is crossflow activity in the Well-3, which, during production, results in hot fluid flowing into the reservoir and heating it.
 - The spinner reads that there is flow activity during shut-in conditions at a depth of 122 m (leak point in the casing) to 135 m (peak liquid in the well at shut-in). Water flowing from 122 m falls to the top of the liquid at 135 m, causing the PTS spinner to rotate.
- Depth 355-360 m.
 - Temperature during Transient conditions shows a significant temperature difference between 355 m and below 360 m.
 - The spinner does not show changes during injection conditions because the dominant flow of injected water flows downwards.

Calculations based on spinner data are as follows. The flow of the casing leak at a depth of 355-360 is relatively small, not detected by the spinner; almost all of it flows down the obstruction at 513 m.

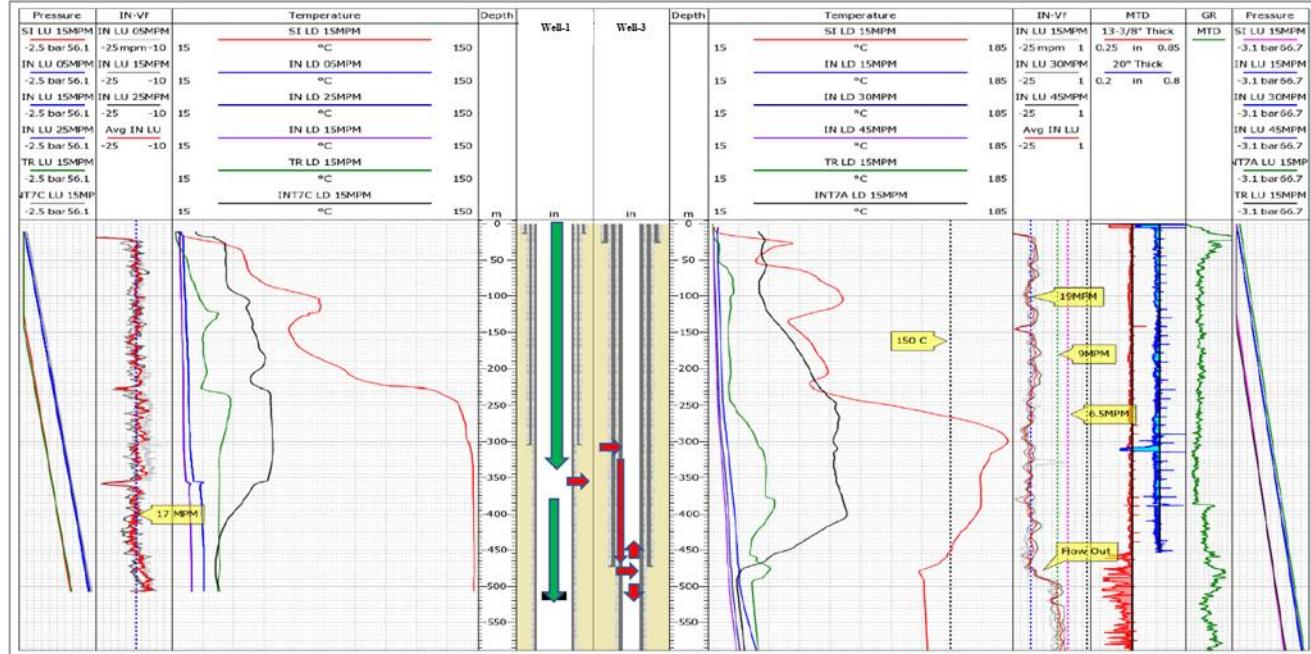
Figure 16: Well-1 and Well-3 PTS log conclusion (Well-1 injection and Well-3 shut-in).

The results of the PTS analysis on the Well-3 show that there is a hole in the 13-3/8" casing with the following details:

- Depth 475-500 m
 - Above a depth of 475 m, spinner data shows the fluid flow velocity in the casing is 19 m/min, and below 500 m, it is 9 m/min. 52.6% of the injected water flows through casing leaks in the 475 – 500 m interval.

- Temperature reading: There is a significant increase in temperature at a depth of 475 m, indicating that some of the cold-water injection flow has shifted out of the casing.

- Depth 1,365 -1,370 m.
 - Temperature during Transient conditions shows a significant temperature difference between 1365 and 1375 m. The potential is that water coming out of the 13-3/8" casing at a depth of 1365 – 1370 m enters the permeable zone at a depth of 1365 – 1375 m.

- The spinner shows there is a contribution of injection flows out of the 13-3/8" casing at 1365 – 1370 m. Above a depth of 1365 m, the water flow speed in the well is 9 m/min; below 1370 m, it is 6.5 m/min. 13.2% of the injection water flows out of the hole at this depth, and 34.2% flows downwards.

The results of the PTS analysis on the Well-3 also show that there is a hole in the 20" casing at a depth of 310 m with the following details:

- MTD (Magnetic Thickness Detector) data in November 2018 shows significant metal loss at this depth.

- Temperature data during shut-in conditions shows local heating at a depth of 300 m. It is very likely correlated with the presence of a permeable zone at 300 m where when this well was producing, there was hot fluid flow into the zone through a 13-3/8" casing leak at 475-500 m, flowing upwards through the 13-3/8" annulus and out to the 20" annulus through the hole at 310 m.

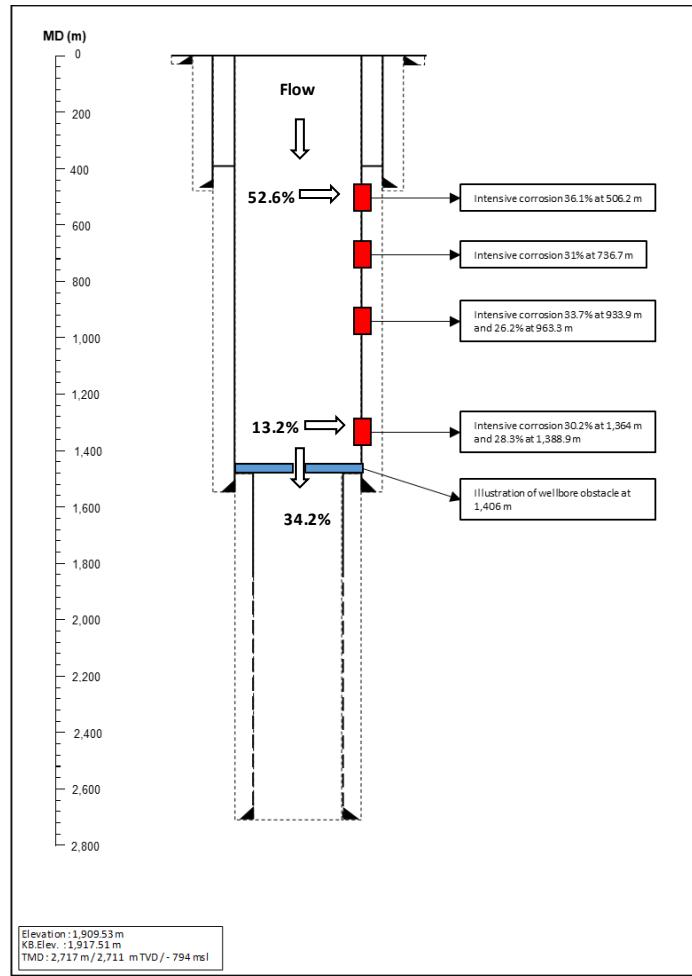
Figure 17: Illustration of a leak in the Well-3 during injection.

Table 6 shows flow distribution and Figure 17 is an illustration of a leak that occurred in the Well-3.

Interval	Distribution
Leak at a 475-500 m of depth	52.6%
Leak at a 1,365-1,370 m of depth	13.2%
Downward flow	34.2%
Total	100.0%

- Reactivation and remediation priority is carried out on the Well-3 with the following considerations:
 - The production potential is more significant than Well-1.
 - Access to the well is much deeper than Well-1, up to a depth of 1380 m. It will most likely only be necessary to open casing access 13-3/8" to the top of the liner 9-5/8" at a depth of 1483 m.

- Obstruction in the 13-3/8" casing on the Well-3 is relatively less than the Well-1. Connection between Well-1 and Well-3.
- b. Temporarily, Well-1 needs to be plugged with the following considerations:
 - There is communication between Well-1 and Well-3.
 - For remediation of the Well-3, it is necessary to close the potential flow from Well-3 to the reservoir in Well-1 to ensure that the cementing work in Well-3 is not disturbed.
- c. Investigation of a problem with a well will be conclusive by overlaying the following data:
 - Geochemistry analysis, including scale sampling inside the wellbore
 - Casing integrity analysis
 - Wellbore clearance survey
 - Pressure & temperature data analysis
 - Spinner analysis
