## **Stuck Pipe Prediction And Avoidance: Invocation Of Basic Principle Of Standard Methods, Pre And Post Sticking**

**Keywords:** Stuck pipe, mitigation, drill string

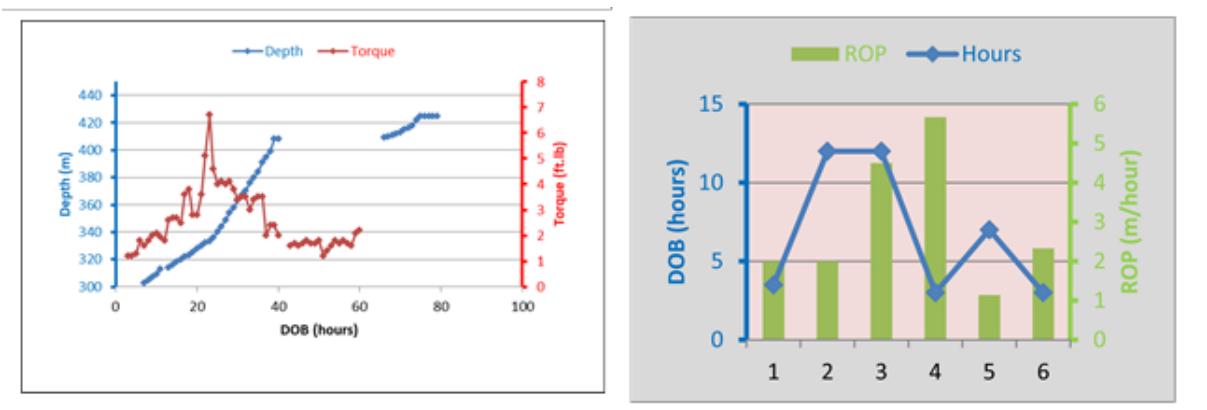
Fig. 11 Drilled depth vs. corresponding torque

Figure 11 shows erratic but increasing operating torque during bottom drilling and reaming process. The torque developed while reaming the hole was an indicator that situation may get worse if non rotational drilling by mud motor was to be initiated. From figure 12, the average rate of penetration (ROP) was found to be 2.94m/h, an indication of a hard formation. Figure 13 indicates fairly high weight on bit (WOB) during formation drilling and slacked weight on string during reaming process prior to kick off. The flow line pressure indicates rising values (figure 14) shortly before well logging was commenced. That the string got stuck while logging was in progress, is a confirmation to hole pack off situation especially when other discussed factors are put into consideration.

Before running in hole new bit, there ought to have been wiper trip to casing shoe in order to confirm hole condition in terms of cuttings quantity. While tripping in new bit, reaming should have begun at least three stands to bottom. After well reaming, use of maximum circulation velocity was necessary in addition to sweeping the hole with weighted pills. Adequate circulation time and confirmation by use of hole cleaning chart could have changed the course of events. It is therefore very important to check at all times that the hole is cleared effectively by the mud. Monitoring cuttings at the shale shakers is also helpful [2].

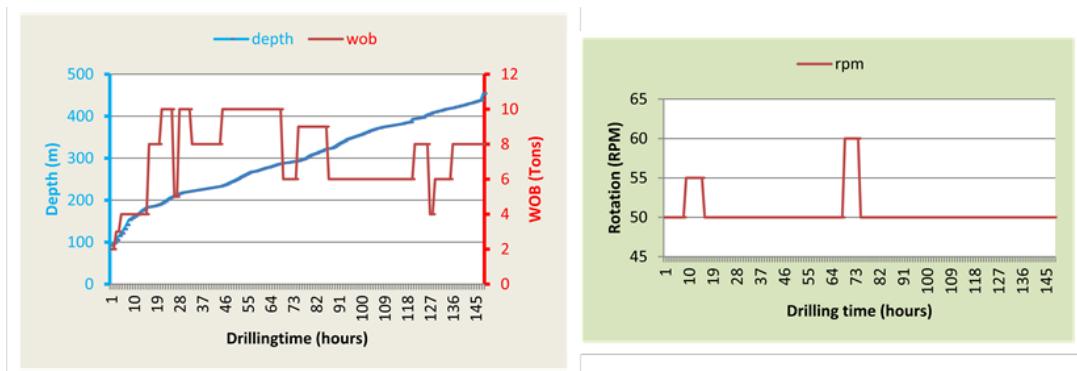
Fig. 16 Depth progression relative to WOB.

Figure 16 shows the continuous bottom drilling and the corresponding WOB which exhibited erratic behavior within the range of 10 tons at maximum and 2 tons on the minimum. This is seen to be in tandem with changing degrees of rock hardness as sampled through lithological analysis. The string rotation was largely constant at 50 rpm over the same period as shown in figure 17.

described, it is indicative that dog legs could have developed as rate of penetration (ROP) erratically changed through varying rock hardness. The immediate failure of the drill string as soon as string pick up was attempted is another indicator to that fact as string over pull occasioned by dog legging of the hole was very likely. Excessive dog-legs cause key seats, rotating torque and trip drags among other hole problems. The occurrence of dog leg profile leads to rapid change of drill string tension and compression every 1/2 turn which accelerates fatigue wear [4].

When running in hole, it is essentially important to do so in such a manner that at no point is more than the BHA weight slacked off at a tight spot. In this case, the guidelines as prescribed by the stuck pipe handbook [2] are that, making use of minimal BHA configuration changes is critical. Frequent reaming of the hole section is highly recommended and avoidance of prolonged circulation across soft overlaid formations. In the planning of directional wells, dog-leg control programme should be included and dog-leg limits established to prevent drill pipe fatigue. The driller should be advised on the maximum dogleg tolerances at respective depth intervals [4].

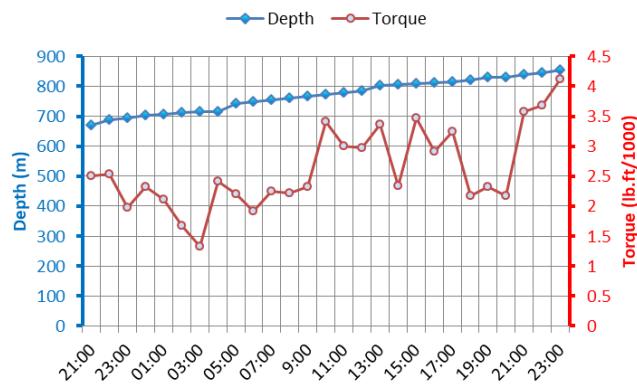
**Fig. 18 Depth/Torque relationship before stuck pipe**

This hole had been drilled to 855m with full circulation returns and later cased at 852.59m. After cementing, the top of cement was tagged at 607m and DOC thereafter. A cement column of 248m had been drilled using water before changing to aerated water and foam on bottom drilling. At 871m, the drill string was stuck i.e. 18.4m below the casing shoe. In view of the cement column that had to be drilled, the hard cement blocks that had caked along the casing wall was possibly dislodged by the string vibrations and settled above bit, hence the cause to stuck string. Figure 18 illustrates the gradual rise of the string torque as the bottom drilling progressed to 871m. The instant rise of torque at or near the stuck point demonstrates the possibility of build-up load of uncleared cement and formation cuttings around the bottom hole assembly.

Application of the right cement slurry properties and accurate annulus volume calculations that limit the casing rat hole length to minimise the source of cement blocks. Sufficient curing time for cement before attempting to drill out must be strictly observed. Tripping in hole the slick BHA for drilling out cement should be conducted at relatively slow speeds prior to casing shoe depth or the plug depth. Reaming the casing shoe and open hole plugs thoroughly before drilling ahead is extremely necessary [6].

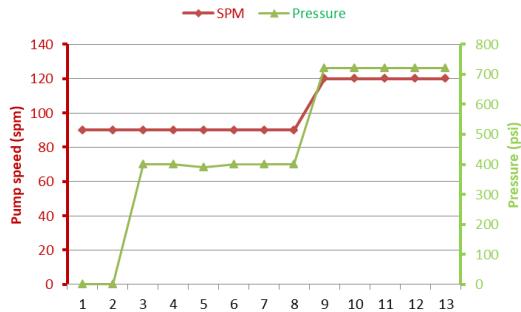
**Fig. 19 Water pump speed and corresponding flowline pressure**

This well had been drilled to 764m, after which circulation was conducted for three hours. While POOH, there was detected resistance to upwards movement of the string at 40m above bottom. Circulation to unload the wellbore was undertaken and constant fluctuations in pump pressure were noticed. One hour later, while still circulating, an over-pull of 40k lbs. was observed. As efforts to unstuck the drill string progressed, the aerated water and foam was introduced but no circulation return was achieved.

In this instance, drilling through chemically reactive formations which seems to be the case here required the right concentration of inhibition additives in oil-based mud (OBM) and water-based mud (WBM) such as salts (KCl, CaCL), glycol and polymer. [2] When shale absorbs water and swells into the well bore, it narrows down the hole diameter and make it very difficult to POOH. This happens when drilling with an incorrect mud specification. The use of inhibited mud system could have been helpful and consistently maintaining the mud properties. The addition of various salts (potassium, sodium, calcium, etc.) could have reduced the chemical attraction of water to the shale. Several wiper trips or reaming may have helped in the event that the shales started swelling. The frequency should be based on exposure time or warning signs of reactive shales and ensuring that the hole is adequately cleaned to remove excess clay balls and low gravity solids [2],[3].

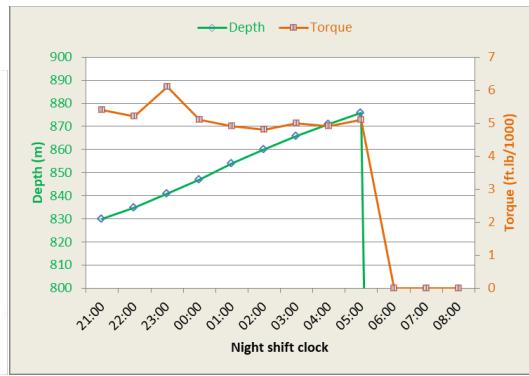
**Fig. 21 Drilled depth vs. corresponding torque**

After attaining 1275m, there was change of drill bit. The previous bit (re-run) had drilled 95m in 50 hours with positive circulation returns. While R.I.H new bit, there was experienced a sudden set down weight at 1208m and shortly after, while circulating prior to initiating reaming process, the drill string got stuck.

Drilling a long column of hole or drilling through hard abrasive rock wears the bit and the stabiliser gauge and results in a smaller than gauge hole. Figure 20 is an illustration of a tight hole. The working torque with respect to depth progression before change of bit is shown in figure 21.

Estimation of the possible occurrence of under gauge hole based on the bit condition as soon as it's been tripped out of hole is very important. Slow trip in of drill string before BHA enters an under gauge section is highly advisable. Reaming of the hole could have been initiated as early as possible from the point of projected under-gauge section. The use of under gauge roller reamer is worth consideration in such situations.

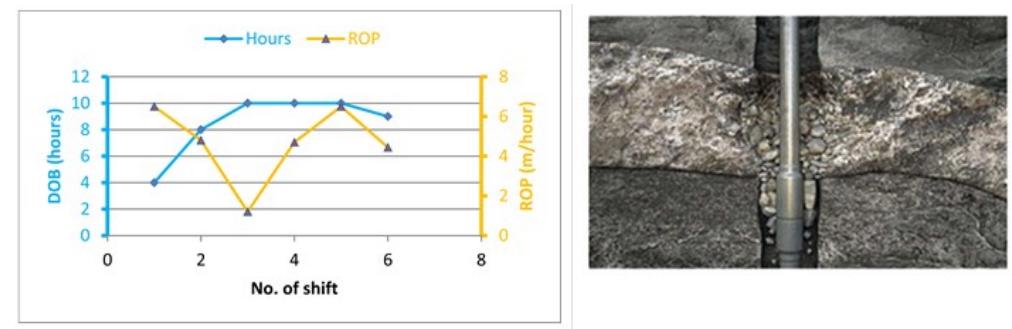
**Fig. 22 Rate of penetration in relation to drilling hours**

In the course of drilling of this well at the depth of 185m, the drill string got stuck while making up drill pipe. The crew managed to free the string after six hours of efforts. At a depth of 204m, there occurred another stuck pipe incident which lasted for one hour. The bottom drilling progressed with relatively high torques to 290m when the drill string got stuck again. There had been observed substantial amount of particles and sand with increased mud weight. While the circulation returns was partially received on the surface, there can be seen non uniform ROP possibly due to changing formation as seen in figure 22.

In the three instances of stuck pipe at 185m, 204m and 290m, the hole pack-off due to unconsolidated formation is the most probable cause. This usually happens when little or no filter cake is present as illustrated in figure 23. The un-bonded formation cannot be supported by hydrostatic overbalance as the fluid simply flows into the formation. Sand or gravel then falls into the hole and packs off the drill string [8].

Use of high vis/weight sweep to clean the hole off cuttings. The establishment of adequate filter cake to help stabilise the formation would have been a better approach. Seepage loss can be minimised with fine lost circulation material. There could have been controlled rate of penetration in the suspected zone to allow time for the filter cake to build up. Control of surge pressure by starting and stopping pumps slowly and slow working of the string is necessary too in such conditions [9].

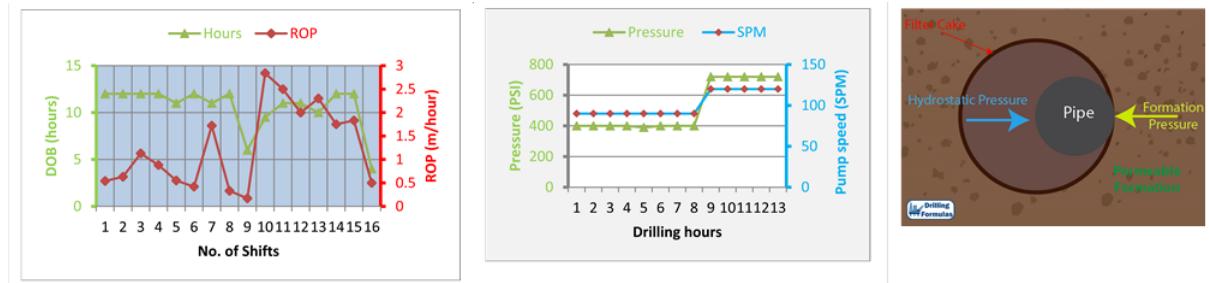
Fig. 24 ROP trend with shifts

Figure 24 indicates the fluctuating but rising torque with drilling time. The pump strokes seems to have been increased at some point and corresponding rise in stand pipe pressure realized as figure 25 shows. Following the flow of events, differential sticking (mud weight in the hole being more than formation pressure) was the most likely cause to this stuck pipe incident. Having the drill pipe stationary during the pipe connection might have led to filter cake developing around permeable zones and the drill string, thus increasing the potential of getting differentially stuck as figure 26 illustrates. [2],[4].

Differential sticking occurs when the drill string is held against the well bore due to pressure difference between hydrostatic and pore pressure. At the first signs of the drill string torqueing up, the pump strokes should be reduced by half [8]. This leads to pressure drop in the event of hole pack-off. The weight of mud is best kept at the required minimum for hole stability and for reduction of filter cake thickness in high formation pressure zones, and reduction of down time while making up pipe connections and deviation survey runs[10],[11].
