WELL INTERVENTION CASE STUDY OF WELL MG-1, LEYTE GEOTHERMAL PRODUCTION FIELD, PHILIPPINES

R. N. Colina, J. B. Omagbon, G. E. Parayno, R. P. Andrino, D. M. Yglopaz,
R. C. M. Malate, F. X. M. Sta. Ana and J. J. C. Austria

Energy Development Corporation
Merritt Road Fort Bonifacio
Taguig City, 1634 Philippines
e-mail: colina.rn@energy.com.ph

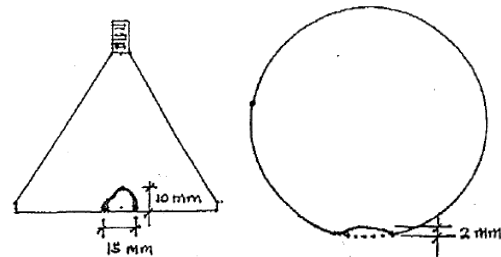
preparation stage, concerns were raised regarding the casing integrity of this 29-year old well. Review of the previous workover data showed that a recurring obstruction was being tagged at the shallow section, inside the production casing. This obstruction was believed to be mechanical in nature based on the two lead impression block surveys conducted in 1999. Upon pullout of the lead impression block, the edge of the block was found to be chipped off as shown in Figure 4.

Figure 4. Result of the lead impression block survey showing the chipped off part of the block.

Considering the previous workover data, the age of the well and the result of previous lead impression block surveys, relining of the production casing is already anticipated.

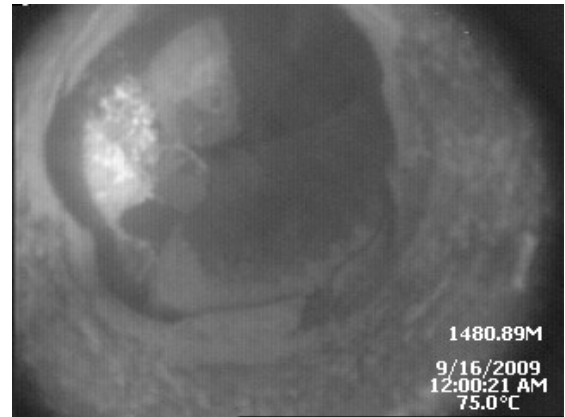
Clearing of the 9-5/8” production casing down to the TOL went smoothly. The obstruction anticipated in the production casing at the shallow section was not encountered. However, during clearing of the 7” liner, an obstruction was tagged at around 1400 m. Attempts to wash down this obstruction proved unsuccessful as the clearing assembly could not penetrate beyond this depth. Also, an indication of metal to metal contact was already observed while trying to penetrate this depth.

Down view camera was run in hole to investigate the obstruction. A parted liner, as shown in *Figure 5* was found to be the cause of unsuccessful penetration of the clearing assembly. Careful inspection of the images showed loose pieces of metal.

Figure 5: Liner damage found

In order to retrieve loose pieces of metal, a 6” junk magnet basket assembly was run in hole. Clearing of the liner continued beyond this depth until another obstruction was tagged. Downhole survey was again run in hole to check the obstruction. Based on the images found, relining with a 5” liner was recommended.

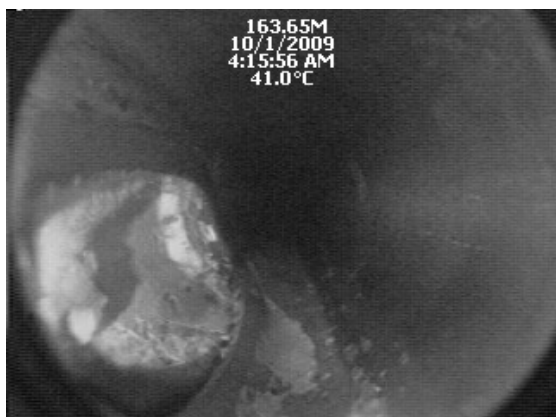
The concern with regards to the integrity of the production casing at the shallow section was next investigated. A third downhole video survey, this time running in the down view camera in tandem with the side-view camera, was conducted to examine the actual condition of the production casing. *Figure 6* is the down view image of the shallow casing damage. A section of the production casing was milled off, exposing the cement portion between the production casing and the anchor casing. The image did not clearly show the extent of the damage at this depth.

Figure 6: Down view image of the shallow casing damage

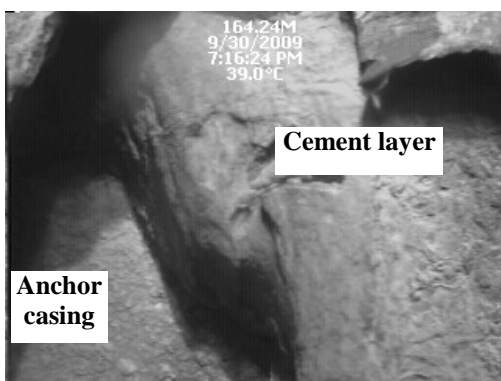
Switching to the side view camera, a better picture of this section was obtained. As shown in Figure 7 the anchor casing behind the cement layer is still intact with no apparent mechanical damage. Note that during this workover, this shallow casing damage was not tagged while clearing the 9-5/8" production casing. The question of whether this section will fail (caused by thermal expansion, erosion/corrosion, etc.) during production of the well was resolved by conducting a pressure test. The well was subjected to a squeeze pressure higher than the maximum shut pressure of the well. With the pressure holding, it was concluded that this section will not be a problem during production and relining of the shallow casing damage was no longer necessary. Thus, the relining scenario was avoided.

Figure 7: Side view image of the shallow casing damage

During the workover, where effective and timely decisions are necessary, the application of downhole video to investigate the actual condition of the casing or liner provided information that ensured appropriate tools were run in hole. For the case of the shallow casing damage, downhole video results became instrumental in the search for a different approach to solve the shallow casing damage issue. Without the side view image, the most apparent solution will be to reline the shallow casing damage to reestablish the casing integrity of MG-1, sacrificing the output of the well. However, because the anchor casing was found to be still intact, through the side view camera, the result of the pressure test sufficed to conclude that the shallow casing damage will not cause future problems.
