IMPACTS OF GEOTHERMAL WELL TESTING ON EXPOSED VEGETATION IN THE NORTHERN NEGROS GEOTHERMAL PROJECT, PHILIPPINES

PNOC Energy Development Corporation, Merritt Road, Fort Bonifacio, Metro Manila 1201, Philippines

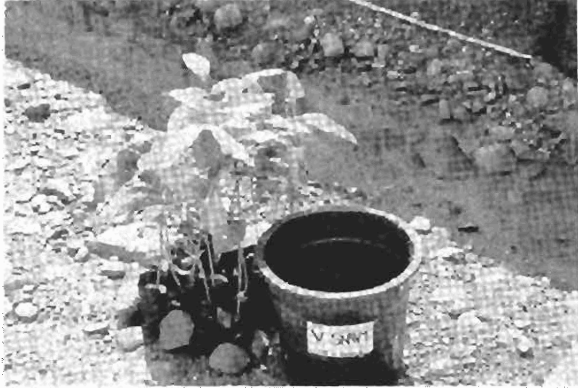
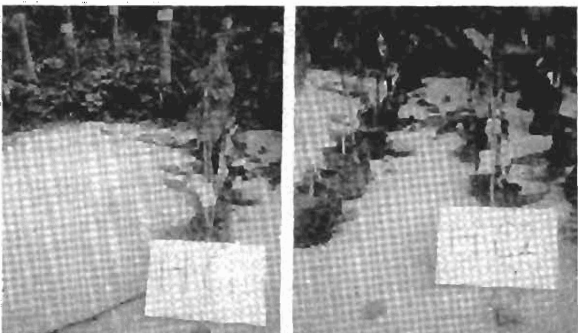
Figure 3a. Test seedlings before horizontal discharge.

Figure 3b. One day after the start of horizontal discharge.

Figure 3c. Seven days after the start of horizontal discharge.

Figure 3d. Thirty days after the start of horizontal discharge.

Early damage symptoms assessed a day after the discharge included drying of leaf tissues or desiccation observed as necrotic areas, which occurred first at the tip of older leaves and progressed along the edges or margins as severity increased, resulting in abnormal early defoliation on the second day after discharge (Figures 3a - 3d). The impact zone is confined

within the 50-m radius of the silencer regardless of the wind direction. Test seedlings at 5-30 meters from the silencer, manifested symptoms a day after the discharge, while those at 50 meters manifested five days later. Natural vegetation were not affected during the horizontal discharge. No impact was observed for seedlings exposed at 75-100-m range. In terms of extent of plant damage and recovery, seedlings within the 5-15-m range were severely affected compared to seedlings at 30-50-m distance.

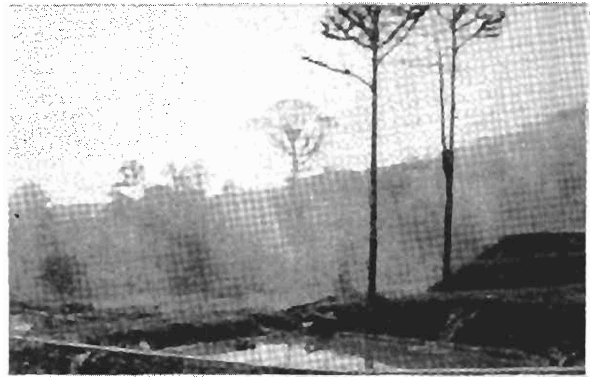
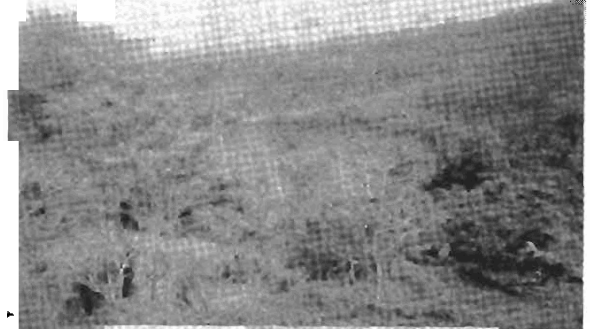
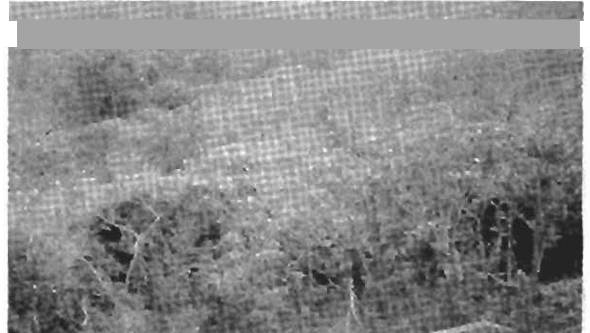
Figure 4a. Natural vegetation during vertical discharge.

Figure 4b. Nine days after the first vertical discharge.

Figure 4c. Three (3) months after the completion of vertical discharge.

Figure 4d. Three (3) months after the completion of vertical discharge.

Due to the angle of dispersion, the impact zone of vertical discharge started only at 50 meters up to 350 meters from the wellhead, and only at the plume direction (NNW) and its immediate left (NW) and right (NE) quadrants. The impact zone is beyond the 50-m radius of the pad. Thus, only the natural vegetation (50m - 350m) within this zone were affected. Damage symptoms manifested were similar to those observed from the test seedlings during the horizontal discharge, except that defoliation started only on the 6th day after the first vertical discharge.

Test seedlings exposed to the horizontal discharge have varying degrees of recovery (Table 8). Severely affected seedlings at 5-15-m distance and those with longer exposure registered low recovery rates. The reverse was noted for those exposed at 30- and 50-m range and those with short exposure. The overall recovery rate of seedlings exposed to horizontal discharge is about 70%. In contrast, the natural vegetation exposed to vertical discharge registered a 100% recovery three (3) months after the discharge (Figures 4a - 4d).
