PREVENTION AND CONTROL OF CALCITE DEPOSITION IN TWO-PHASE HEADER: THE BACMAN-2 BOTONG EXPERIENCE

ABSTRACT

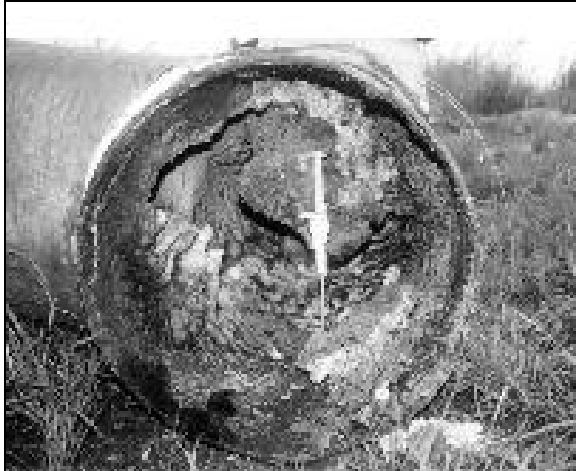
Figure 5. The 610-mm diameter header where fluids of OP-5DA and OP-6D mix. The main blockage area.

The calcite deposition problem was initially manifested by simultaneous and abnormal increases in wellhead and branchline pressures of OP-5DA and OP-6D after eight months (March - November, 1998) of utilization. Inspection in February 1999 revealed that the cause of pressure increases was due to calcite scale deposits formed at the mixing area of OP-5DA and OP-6D at the header (Fig. 4). Bulk of the deposits occurred within a six-meter length header downstream from the mixing point with a calculated volume of 1.63m^3 within a 10-month period. The deposition rate is about 0.163m^3 per month. The calcite scale thickness declines further downstream in corral-like formation. Petrography analysis of the scale deposits (Ramos, 1999) indicates 82% calcium carbonate (calcite), 15% amorphous silica and 3% impurities (Fig. 5). Thin platy calcite crystal and laminates were also observed at the bottom of OP-5DA branchline (Fig. 6).

Previous physical and chemical simulations (Solis, et al., 2000) indicate that the steam-dominated fluid of OP-5DA is supersaturated with respect to calcite, while that of pure-steam discharge of OP-6D is superheated by 16°C . As both fluids mix, boiling and volatilization occur, thus further increasing the calcite supersaturation. The mixing and further boiling processes contributed significantly to the voluminous calcite scale deposits at the mixing point at the header.

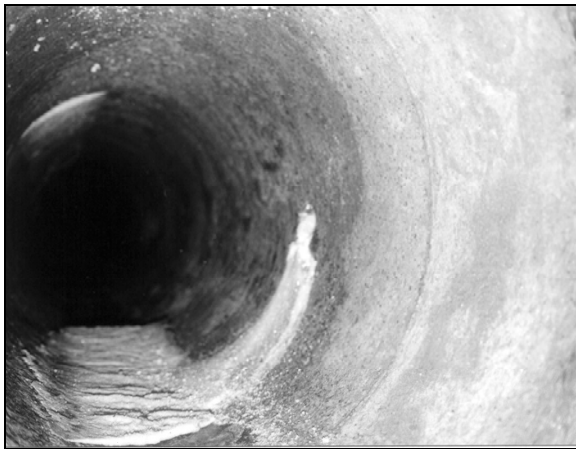
Figure 6. OP-5DA branchline with platy calcite.

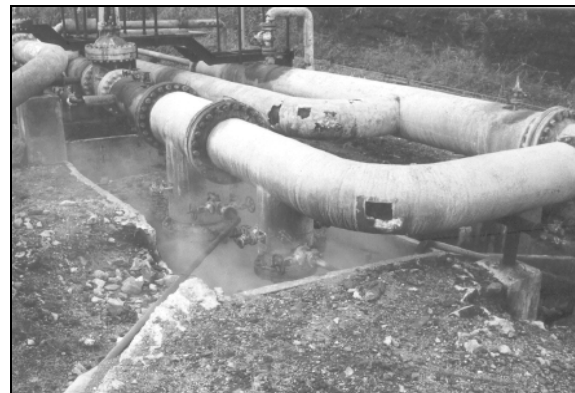
Figure 9. OP-5DA ODP and SDP actual set-up

actual set-up of the liquid removal system is shown in Figure 9.

Downstream of the ODP is a 457-mm diameter T-shaped standard drainpot (SDP). This is eccentrically flanged connected with the branchline with installed steam traps to discharge carry-over liquid that may have escaped the ODP. Both ODP and SDP had 0.51-mm diameter valve bottom drains. The
