## ACIDISING CASE STUDY – KAWERAU INJECTION WELLS

### ABSTRACT

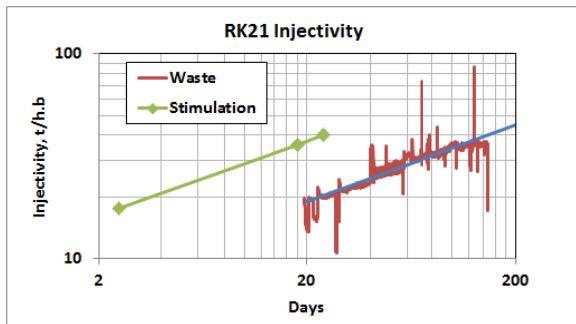
The decline in injectivity is in contrast to the performance elsewhere. In the absence of deposition problems, injectivity should increase roughly with the square root of the time injecting, as shown in Figure 2. The injectivity is higher under stimulation, for the same time injecting, as cold water is used for injection whereas the waste water is hotter.

Figure 2: Injectivity history of RK21 during stimulation with cold water and under operation with waste water.

Not only did the Kawerau wells not follow the trend of increasing injectivity with time, but injectivity declined.

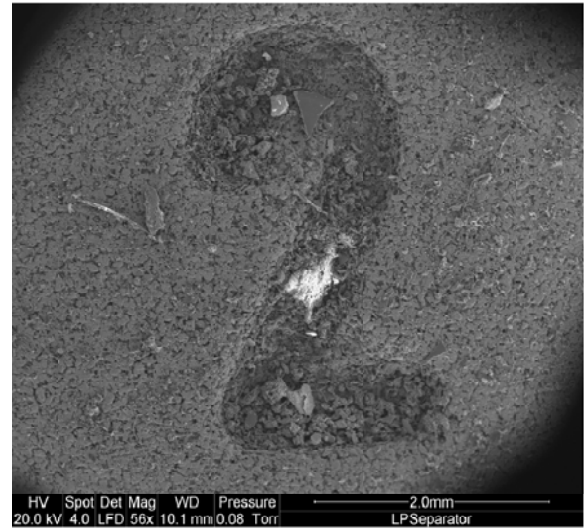
Brine was also filtered through a Swagelok 2  $\mu\text{m}$  stainless steel filter at the LP separator and injection wellhead. An environmental scanning electron microscope (E-SEM) was then used to investigate the precipitates. The LP separator filter (Figure 3) had a small amount of debris which mainly consisted of silica. The injection wellhead filter (Figure 4) had a larger amount of material deposited with compositions similar to the LP filter.

Figure 3: Low magnification of the 2 $\mu\text{m}$  stainless steel filter from LP brine.

Interpreting the results of this test, it was postulated that the most likely cause of scaling is due to colloidal silica scaling. Subsequent downhole camera runs done in all wells identified that the wellbores were relatively clean confirming that the restriction was occurring at the well face.

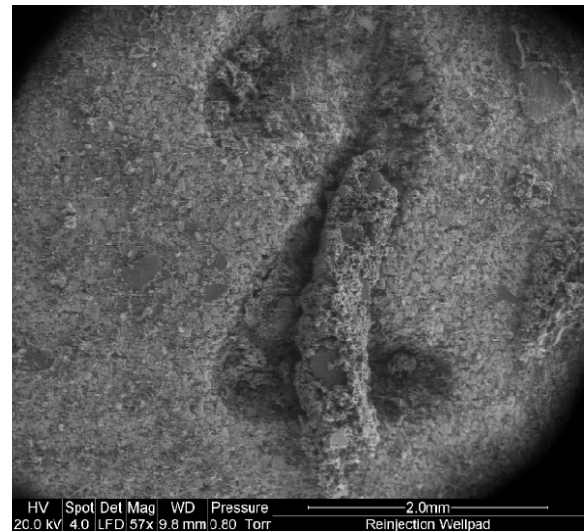
Figure 4: Low magnification of the 2 $\mu\text{m}$  stainless steel filter from injection wellhead brine.

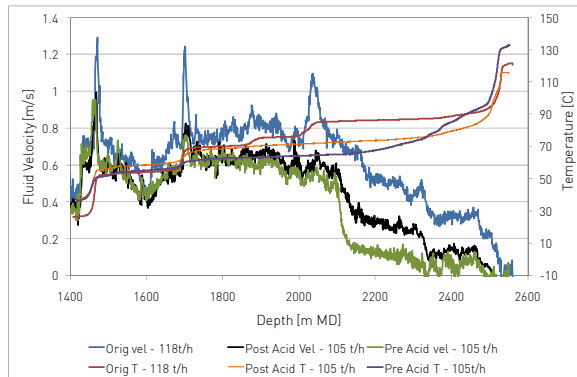
Spinner runs into KA44 (Figure 7) showed that prior to acidising, the bottom zones were almost fully blocked and the majority of fluid was exiting at 2090-2135mMD. Gross Injectivity index (i.e. without compensating for inflows) at this point had decreased to 25 t/h/b. Post-acidising, the spinner profiles were similar to original well conditions suggesting the bottom zones had recovered most of its original performance. Gross injectivity index post-acidising had doubled to 50 t/h/b.

Figure 7: KA44 PTS profiles comparing original performance to pre and post acidising performance.

At KA44, the deeper zones achieved the greatest improvement with acidising, particularly the zone at 2295-2335mMD. The shallower zones showed very little improvements. PK4A's calculation showed a similar result with deeper zones achieving the greatest improvements with minimal effect on the shallower zones. However, it should be noted that the spinner bias seen at PK4A's post-acidising run may have affected the calculations.

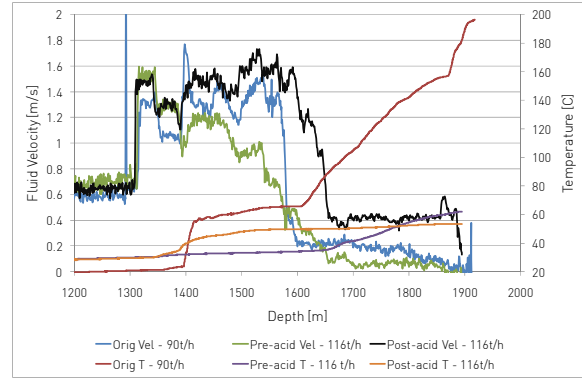
At PK4A (Figure 8), the spinner runs for the post-acidising run had a large bias with velocities at the casing showing much higher values compared to the pump rate. Applying a correction factor solves this, but a bias still exists from 1700mMD onwards.

However, even with this issue it is still clear that the main zone at 1570-1595mMD is partially blocked prior to acidising. Injectivity index at this point had decreased to 50 t/h/b. Post-acidising, the main zone has completely recovered its original permeability increasing the injectivity index to 84 t/h/b.

Figure 8: PK4A PTS profiles comparing original performance to pre and post acid performance
