Recent Geothermal Well Work-Over Experiences at the Kawerau Geothermal Field, New Zealand

Will Clements and Jaime Quinao

Ngati Tūwharetoa Geothermal Assets Ltd., 1 Parimahana Dr, Kawerau, New Zealand

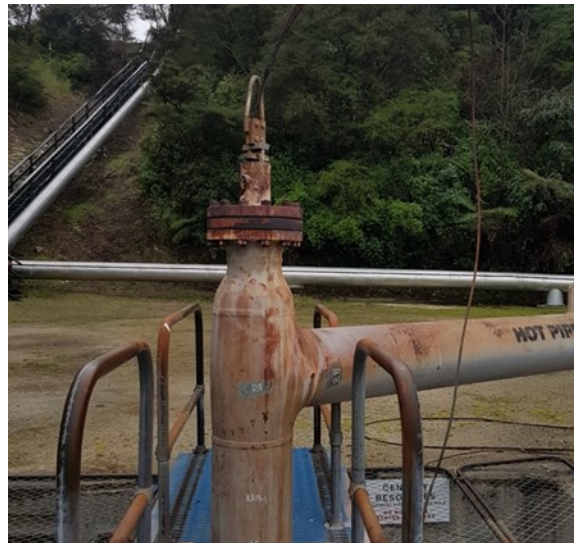
Figure 2: Production well with first-generation anti-scalant tube installed.

Anti-scalant systems are downhole tubes that inject anti-scalant chemicals deep into the production wells to mitigate calcite deposition. The new production wells drilled by NTGA have been fitted with an updated anti-scalant design that utilises a 1/4-inch ID tube, lubricators and risers which allow for regular tube pull-outs for anti-scalant maintenance and reliability testing, and for downhole well condition monitoring and reservoir data measurements. However, a number of the older production wells still have the first-generation anti-scalant design (armoured 1/4-inch tubes) installed (see Figure 2).

This first-generation anti-scalant tubes are effective in mitigating calcite deposition but are challenging to maintain because tube pull out requires wells to be quenched and the wellhead master valve to be closed. Pulling out the first-generation designs is an inefficient and costly process if the wells are to be regularly monitored. Also, a previously uneven maintenance schedule has left some tubes inside the wells for a long time, resulting in additional risks during tubing pull-out. These additional risks include fraying of the tubing armour when it fails during pull-out, creating a “bird’s nest” inside the wells that causes stuck tubes during maintenance checks. Another risk of undisturbed old anti-scalant tubes involves cementing of the tube into the casing wall through the deposition of residual calcite and/or other minerals. The cemented tube could fail during pull-out, leaving the dispersion head or parts of the tubing as “fish” inside the well. These first generation designs are in the process of being replaced by the retrievable anti-scalant tubing design.

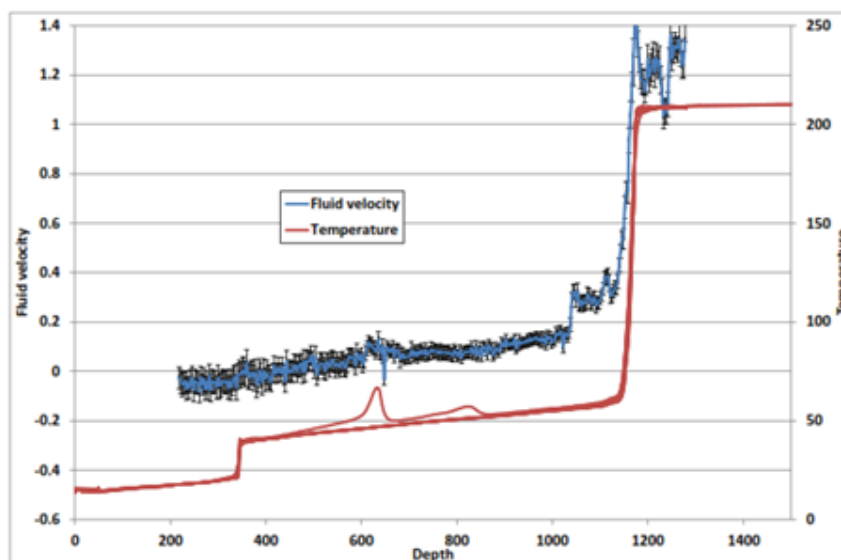
Figure 3: Fluid velocity and well temperature profile under injection indicating an inflow at ~355 m depth (Grant, 2016).

Due to the suspected casing issue, the well was slowly quenched from the bottom using the anti-scalant tubing system. An HTCC survey was completed and results indicated no significant metal losses along the casing. However, the PTS survey carried out with the well under a 50 t/hr quench water injection indicated a hot fluid inflow to the well from a possible leak in the production casing. A multi-finger caliper and a downhole camera run were carried out to verify the possible leak. While the camera run was unsuccessful, the multi-finger caliper results confirmed a poor casing liner lap joint at the same depth as the hot inflow observed in the PTS.

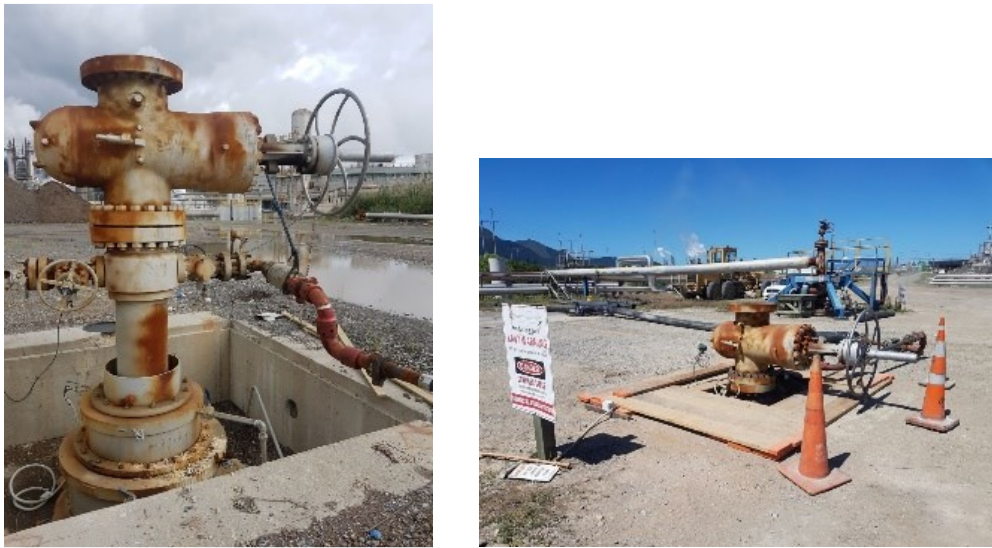
Figure 5: Before and after photos of KA47 wellhead lowering and master valve refit.

One of the key challenges of the plan is the elevation of the well's master valve. KA47's master valve was fitted at 2 m above ground level based on the original drilling rig used to complete the well. This rig is no longer available and at this elevation, no available work-over rigs would fit over the well.

The well's casing head flange (CHF) was successfully lowered to just above the ground level and the master valve was refitted. This was carried out by MB Century using a geothermal wellhead equipment repair tool (GWERT), one of the first use of this rigless temporary packer technology in New Zealand to isolate the well during the wellhead lowering and master valve refit.

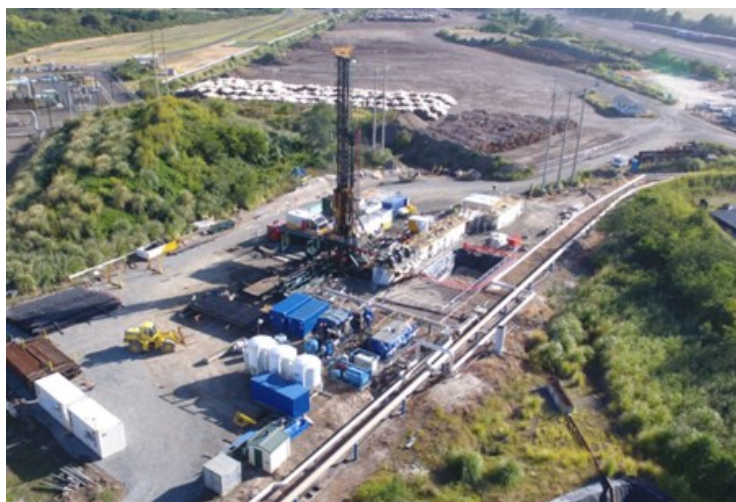
Figure 6: KA47 work-over using the Nova-1 rig.

Another key challenge encountered was the small area in the KA47 well pad. The well pad had a small available area and would not be able to accommodate larger work-over rigs. MB Century's geothermal rig 16 would fit the area but the rig has already been decommissioned by this time. NTGA engaged Webster Drilling and Exploration Ltd., an oil and gas drilling company, to complete the well repair. Webster's Nova-1 rig on the KA47 well pad is shown in Figure 5.

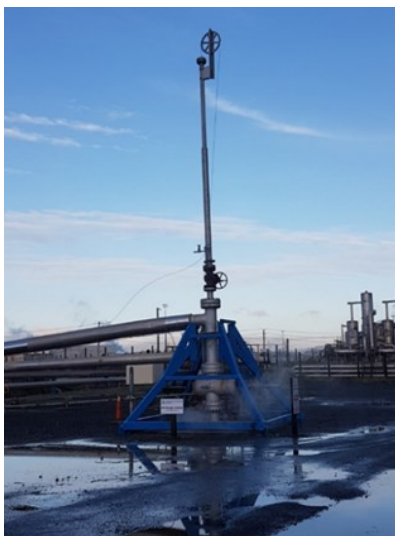
Figure 7: KA47 after well repair and anti-scalant system upgrade.

With the key challenges resolved, a successful work-over was carried out on KA47 by installing a new 10 3/4-inch scab liner/sleeve to repair the casing liner lap joint leak. A new casing head flange and a new master valve were installed on the well to match the new 10 3/4-inch production casing. A new retrievable anti-scalant system was also installed.

Well performance evaluation after the repair showed minimal flow reduction due to the smaller diameter liner. An injecting PTS downhole survey carried towards the completion of the work-over also confirmed that the casing leak has been successfully cased off. The well was successfully returned to service by top-heating it from nearby wells. KA47 is back as a reliable production well for NTGA and is now accessible for regular downhole surveys and well integrity monitoring. The repaired well with the retrievable anti-scalant is shown in Figure 6.

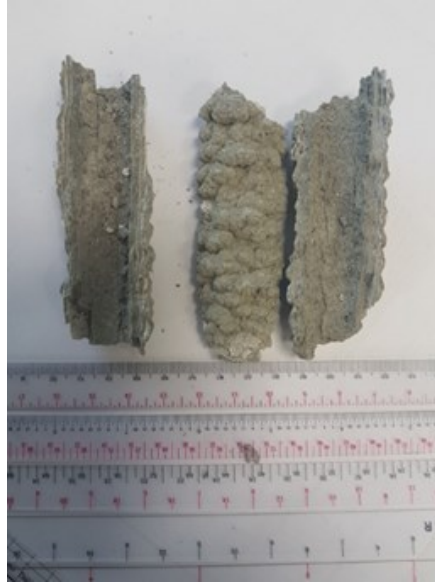
During the tubing pull-out, residual scale was coating the anti-scalant tubing (Figure 8) for about 790 m before the tubing was held up at 576 m depth. At this point, the well also stopped accepting quench water indicating a blockage in the well. High pressure pumps were used to cycle the quench pressure up to 100 bars to dislodge the blockage. The blockage was dislodged, the quench flow was re-established, and the acid flush plan was implemented to ensure maximum tubing recovery.

Figure 8: Scale around the KA27 anti-scalant tubing.

Around 7,400 litres of acid mixture (hydrochloric acid and formic acid) and acid corrosion inhibitor was injected into the well to dislodge the stuck tubing. The stuck tubing was successfully pulled out except for 11 m length of tubing and the 4-meter dispersion head attached at the bottom of the anti-scalant tubing. The well quench was maintained.

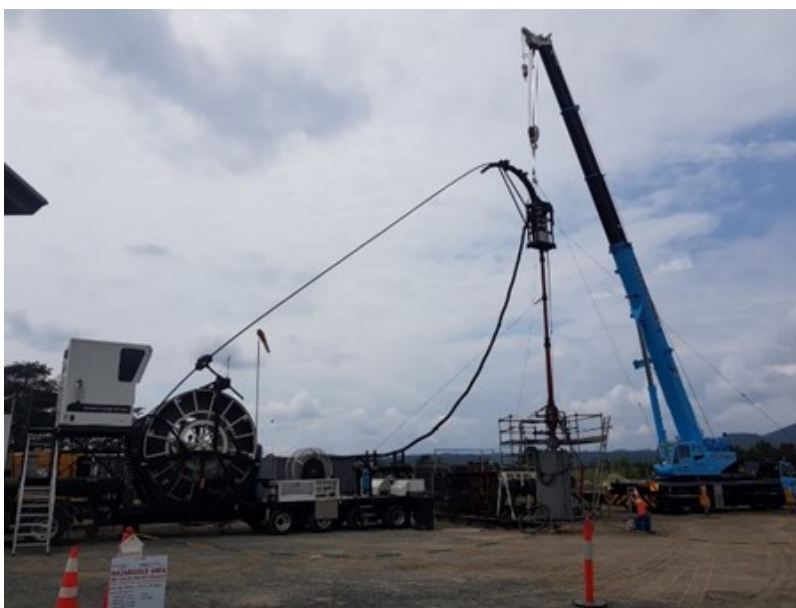
Figure 9: KA27 mechanical clean out using a coiled tubing unit.

The live mechanical clean out used a coiled-tubing unit (CTU) to convey the mill downhole and clear out the blockage at 610 m depth and all remaining obstruction down to the bottom of the well.

Successful clearance of the main blockage was confirmed when the well started to flow while the mill was drilling through the obstruction. The rest of the mechanical clean out operation was carried out while the well was flowing through the muffler/silencer. This ensured that the well could be returned to service quickly, if required.

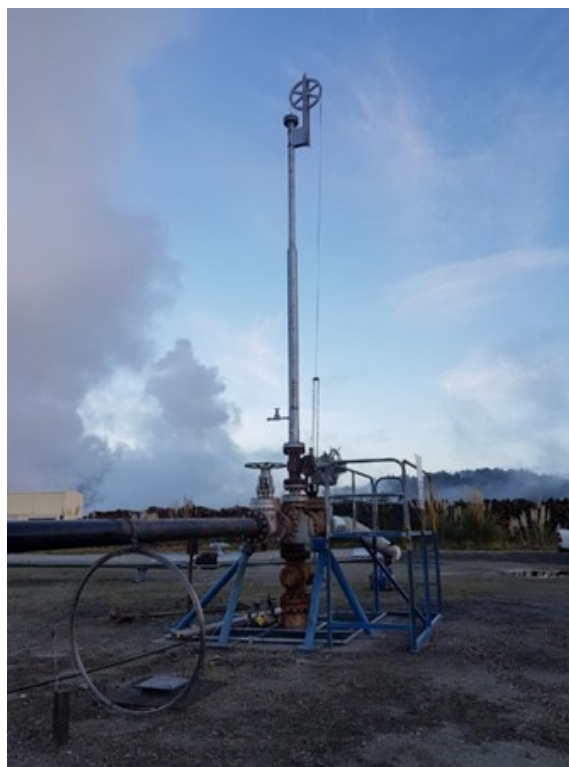
Figure 10: KA27 with new anti-scalant system installed.

Once the well was cleared of obstructions, downhole HTCC and PTS surveys were carried out to check the condition of the casing and the feed zones of the well. The HTCC and PTS survey results showed that the 39-year old well has excellent casing condition. A new retrievable anti-scalant system was installed in KA27 (Figure 10) and the well was easily brought back online.
