Evaluation of Proppant Performance in Maintaining Fracture Conductivity Under Simulated Geothermal Reservoir Conditions

Najiba Hozeh, Wahidur Rahaman, Xuejun Zhou, Sree Sujon Sutradhor, Ahmad Ghassemi
Reservoir Geomechanics and Seismicity Research Group, The University of Oklahoma, Norman, OK, USA
Ahmad.ghassemi@ou.edu

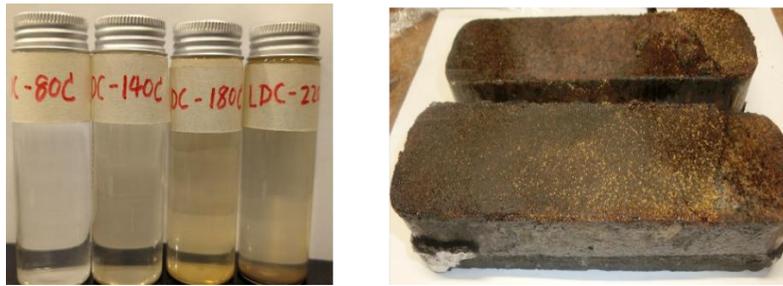
Figure 3: Left: Effluent collected at different temperature stages during LDC proppant testing, showing progressive darkening of the fluid with increasing temperature. Right: Post-test LDC proppant bed exposed to combined high temperature (up to 220 °C) and high axial stress (up to 9,500 psi), showing evidence of some particle crushing while still retaining overall structural integrity under extreme conditions.

During the conductivity tests performed with low-density ceramic (LDC) proppant, the axial load was cycled below 4000 psi while the temperature was raised to a maximum of 220 °C. At last stage, the axial load was ultimately increased up to 9,500 psi. Throughout the experiment, fluid overflow was collected at each temperature stage to document any changes in effluent appearance, and the proppant bed was inspected after exposure to combined high temperature and high stress. A noticeable change in the effluent color was observed as temperature increased: the initially clear flow gradually turned darker at elevated temperatures. This darkening suggests increasing dissolution, mobilization of fines, or thermal alteration of the proppant surface (Figure 3, left). Despite the darkening of the effluent at elevated temperatures, the proppant bed appeared generally intact at the macroscopic scale, with only limited or regionally distributed crushing visible after testing under the highest loads and temperatures (Figure 3, right). While significant deformation was not immediately apparent to the naked eye, localized grain breakage and subtle compaction were evident upon closer inspection. SEM analysis further confirms these observations, revealing micro-scale damage such as surface alteration, partial grain fusion, and localized crushing that is not easily detectable through visual examination alone (Figure 4). Together, these observations indicate that although the LDC proppant maintains an overall coherent structure under simulated deep-reservoir conditions, measurable mechanical and thermal degradation does occur at the grain scale, which may contribute to the observed reduction in fracture conductivity.

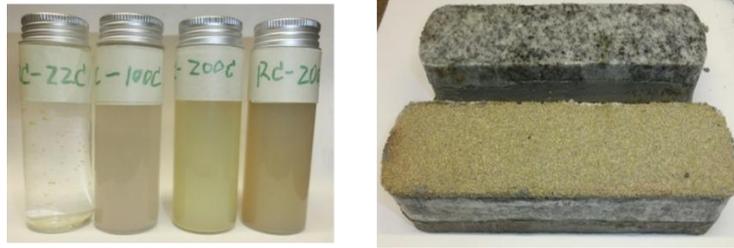
Figure 6: Left: Darkening of effluent fluid across temperature stages during RC proppant testing. Right: The overall intact proppant pack after exposure to final conditions of 10,000 psi and 220 °C.

During conductivity testing of the high-strength resin-coated (RC) proppant, the axial load was cycled below 8,000 psi while the temperature was elevated to a maximum of 220 °C. Throughout the experiment, fluid effluent was collected at each temperature stage to monitor changes. A noticeable darkening of the effluent was observed as temperature increased, shifting from initially clear to a darker hue (Figure 6, left). This change suggests potential thermal degradation of the resin coating, mobilization of fines, or dissolution products.

Post-test inspection of the proppant pack under macroscopic examination revealed a generally intact structure, even after exposure to the highest stress and temperature (Figure 6, right). However, closer inspection indicated subtle signs of deformation, including localized pellet embedding and slight compaction, but no widespread crushing.

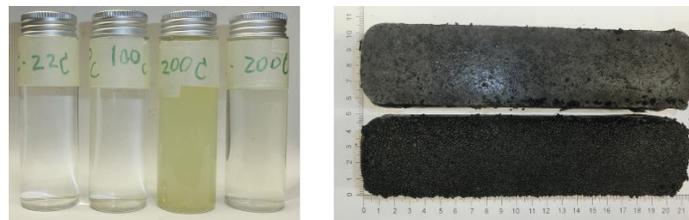
Figure 9: Left: Effluent fluid across temperature stages during PC proppant testing. Right: The overall intact proppant pack after exposure to final conditions of 5,000 psi (which exceeds crush resistance ~2100 psi of the PC) and 200 °C.

The test was completed successfully, with all procedures executed according to the planned methodology. Post-test inspection showed that the proppant pack remained well consolidated, with no visible signs of significant particle displacement or channel development (Figure 9, right). Fluid overflow was collected at 22 °C, 100 °C, and 200 °C to document changes in effluent appearance with increasing temperature. At 200 °C, the overflow initially displayed a dark coloration that became clear after standing for one day, indicating a transient response rather than sustained deterioration. Thus, two bottles represent the 200 °C condition: an early-stage yellowish fluid and a later clear fluid. Despite this temporary discoloration at elevated temperature, the proppant bed maintained good macroscopic integrity throughout the test (Figure 9, left).

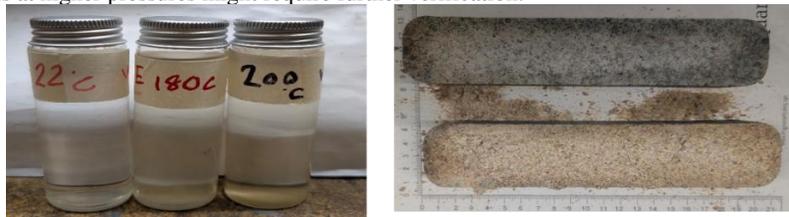
Figure 12: Left: Effluent fluid across temperature stages during Sand proppant testing. Right: The sand Bed after exposure to final conditions of 6,000 psi (which exceeds crush resistance ~910psi of the sand) and 200 °C.

During conductivity testing of sand, the axial load was cycled below 6500 psi while the temperature was elevated to a maximum of 220 °C. Throughout the experiment, fluid effluent was collected at each temperature stage to monitor changes. A slight darkening of the effluent was observed as temperature increased, shifting from initially clear to a darker hue (Figure 12, left). This change suggests potential thermal degradation of the sand, mobilization of fines, or dissolution products. Sand color was initially bright reddish yellow before testing, whereas post-test observations showed a clear loss of color intensity. During the conductivity tests conducted using sand proppant, several operational challenges were encountered. As the axial load and temperature were progressively increased, significant fine generation was observed, which led to partial blockage of the flow lines and hindered stable fluid circulation through the system. Repeated flow-line blockage required intermittent shutdowns and cleaning of the system. These interruptions became more frequent at higher axial loads and temperatures; as such, conductivity data beyond 4000 psi may be subject to increased uncertainty. Post-test inspection showed that the sand bed remained unconsolidated, with approximately 54% fines generated after a 10-minute sieve analysis. At stresses exceeding the packing strength, the generation of fines may have promoted more complicated flow paths within the proppant bed. Consequently, the conductivity measurements at higher pressures might require further verification.
