FIELD TESTING OF pH MODIFICATION SILICA INHIBITION WITH CHEMICAL CORROSION INHIBITION

A.I. Remoroza, A.V. Mejorada, A.T.N. Salazar

Energy Development Corporation
Fort Bonifacio
Taguig City, MetroManila, 1630, Philippines
e-mail: remoroza.ai@energy.com.ph

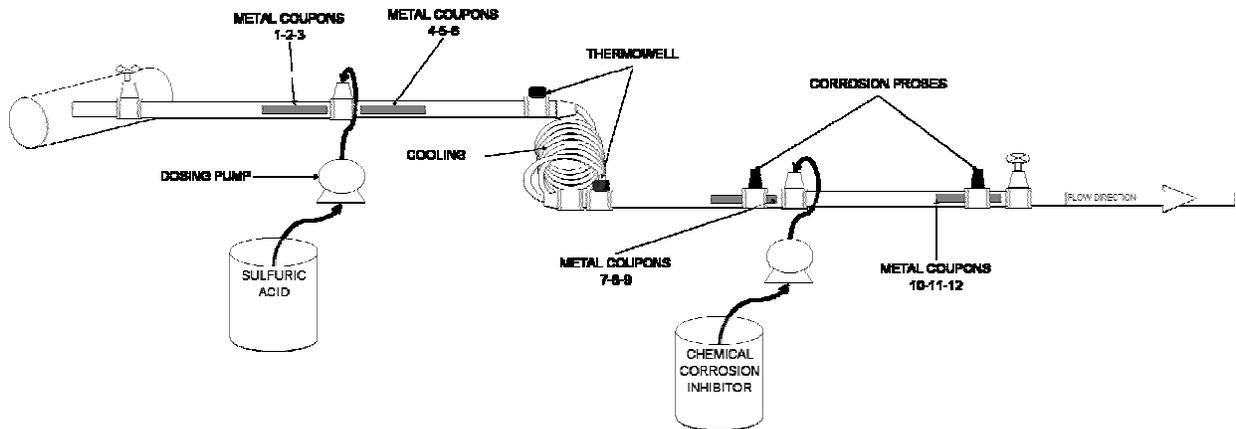
Figure 1. Schematic diagram of pH modification Silica Inhibition with Corrosion Inhibition Experimental Set-up

The pilot test facility for the pH modification and corrosion inhibition studies is basically a compartmentalized pipeline where each section is set to a specific condition (Fig.1).

The first section of the pipeline serves as the blank or reference line condition; it has the same brine temperature as that of main reinjection line (approx. 160°C). Sulfuric acid is introduced at the second section, dropping the pH from ~7.0 to 4.5 while maintaining brine temperature at about 160°C. A series of cooling coils between the second and third sections of the pipe drops the pH-modified brine temperature to ~120°C. Between the fourth and final sections is where corrosion inhibitor is injected.

Corrosometer probes were placed at key locations to determine the corrosion rate at specific intervals. Metal coupons were also placed at each section to determine material loss due to corrosion. These corrosion coupons were polished, cleaned and weighed prior to testing.

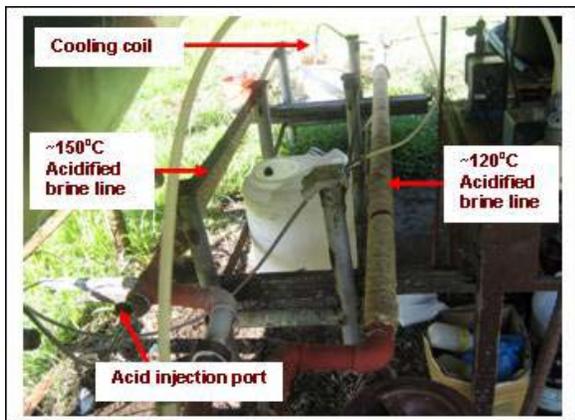
Figure 2. Nasuji Testing Facility showing pre-cooled and cooled section of the brine line.

ensure adequate mixing of the brine with the chemical introduced. Sections of the pipe were insulated using abaca fiber to maintain constant temperature (Fig. 2). A high temperature corrosion inhibitor was used to control corrosion in the experiment and was injected at a concentration of 10 ppm. The chemistry, temperature, pH and flow rates were monitored; the test was run for a month to achieve stable corrosion rates.

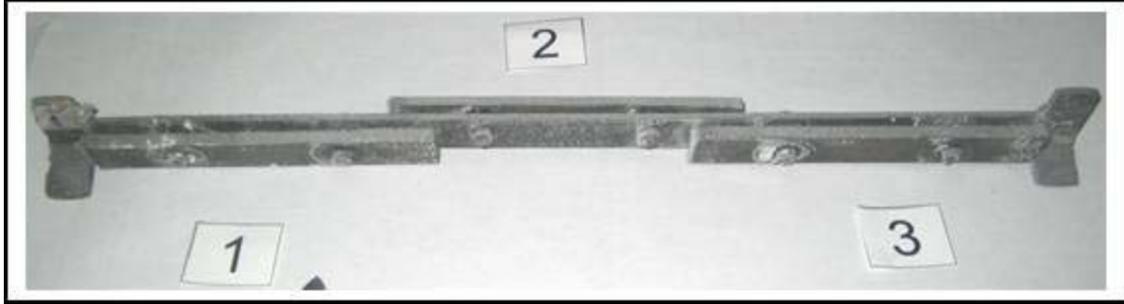
Figure 3. Metal coupons 1 – 3, blank/reference line condition, ~160°C, un-acidified

Deposits from coupons 1-3, on the other hand, were identified as amorphous silica scales, relatively hard and adherent to the metal coupon surfaces. Further, these are white to off white, grayish, exhibiting ripple marks, non-uniform or irregular deposition and thick deposition noted at edges, brittle and easily breaks (Fig. 3– 6).

The Nasuji brine apparently showed a short induction time as metal coupons 1 – 3 exhibited significant silica depositions. The residence time between the separator vessel and metal coupons 1-3 is less than 5 minutes. That explains the silica depositions in metal coupons 4 –12; colloidal silica already exists when acid is introduced to the system and the change in pH resulted in the association of colloidal silica with metal ions to form colored precipitate.

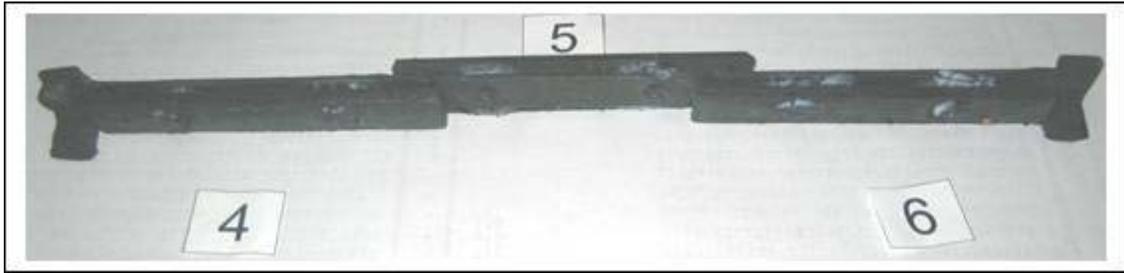
Figure 4. Metal coupons 4 – 6, ~150°C, acidified pH ~4.5

Petrological analyses of deposits formed on metal coupons 4 -12, scraped off using plastic spatula, yielded generally soft and easily removable deposits. Coupons 4 - 6 are greenish gray in color, very thin deposits covering almost the entire surface, very similar texture/structure, with small ripple marks, relatively thicker deposition noted at the edges, soft and can easily be wiped and removed. Coupons 7-9 have thick whitish gray deposits showing wider ripple marks, soft and can easily be wiped and removed. Coupons 10-12 have light brownish deposits covering most of the metal surface, exhibits ripple marks, soft and can easily be wiped and removed.

Generally for coupons 4-12, two layers of silica deposits formed on the surface of corrosion coupons: a thin and dense basal layer that is attached to corrosion products (hematized magnetite), and an overlying porous, thicker layer of globular silica dendrites (Delfin & Rosell, 2006).

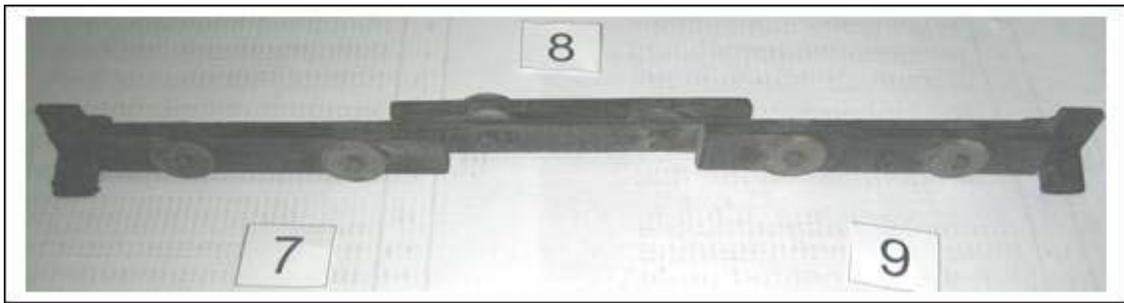
Figure 5. Metal coupons 7 – 9, ~120°C, acidified pH ~ 4.5

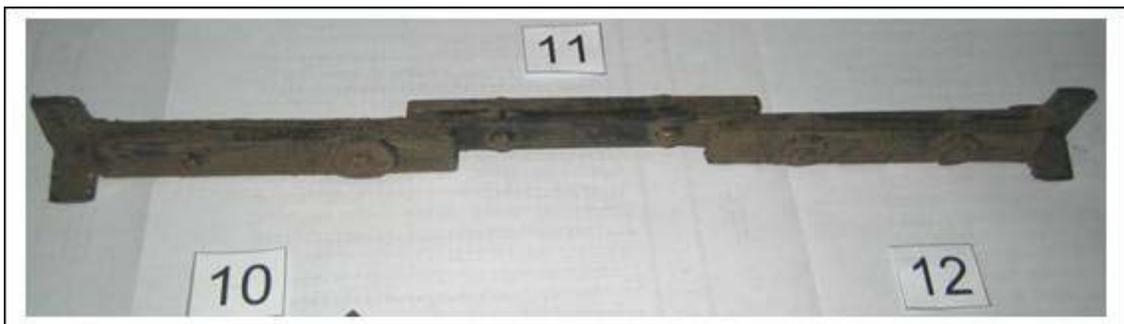
Figure 6. Metal coupons 10 – 12, ~120°C, acidified pH~4.5 and with corrosion inhibitor

These chelate-like bonding of colloidal silica with metal ions in the brine can explain the observed coloration of precipitated amorphous silica in metal coupons 4 –12. This can also explain why the amorphous silica formed in metal coupons 4 –12 is loosely attached; the bonding sites of the colloidal silica were reduced due to adsorbed metal ions. The different coloration of the metal coupons is due to the preferred metal ions adsorbed at different conditions. The brownish coloration of metal coupons 10 –12 can also be attributed to adsorbed organic polymer from the injected corrosion inhibitor.

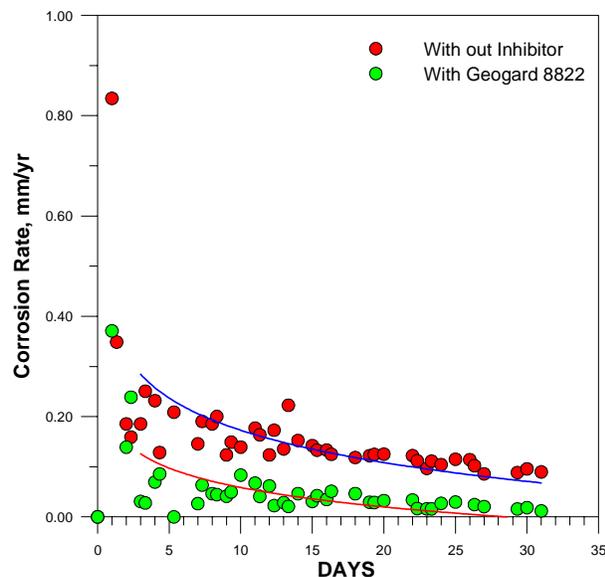
Figure 7. Measured corrosion rates based on corrosometer readings

Corrosion rates of the acid-treated brine were measured for more than 30 days. The average corrosion rate of the ~120°C, acid-treated brine was computed at 0.165 mm/year, while the ~120°C acid-treated brine with corrosion inhibitor had an average

corrosion rate of 0.048 mm/year (Fig. 7). This translates to a ~70% decline of the corrosion rate due to the 10 ppm injection of the inhibitor. Towards the end of the experiment the corrosion rates measured were ~0.1 mm/year and ~0.02 mm/year, respectively and could still go down as the passivating film formed along the pipe walls thicken. For reference,

the allowable corrosion rate of carbon steel pipes is 0.125 mm/year for a 25-year life span.
