CASE STUDIES OF LANDSLIDE HAZARD OCCURRENCES IN GEOTHERMAL FIELDS: THE PNOC-EDC EXPERIENCE

R. D. Leynes, W. P. C. Pioquinto and J. A. Caranto

PNOC Energy Development Corporation, Merritt Road, Fort Bonifacio, Metro Manila 1201, Philippines

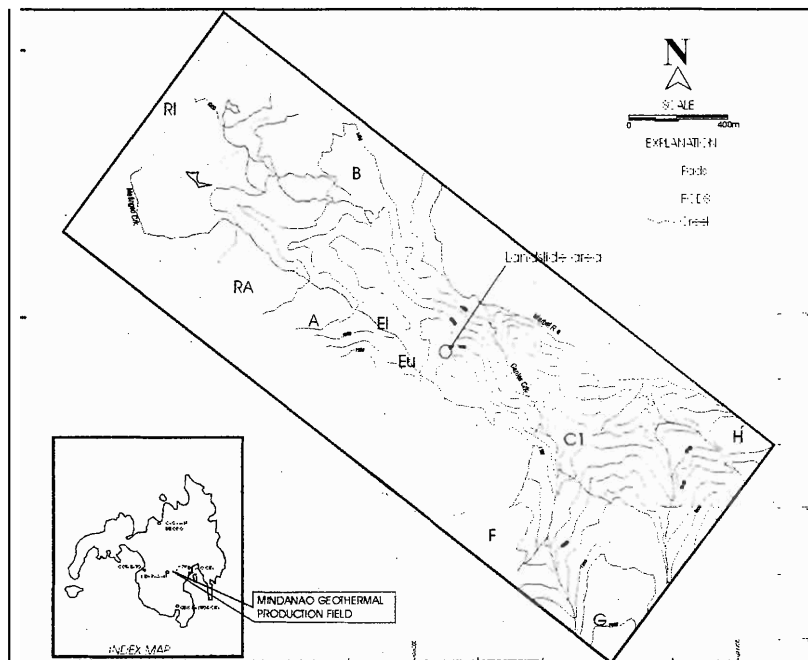
Figure 5. The 701 has. Mindanao geothermal production field showing slide area above E upper Pad

A portion along the Fluid Collection Disposal System (FCDS) route of the Mindanao II Geothermal Project (M2GP) above Pad E upper (Fig. 5) was assessed for slope failure potential (Pioquinto, 1998). The slope face is composed of intensely altered and highly to moderately weathered volcanics with boulders about 7-10 m above the road embedded in a weak sandy to clayey matrix which is overlain by weak semi-solid colluvial materials. The area is therefore prone to sheet slides or movement of shallow surficial debris (Zaruba and Mencl, 1982) and rockfalls/rockslides which are landslides with
