FAILURE INVESTIGATION OF CAPILLARY TUBING (ASTM 316L) USED FOR CALCITE INHIBITION

Mayflor N. Ramos-Candelaria¹ and Keith A. Lichti²

¹PNOG Energy Development Corporation, Merritt Road, Fort Bonifacio, Taguig City, Philippines
²MPT Ltd., Gracefield Research Center, Gracefield Rd., Lower Hutt, New Zealand

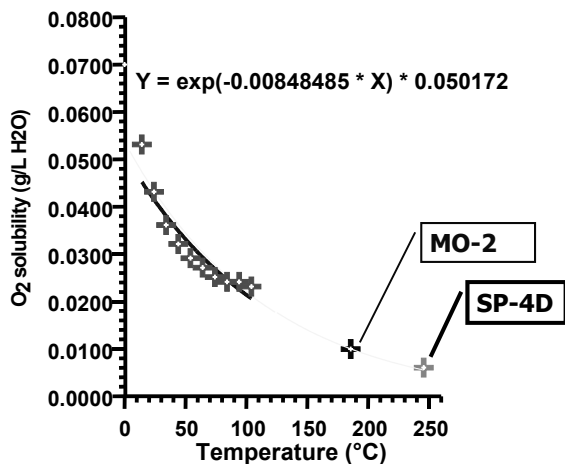
Figure 7. Solubility curve of oxygen in water at various temperatures with P=750mmHg (Data from NACE Corrosion Engineer's Reference Book, 1983; Ed. By R. S. Treseder)

The very low DO levels (Fig. 7) in the high temperature environment ranging from 180°C to 210°C, would discount oxidative corrosion. Acidic corrosion, which results in more aggressive intergranular attack (H_2 cracking from $2H^+ + 2e^- = H_2$) is also not possible. Acid conditions at 180°C occurs only at $pH < 5.67$, a condition definitely not present in the wellbore. Fast and catastrophic failure of SS316 is not expected in this type of environment.

The reservoir fluids of well SP-4D are similarly close to neutral at pH=6.6, Cl_{res} = 4400-4600 ppm, Ca_{res} = 70-80 ppm, Mg_{res} = 0.1 ppm, SO_{4res} = 36-40 ppm, and over-saturated with calcite at CSI ~ 4, T_{SiO₂} ~240°C, CO_{2TD} of 18 mmols/100 moles steam and H_{2S_{TD}} of ~1 mmol/100 moles H₂O. Neutral pH at 240°C is at 5.55, making the reservoir fluids of SP-4D slightly basic. Similar to MO-2, dissolved oxygen levels at 240°C is almost nil (Fig. 7), rendering oxidative corrosion impossible inside the wellbore.
