SCALING AND CORROSION IN SEPARATOR VESSEL 303, BACMAN GEOTHERMAL PRODUCTION FIELD, PHILIPPINES

Sylvia G. Ramos¹, Josephine B. Rosell¹, Keith Lichti², Fidel S. See¹,
Jimmy J. Fragata¹, Danilo B. Rubin¹, and Raul Evangelista¹

¹PNOG Energy Development Corporation, Merritt Road, Fort Bonifacio, Taguig City, Philippines

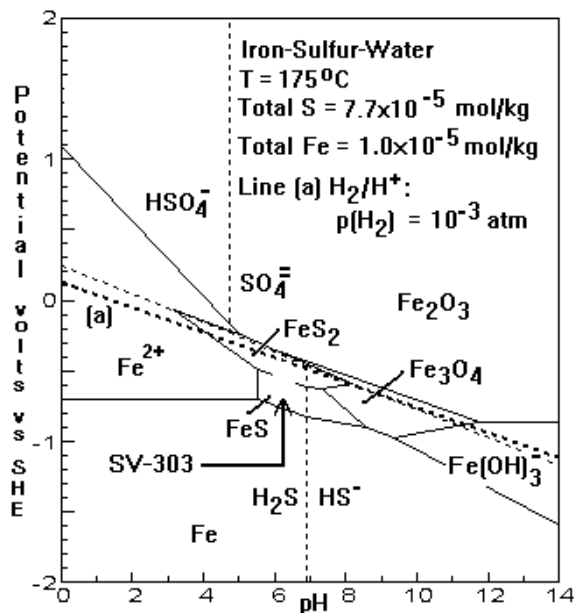
Figure 8. Pourbaix diagram for iron-sulfur-water system for BacMan geothermal steam in SV-303 at 175°C.

equilibrium with steam in the upper portion of the separator vessel, Figure 8. Lichti et al. (1997) described the methodology for preparing Pourbaix diagrams and their interpretation for geothermal steam applications. Illustrations of reactions that result in formation of the observed iron sulfide and iron oxide corrosion products include:

The previous work has demonstrated that there is a strong tendency to form stable, adherent corrosion products in geothermal steam and that these corrosion products block the underlying metal from the corrosive solution. Pourbaix diagrams of the type shown in Figure 8 describe the stability of these products and the models have been shown to be valid for low chloride, near neutral pH solutions. Based on Figure 8, iron sulfides (pyrite and pyrrhotite) are the corrosion products which are in equilibrium with separated steam at the upper portion of SV 303. The formation of iron sulfide layer reduces concentration of sulfur at the metal surface allowing subsequent deposition of iron oxides.
