Lesson Learned: Well Logging Analysis to Interpret Shallow Connection Between Two Wells in Dieng Geothermal Field, Indonesia

Ichwan Agusta Elfajrie¹, Reza Jamil Fajri¹, Elfina¹, Muhammad Istiawan Nurpratama¹, Nurkholis Hariyadi¹ and Alan Muhadjir²

¹PT Geo Dipa Energi (Persero), Aldevco Octagon 2nd Floor, Jl. Warung Jati Barat No. 75, South Jakarta 12740 - Indonesia

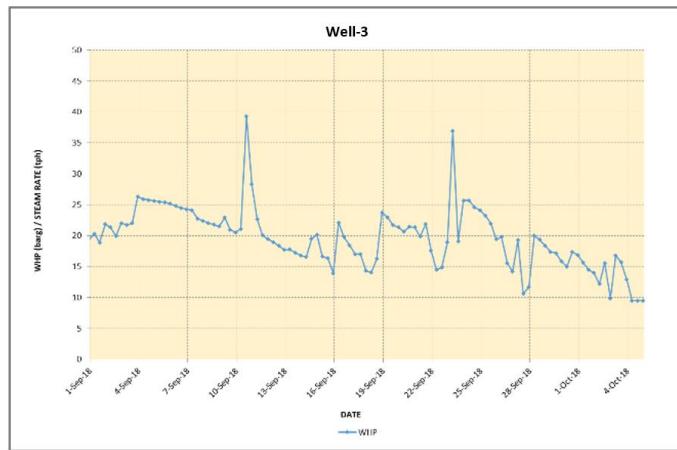
Figure 2: WHP and production profile of Well-3.

Dieng Geothermal Working Area, located in Central Java Province, Java Island, Indonesia, is one of the geothermal fields operated by PT Geo Dipa Energi (Persero) (GDE) since 2002 with an electricity generation capacity of 60 MWe. Well-1 and Well-3 are two production wells for Dieng Geothermal Power Plant Unit 1, located in the same well pad (Figure 1). Well-1 has not been operated since 2012, while Well-3 still produces steam with about 14% of total power generation. The decrease in Well-3 performance started in September 2018, even though several heating-up programs were conducted (Figure 2).

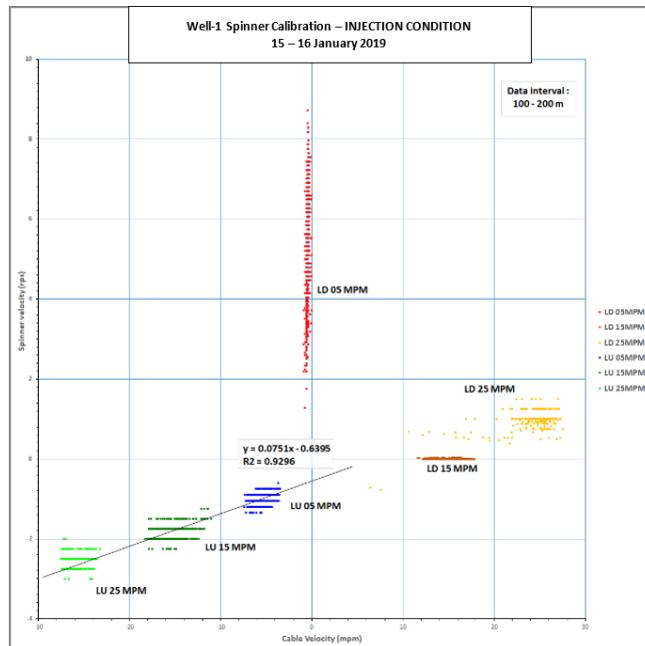
Figure 13: Well-1 spinner calibration crossplot.

Figure 14 show the analysis for these two wells. The measurement results in the Well-1 show that the data at a speed of 5 mpm cannot be used, while all measurement data in the Well-3 is of good quality so that it can be used.
