## **Stuck Pipe Prediction And Avoidance: Invocation Of Basic Principle Of Standard Methods, Pre And Post Sticking**

**Keywords:** Stuck pipe, mitigation, drill string

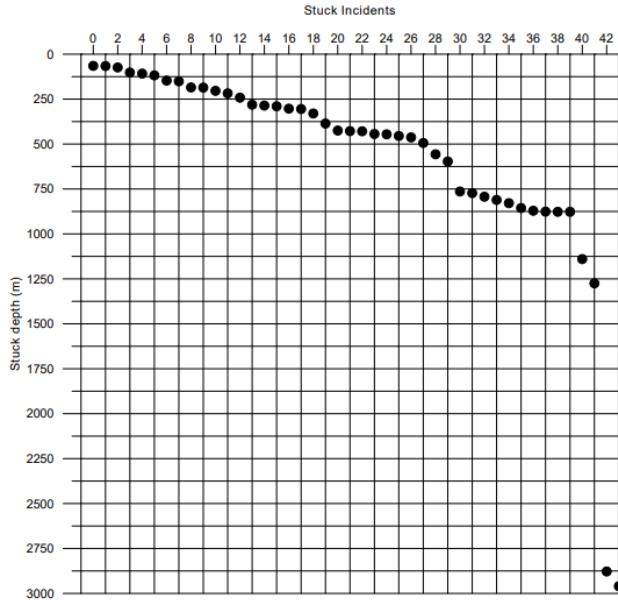
Figure 1: Stuck depths with time progression

In this investigation, the stuck incidents were plotted against the stuck depth as shown in figure 1. It was therefore found that 86.96% of all the stuck pipe cases happened in shallower depths above 1000m. These findings therefore make this region a point of interest that calls for more than average attention by the relevant stakeholders. As earlier mentioned, in well planning, the key to achieving objectives successfully is to design drilling programs on the basis of anticipated potential hole problems. At the design stage of a well, planning and preparing for drilling challenges in the range of 60m to 1000m is key. Below 1500m, the stuck pipe cases have not been common.

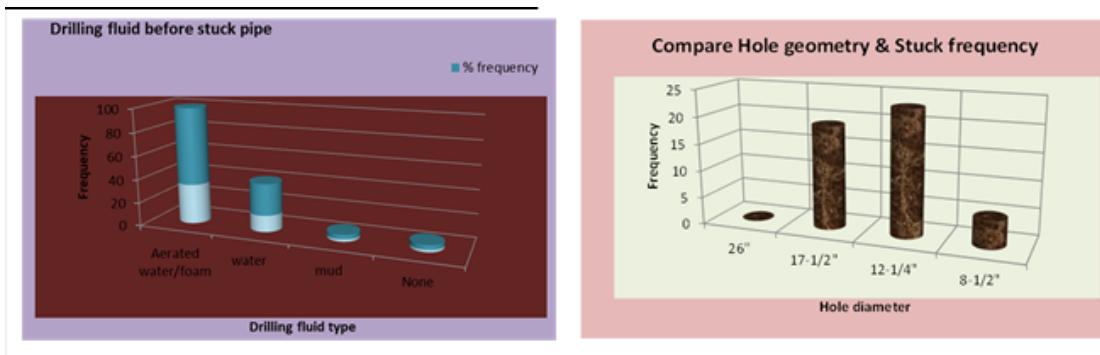
Fig. 2 drilling fluid on use at the instance of stuck pipe.

Most stuck pipe occurrences happened while using aerated air and foam at 65%, water at 26.92% and mud at 3.85% as is indicated in figure 2. As has been observed, drilling fluids can create as many problems as they can solve. Application of the correct mud system is therefore crucial if drilling troubles were to be avoided.

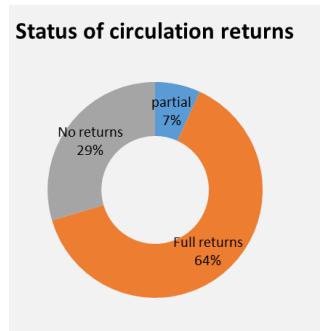
Fig. 4 Stuck pipe in relation to status of circulation

When intermediate or severe losses occur, cuttings will settle out around the BHA, and mechanically stick the pipe. The cuttings will act as a packer, and make the losses worse. It was observed that 64% of stuck pipe incidents occurred while circulation returns was received on the surface, 29% during blind drilling (total loss of circulation) and 7% with partial returns. More often, it is assumed that with full circulation returns, chances for getting stuck are minimal contrary to the findings of this research. According to C. Bowes & Procter [Drillers Stuck pipe Handbook, 1997], the effect of mud rheology on hole cleaning depends on the annular flow regime. When laminar flow exists, increasing the mud viscosity will improve hole cleaning. This is particularly effective if the low shear rheology and YP/PV ratio are high.) · When turbulent flow exists, reducing the mud viscosity will help remove cuttings [2], [3].

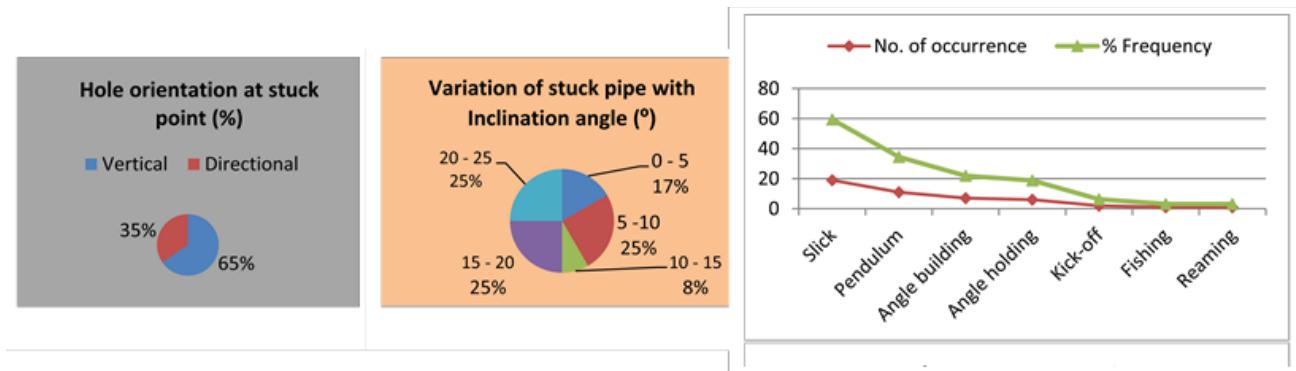
Fig. 5 Effects of hole orientation

As figure 5 indicates, 65% of problems were encountered while drilling the vertical section of hole contrary to anticipated deviated section which conventionally poses more challenges due to cleaning problems. The hole pack-off incidents which have immensely contributed to stuck pipe happened majorly in vertical sections of the hole. Arising from these findings, potentially risky hole sections should be drilled with rotational drill string even if it requires to re-programme motor kickoffs [3].

It was noted that stuck string was experienced due to doglegs/ledges that was developed especially during kick-off and angle building section of the hole. It was during trip out that most stuck situation was experienced as figure 6 indicates. Below 5° of deviation from vertical trajectory, less stuck problems was experienced at 17% and 25% during angle build up to 20°.

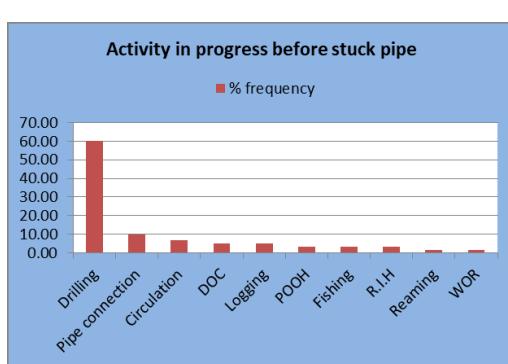
Fig. 8 Activity prior to stuck pipe

For better understanding of the true cause and stuck mechanism, it was of interest to review the drilling activity on progress shortly before, during and after stuck pipe situation. Figure 8 shows 60% of cases to have occurred while drilling on bottom, 10% while making up the pipe and in the least of cases while reaming and waiting on repairs at 1.67% each respectively.

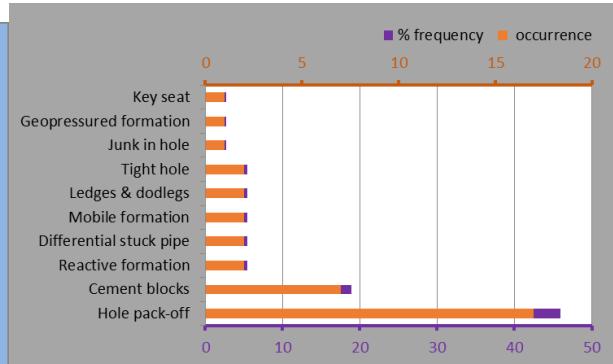
Fig. 9 Stuck mechanism

Most cases of stuck pipe are avoidable with proper attention to detail, and once stuck pipe is recognized, fast action is necessary. The best chance of getting free is just after getting stuck. Recognizing the different ways drill pipe can get stuck is the first step in prevention and recovery [4]. Before any attempt is made to get the drill string free, it is of paramount importance to try and identify the possible cause and mechanism of stuck pipe. Different stuck mechanisms may require different approach if any success to overcome the problem is to be achieved in timely and cost effective manner. For instance, due to insufficient hole cleaning, when the circulation stops, cuttings will settle around the drill string, effectively leading to hole pack-off, which in this case accounted for 45.95% of stuck pipe. Cement blocks related stuck situations was established to have been 18.92% while key seats, geopressedured formations and tight hole was found to contribute the least stuck pipe incidents at 2.70% respectively as indicated in figure 9. Pipe stuck in a key seat which was one of the least contributors to stuck pipe had occurred at 2.7% of the total cases.

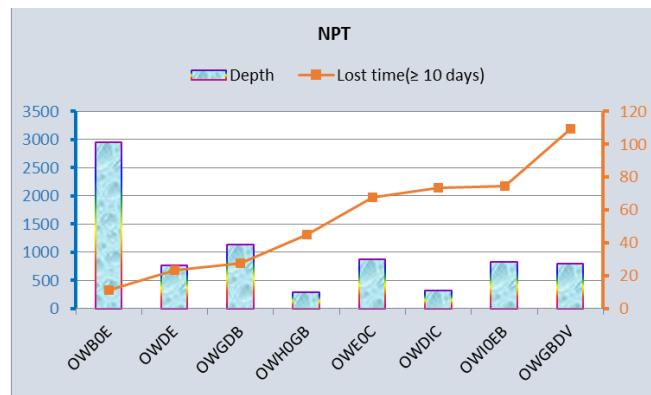
Fig. 10 NPT relative to stuck depth

The NPT arising from stuck pipe was found to range from as low as 1 hour to as high as 2616 hours. Some of the worst times of stuck situation in terms of NPT are as indicated in figure 10. At a depth of 793m, geothermal well referenced as OwgBDV incurred a total loss of 109 days, making it the worst case of stuck pipe situation.

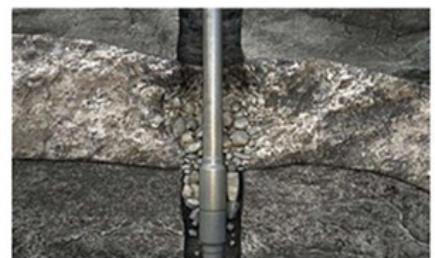
**Fig. 23 Illustration of unconsolidated formation [8].**

In the three instances of stuck pipe at 185m, 204m and 290m, the hole pack-off due to unconsolidated formation is the most probable cause. This usually happens when little or no filter cake is present as illustrated in figure 23. The un-bonded formation cannot be supported by hydrostatic overbalance as the fluid simply flows into the formation. Sand or gravel then falls into the hole and packs off the drill string [8].
