COMPARATIVE STUDY OF FRACTURES IN CORE AND BOREHOLE TELEVIEWER IN WELL VC-2B, VALLES CALDERA, NEW MEXICO

Dennis L. Nielson¹, Colleen A. Barton² and Kelly E. Keighley¹

ABSTRACT

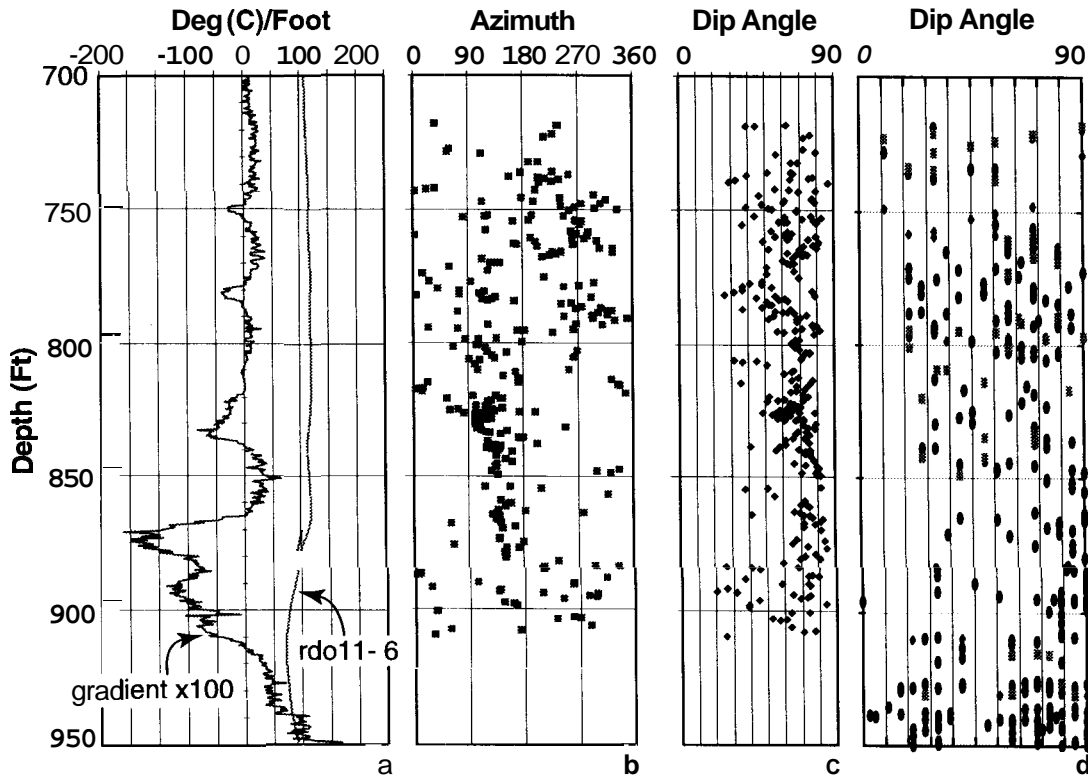
Fig. 3. Depth plots for interval studied in VC-2B a) Temperature log and calculated gradient, b) Dip azimuth and c) Dip angle plots from BHTV interpretation, and d) Dip angle of fractures measured on core. Solid dots are undifferentiated fractures, squares are faults and diamonds are mode I fractures.

Figure 3a shows the RDO11-6 temperature log with a plot of the calculated gradient that gives a better definition to the fluid loss zones. From this data, we have determined that the fluid was principally lost in the following zones that are defined by gradients of 0: 748.5 to 754 feet, 778.5 to 787 feet, 819 to 840.5 feet and 865 to 914.5 feet.

Fracture orientation was systematically measured using the processing system summarized above. The orientations of fractures measured in well VC-2B are plotted as a function of depth in Fig. 3b and c. Detailed interactive analysis of borehole televiewer data reveals a dominant northeast striking, steeply dipping fracture population for the VC-2B well. The fracture population for well VC-2B is dominated by high-angle fractures, and a histogram of the number of fractures per foot shows that the fracture distribution is not significantly changed as a function of depth. Although these results are from a somewhat shallower depth interval than other published data on the depth dependence of fracture frequency, they are similar to a number of other studies (Seeburger and Zoback, 1982; Barton and Zoback, 1989) which show no decrease in fracturing with depth.

The next major zone of lost circulation, Zone II, is located in the depth interval of 778.5 to 787 ft (Fig. 3a). Physical evidence for increased porosity within the core, including dissolution (etched) textures, brecciation, and vugs, markedly increases at a depth of 775.5 ft. Between 780 to 787 ft, a rubble fault zone exists with abundant open spaces, etching, and fillings of euhedral quartz crystals. This intensely fractured, etched, and brecciated zone extends to 791 ft in the core. The fracture intensity for Zone II is 1.06 fractures/ft; however, this is a minimum approximation since the core is severely broken and impossible to piece back together. Based on physical characteristics, most of the fractures inventoried in this zone are mode I and fractures of unknown origin. The presence of faulting is suggested by alteration along fracture surfaces which has been associated elsewhere in the core with faulting. Nonetheless, the relative displacement is uncertain so the fracture origin is undetermined. The fractures are shallow to steeply dipping, ranging from 20" to 85°. Two major breccia zones, at 780.42 ft and 789.5 ft, dip approximately 70" and are 2.5 to 5 cm thick. Numerous fractures terminate and/or extend from these breccia zones. Abundant LCM is found throughout the etched, brecciated, and vuggy openings within the core. Minor amounts of LCM are observed on a few of the fracture surfaces.

Zone III is located between about 819 and 840.5 ft. (Fig. 3a). This correlates well with an intensely fractured, etched, and brecciated region from roughly 819 to 843 ft on the core; and also includes a hydrothermal breccia dike with a 70" dip from 817 to 819.5 ft. A breccia up to 3 cm thick at 832.65 ft is also observed

Figure 3b and c shows the orientation of fractures interpreted from the televiewer log. The Azimuth vs Depth plot shows a concentration of the fractures with a dip azimuth of 130° (N40°E strike). This is the orientation of the SCF and also the principal zone of fluid loss between 865 and 914.5 feet. Considering also the temperature and lithologic data, we would propose that the drill has intersected a normal fault zone parallel to the SCF. Our interpretation is that the principal zone of fluid loss represents the principal displacement zone (PDZ or core zone in the terminology of Forster et al, 1997) of the fault. The hanging
