# Experimental Study on Injection-induced Fracture Propagation and Coalescence for EGS Stimulation

Zhi Ye and Ahmad Ghassemi

Reservoir Geomechanics and Seismicity Research Group, The University of Oklahoma, Norman, OK 73019

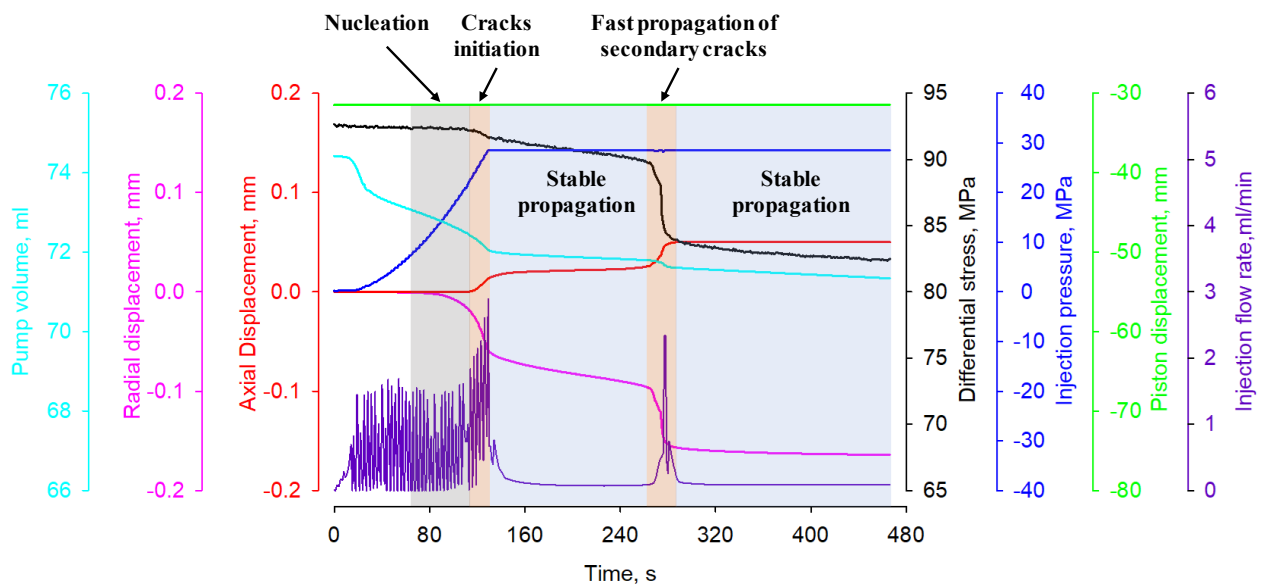
Figure 4: Injection-induced fracture propagation test on single-flawed sample SW-1.

The test results during injection are shown in Figure 4, the deformation properties and flow parameters during confining pressure increase and axial loading on the sample in the pre-injection stage are not shown in this graph which means the displacements and flow rates are zeros before injection. In Figure 4, the green curve represents the loading piston displacement of the MTS 816 frame, kept as constant under a constant displacement control mode during the injection process; the differential stress is plotted using the black curve, which significantly drops as the fracture propagates (because the compression exerted on the sample decreases with gradual propagation of the fracture); the blue curve shows the injection pressure and consists of a pressure buildup stage when the injection pressure is continuously increased at constant rate, and a pressure hold stage when the pressure is kept as constant; the axial displacement and radial displacement are illustrated by the red and pink curves, respectively; the purple curve shows the flow rate caused by injection by the syringe pump; the cyan curve shows the volume of injection pump. To characterize the crack types after testing, the sample SW-1 was cut axially in two halves. A fluorescer was used to detect the morphology of the fractures under ultraviolet light. The sample surface (side wall) and the surface of the central cut, as well as the corresponding fluoresced pictures are shown in Figure 5. In Figure 5(a1) and Figure 5(b1), the black arrows indicate the injection direction (water was injected from bottom to up).

Considering the morphology of the propagated cracks, the water injection process in Figure 4 can be divided into five zones. Zone I is the crack nucleation zone (light-gray zone), where micro-cracks were nucleated due to the stress field caused by increased injection pressure. The first jump in the measurements of deformation properties and flow parameters is observed in Zone II (light-golden zone), the increased displacements (axial and radial) and the decreased differential stress represent propagation of cracks formed in Zone I, resulting in rapid flow rate increase. After that, a stable fracture propagation zone (Zone III, light-blue zone) is noticed on the graph with gradual changes in displacements, stress, and pump volume until the second jump zone. In the second jump zone (Zone IV, light-golden color), much larger changes of stress drop, displacements increase, and flow rate increase can be observed. Considering the wider and longer secondary cracks in Figure 5, it is reasonable to assume the second jump is caused by the fast propagation of secondary cracks since they initiated later than the wing cracks. The last zone is a stable propagation zone (Zone V, light-blue color), it can be inferred that secondary cracks continually propagated to form shear branches at their tails, while the propagation of primary wing cracks was restricted due to the secondary cracks taking more fluid. The secondary cracks can be longer than the primary wing cracks, a feature that is similar to some previous experimental fracture propagation tests under uniaxial compression (Chen, et al. 1992, Wong and Einstein 2009, Lee and Jeon 2011).

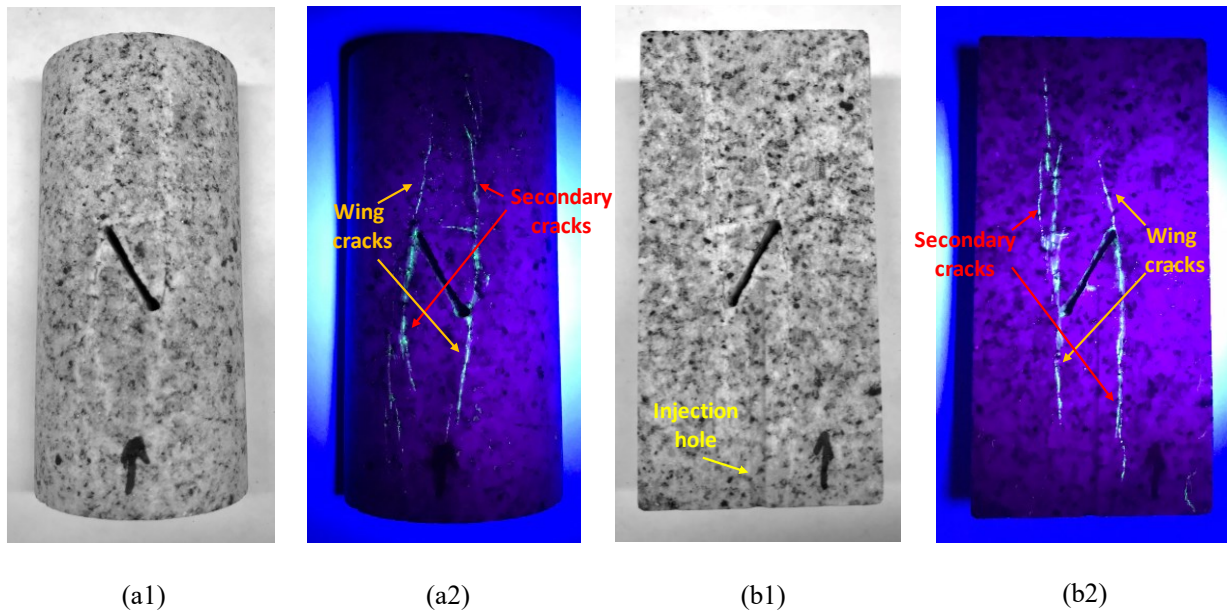
**Figure 5: The morphology of cracks on tested sample SW-1: (a1) the side wall; (a2) fluoresced cracks at the side wall; (b1) the surface of the central cut; (b2) fluoresced cracks at the surface of the central cut.**

The wing cracks or primary cracks are usually found to be the first fractures emanating from the pre-existing flaws, and always initiated from the tips of the pre-existing flaws. Often, wing cracks induced by tensile stress are thin without branches. A pair of wing cracks can be found on the side wall of the specimen in Figure 5(a2) and on the central surface shown in Figure 5(b2); they are both a thin single crack without any branches. On the other hand, two secondary cracks, which are wider and longer than the wing cracks are also detected on the tested sample SW-1. Unlike the wing cracks, the secondary cracks initiated at a distance away from the flaw tips. Moreover, the secondary cracks appear to be of mixed mode type which initially opened as tensile cracks and then propagated in shear. The shear zones with multiple crack branches on the tails of the secondary cracks are clear indications of this mixed-mode crack propagation. The shape and length of major cracks on the sidewall and on the central cut section are similar, however, the branches in shear zones propagating from the tails of the secondary cracks are not identical.

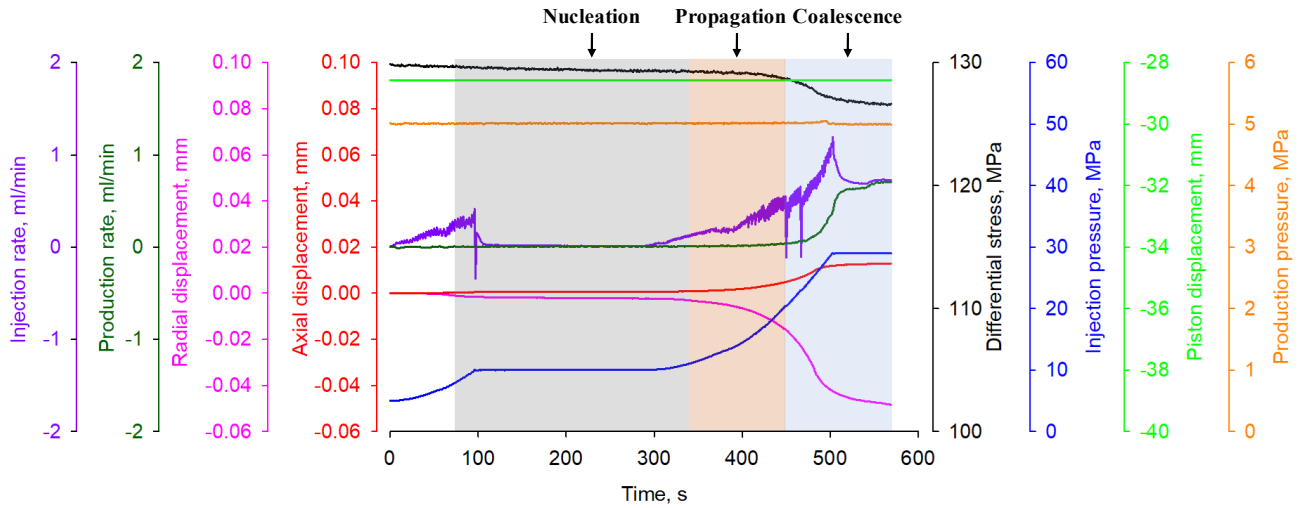
Figure 6: Injection-induced fracture propagation and coalescence test on double-flawed sample SW-2.

In the Figure 6, the process of injection-induced fracture propagation and coalescence on sample SW-2 can be divided into three zones with reference to the cracking behavior. Zone I marked with light-gray color is the cracks nucleation zone. In this zone, the sample’s radial expansion (expansion is negative using rock mechanics sign convention) gradually increased, while the axial deformation and differential stress changed slightly. This feature in the deformation record indicates that micro-cracks were opened and nucleated around the tips of pre-existing flaws but did not propagate since there were not sufficient axial deformation and differential stress drops. In the Zone II (light-golden color), both displacements (axial and radial) and differential stress display significant changes along with increase of the injection pressure, which means the cracks propagation was initiated. However, the lower flaw and the upper flaw did not coalesce with each other in Zone II since the flow rate of pump B was still zero. The last Zone III shown as light-blue color is the fracture coalescence zone where the flow rate of the pump B (dark green curve in Figure 6) shows continuous increase, and much larger deformations and stress drops are observed. In this zone, the two pre-existing flaws have completely coalesced through the bridge crack. Therefore, the water could flow from the lower flaw to the upper flaw. At the end of Zone III, the pump B almost has the same flow rate as which of

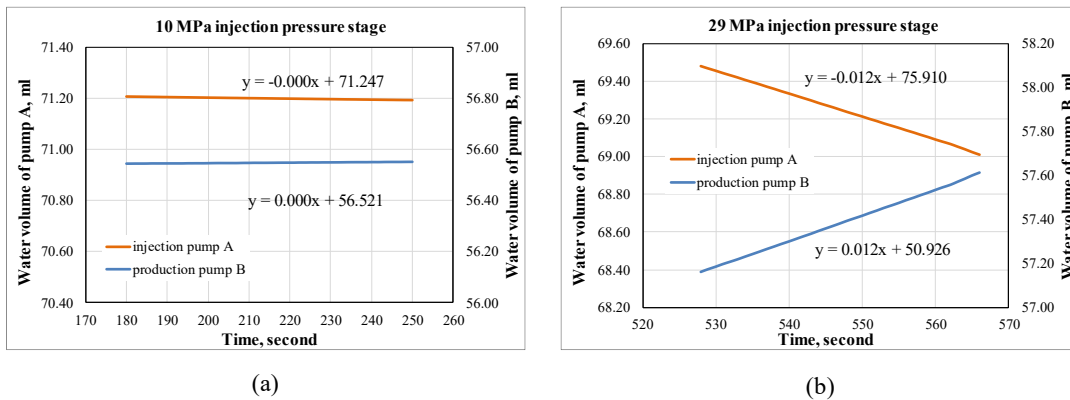
Figure 8: The steady-state flow rates of pump A and pump B under two constant pressure hold stages: (a) 10 MPa injection pressure stage; (b) 29 injection pressure stage.

Another important issue in Test 2 is the possibility of production increase due to the fracture network generation caused by fracture propagation and coalescence. Two hold stages with constant injection pressures (10 MPa and 29 MP, respectively) were designed to compare the steady-state flow rates before and after fracture network generation. Figure 8(a) and Figure 8 (b) are used to illustrate the steady-state flow rates (Ye, et al. 2017) of the two pumps under 10 MPa injection pressure and 29 MPa injection pressure, respectively. In each plot of Figure 8, the x-axis is time while the two y-axes are separately the water volume of the injection pump A and the production pump B. Therefore, the slopes of the curves are injection flow rate (orange curve) and production flow rate (blue curve), respectively. The negative flow rate of pump A represents injection due to its volume decreased during water injection, while the positive flow rate of pump B means production because of the water volume of pump B raised significantly after the pre-existing fractures coalescence. During the stage with constant 10 MPa injection pressure, both injection flow rate and production flow rate are almost zero, which means there was no fracture coalescence. Moreover, the zero flow rates also indicate that the cracks nucleation and fracture propagation are resulted from the change of stress field due to injection but not are directly originated from the fluid flow. On the other hand, at the later stage with constant 29 MPa injection pressure after fracture coalescence, both the injection flow rate and the production flow rate achieved remarkable increase and they were almost identical as 0.012 ml/min (all injection water from pump A was produced by pump B). Here, it is noticed that the steady-state flow rate is smaller than the corresponding transient flow rate.
