## MITIGATION OF SILICA DEPOSITION IN WELLBORE FORMATION IN MALITBOG SECTOR, TONGONAN LEYTE

Edwin H. Alcober, Mayflor N.R. Candelaria, Arnel V. Mejorada and Adriano C. Cabel, Jr.

PNOG Energy Development Corporation, Merritt Road, Fort Bonifacio, Taguig, Philippines

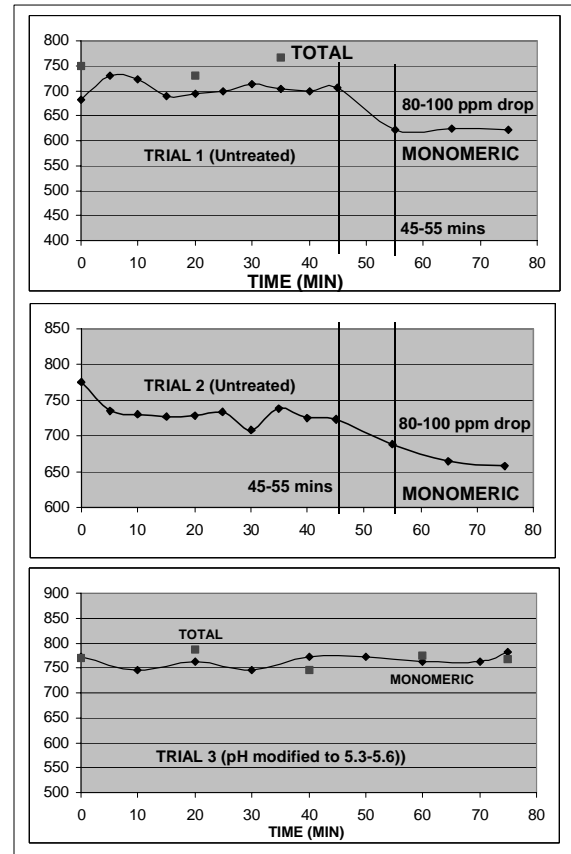
Figure 4. Results of Malitbog brine induction time determination.

Three induction time tests were conducted using the polymerization vessel, two for the untreated brine to determine the time for the excess silica to start polymerizing in the baseline condition, and one with the brine pH modified to 5.3 – 5.6. The target pH of 5.3 – 5.6 in the pH MOD induction time test was determined earlier in a similar induction time test using a mini-silencer, with brine sample allowed to flash to ambient condition. This case is the worst condition because the brine temperature is allowed to reduce to 93.5°C and silica over-saturation increases to SSI=2.57. Since silica polymerization time was extended for at least 60 minutes in the worst condition (with brine pH modified to 5.3 – 5.6), this was the target pH range used in the pH MOD test. Results of the induction time tests (Fig. 4) showed that in the untreated brine (pH = 6.8), induction time is between 45 – 55 minutes and this was repeatable in two trials. About 80-100 ppm monomeric silica polymerizes, which is within the calculated excess silica in the brine. In the acid treated brine (pH = 5.3 – 5.6), monomeric and total silica concentrations were maintained for at least 75 minutes. Since the residence time (RT) of the brine in the Malitbog FCRS from the

separator to the shallowest wellbore loss zone in well 5R1D is calculated to be 23 minutes, the induction time test results confirm that silica will deposit in the wellbore formation and not upstream in the FCRS surface facilities.

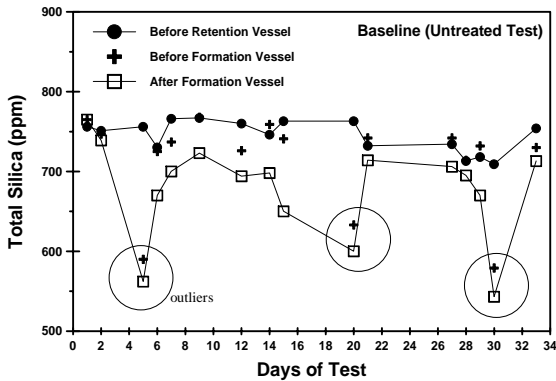
Figure 9. Total silica monitoring in three sampling locations during untreated test.

In the untreated test total silica monitoring (Fig. 9), total silica concentrations after the formation vessel were 20-100 ppm lower than concentrations before the brine sample enters the formation vessel, indicating that about 20-100 ppm silica are deposited in the formation materials. These levels are within the calculated excess silica in the brine. Except for three outliers, the total silica concentrations are generally maintained before the retention vessel and before the formation vessel, supporting the

results of the induction time test wherein it was determined that silica will only significantly deposit after about 45-55 minutes or just before it enters the formation vessel.

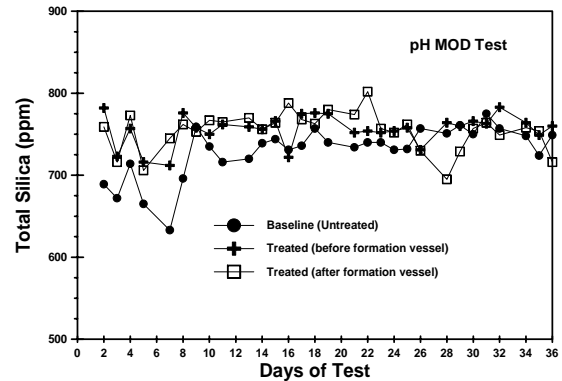
Figure 11. Total silica monitoring in three sampling locations during pH Modification test.

In the pH MOD test, brine pH monitoring (Fig. 10) showed baseline (untreated) pH at around 6.8-7.0, while the sulfuric acid dosed section mostly at pH range of 4.5 – 5.7. The brine pH before and after the formation vessel was also maintained, indicating no neutralization as the acid-dosed brine comes in contact with the formation materials. The lower pH range was attained by dosing a prepared sulfuric acid solution (0.02N) at an average dosing rate of 2.53 LPH. There were instances of overdosing (pH of 3.3 – 4.5) and underdosing (pH of 5.8 – 6.0) due to the manual control of the dosing pump and the in-exactness of the concentration of the prepared acid solution. The intermittent overdosing is the main cause of the corrosion observed in the pH MOD test. In the total silica monitoring of the pH MOD test (Fig. 11), total

silica concentrations were generally maintained before and after the formation vessel, indicating no significant deposition in the formation materials. This result is consistent with the acid-treated induction time test, and documentation of the inspection nipples and formation materials in the pH Mod test. However, it was observed that total silica before the formation vessel was slightly higher than before the retention vessel, indicating some flashing occurring in the retention vessels.

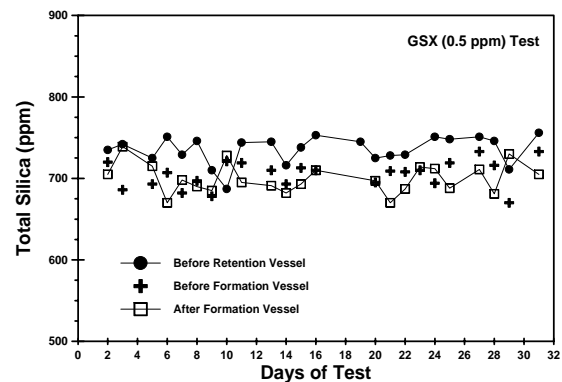
Figure 12. Total silica monitoring in three sampling locations during GSX test.

In the GSX test total silica monitoring (Fig. 12), a slight decline in total silica concentrations (5-25 ppm) were observed before and after the formation vessel, indicating slight deposition occurring in the formation materials. This was consistent in the documentation of the inspection nipples and formation materials in the GSX test. However, around 10-25 ppm silica is also observed to be lost between the retention vessels, indicating that minute amount of silica has also deposited in the retention vessels. This

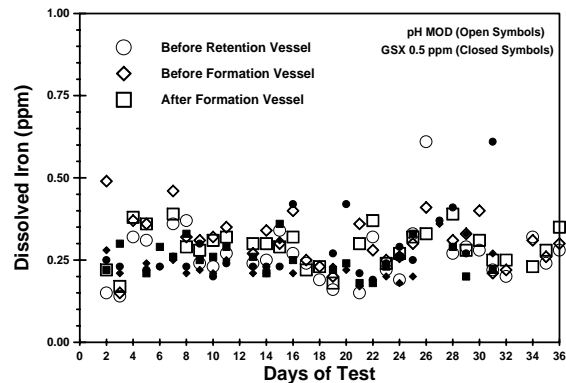
Figure 13. Dissolved iron monitoring during pH Modification and GSX tests.

inspection nipple (Nipple B). This supported the results of the inspection nipple internal diameter measurements in the pH MOD test indicating material loss. The material loss or corrosion observed is attributed to the episodes of uncorrected overdosing (pH=3.3-4.5) during the pH MOD test. However, dissolved iron monitoring during pH MOD and GSX tests (Fig. 13), indicated no significant difference in dissolved iron concentrations monitored in the pH MOD and GSX test brine, indicating that corrosion was not that significant to elevate the dissolved iron concentrations in the pH MOD test. Thus, automated dosing rate control and monitoring of the resulting brine pH will be a significant factor in the design of future industrial scale pH MOD applications. If in future monitoring of industrial scale installation, the corrosion rates measured are still high, then it would be more prudent to shift the solution to be dosed from sulfuric acid to GSX, but at dosing rates higher than 0.5 ppm.
