High-Pressure and High-Temperature Testing Protocol of Isolation Tools with Focus on Geothermal Wells

Keywords: FORGE, HPHT, downhole tools, zonal isolation tool, leakage

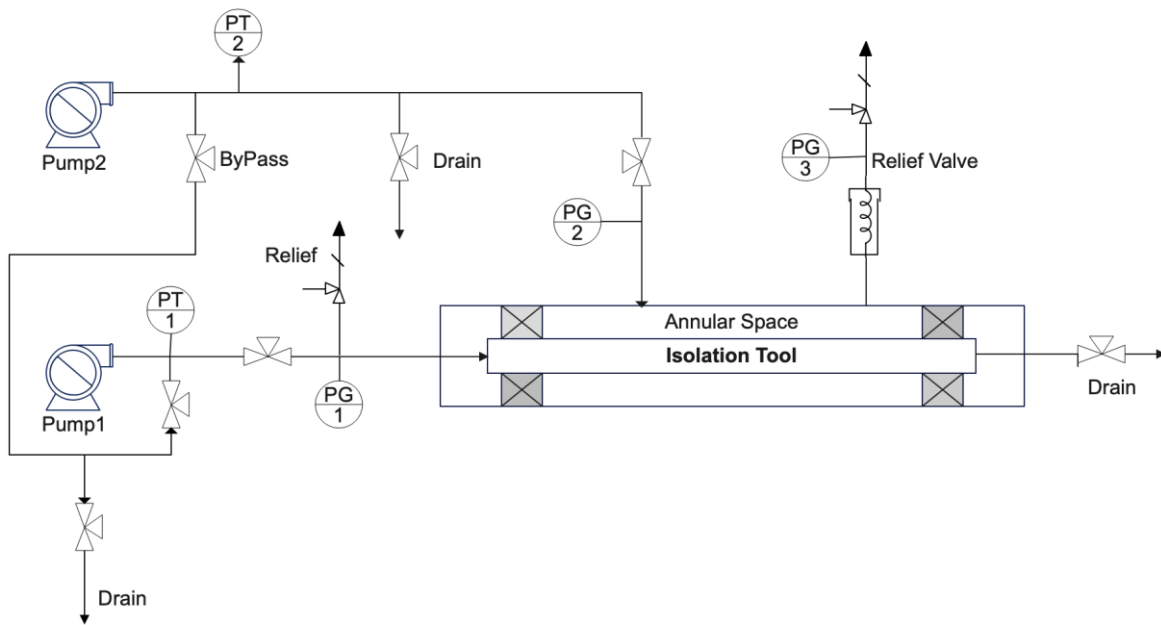
Figure 1: Schematic diagram of the long-scale testing setup (Alvarez Escobar et al., 2024)

A testing protocol was developed to meet the requirements of the Utah FORGE project, and a unique high-temperature facility was constructed at the University of Oklahoma to conduct HPHT tests on downhole tools. The testing setup consists of pumps (to apply pressure inside the tool and in the annular space), pressure and temperature transmitters, relief valves to ensure safety from overpressure, induction heating devices to increase temperature, and a casing where the isolation tool was installed for testing, this setup can increase the temperature and pressure to 350 °C and 10,000, along with the continuous monitoring of the system. Figure 1 illustrates the schematic of the testing setup in which the isolation tool is placed, while Figure 2 presents the testing protocol used for expanding and testing the isolation tool. It is important to note that, under the conditions for which the isolation tool was designed during the HPHT test, it was required to limit leaks to no more than 0.5 GPM. A similar testing setup was developed to evaluate smaller tools under HPHT conditions; the setup followed the same concept and was successfully used to test flow valves and stimulation initiation devices (Baena Velasquez et al., 2024).

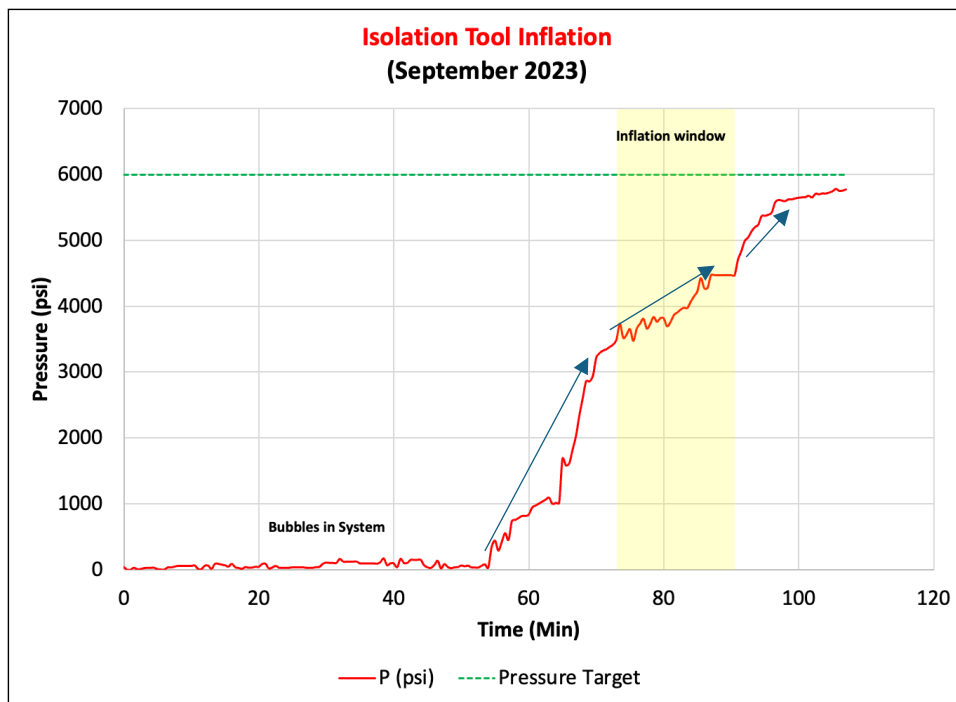
The first testing cycle involved installing the isolation tool inside the casing and inflating it by heating the system to 150°C and applying 6,000 psi pressure. Figure 4 This shows the behavior of the pressure during the tool expansion. It can be observed that the increase in pressure around the 80-minute mark slows down, which indicates that the packer has expanded. This stage represents the deployment of the packer in a well that is partially cooled or at a geothermal gradient. Thus, the inflated temperature was kept lower, and it must be noted that higher temperatures help the expansion process.

Figure 4 Isolation tool expansion

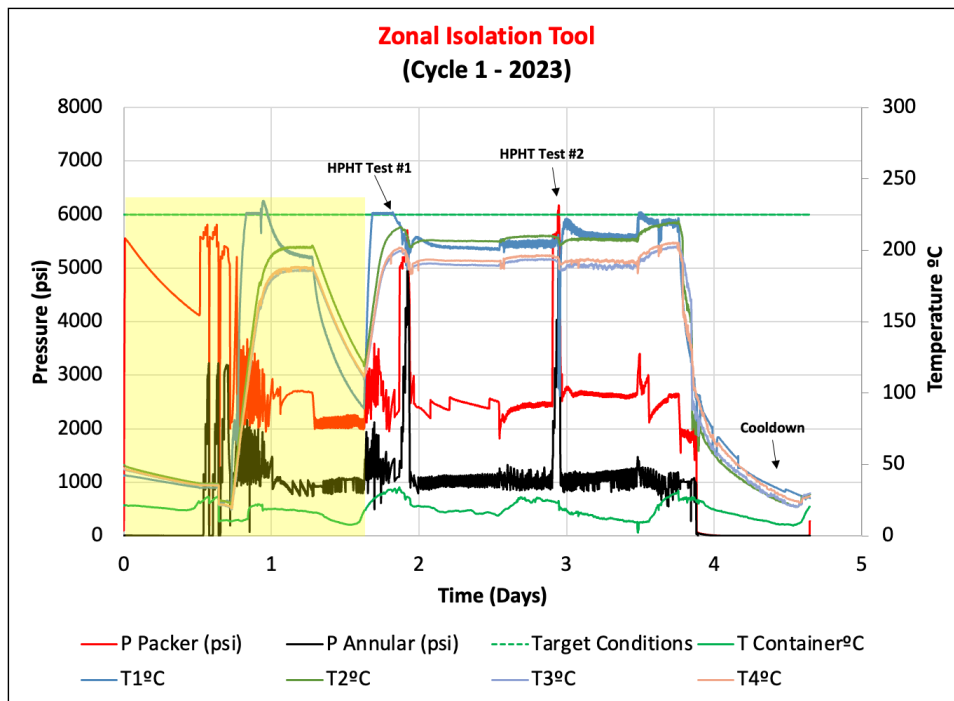
After the expansion, Cycle #1 was started by increasing the system pressure to around 2,000 psi and heating the isolation tool to the target temperature (225°C). The result of the first testing cycle is presented in Figure 5; the yellow section shows the initial part of the test, during which some equipment problems were encountered, causing a fluctuation in the system's temperature. After overcoming those problems, two HPHT tests lasted almost 5 days.

Figure 5 Testing Cycle 1 results

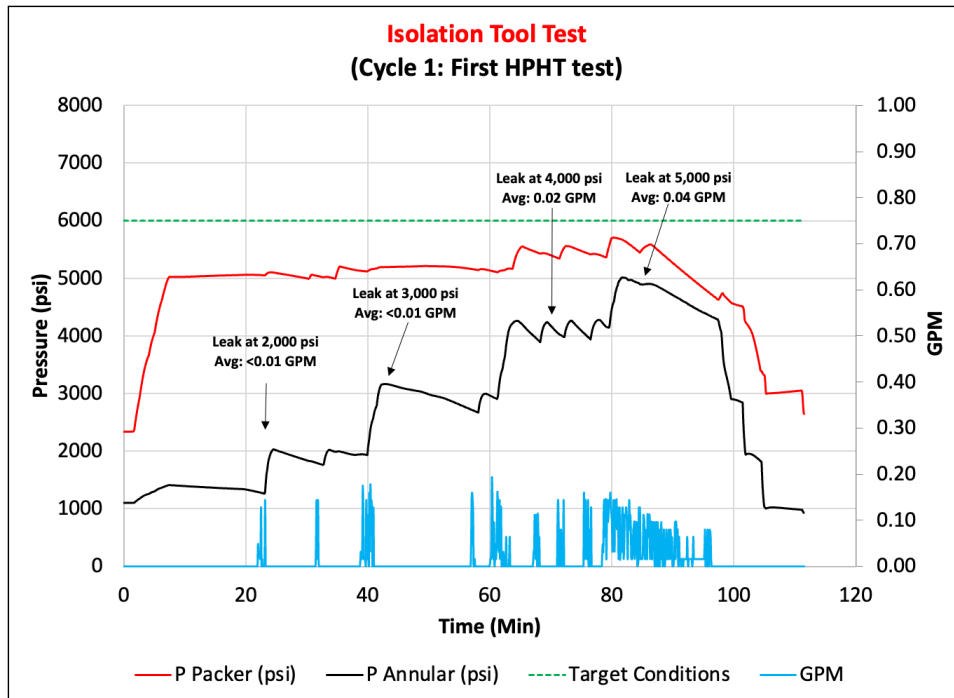
The maximum leak observed in the system during this test was about 0.04 GPM, remaining below the allowable limit (0.5 GPM). Despite the low leak, the target pressure was not achieved. This test concluded that an upgrade in pump setup is required to achieve high flow rates. Figure 6 shows the inlet and annular pressure during this HPHT test.

Figure 6 Result of the first HPHT test in Cycle 1

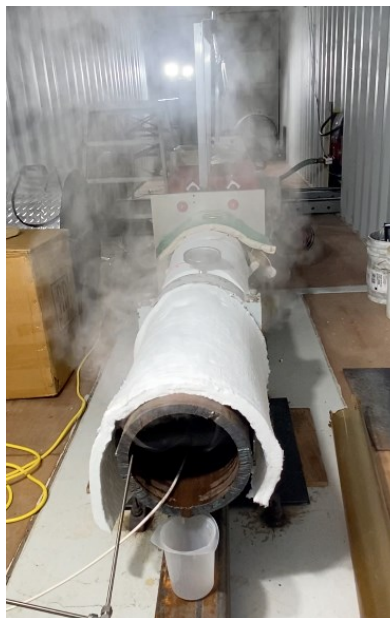
Figure 8 Steam leak from annular

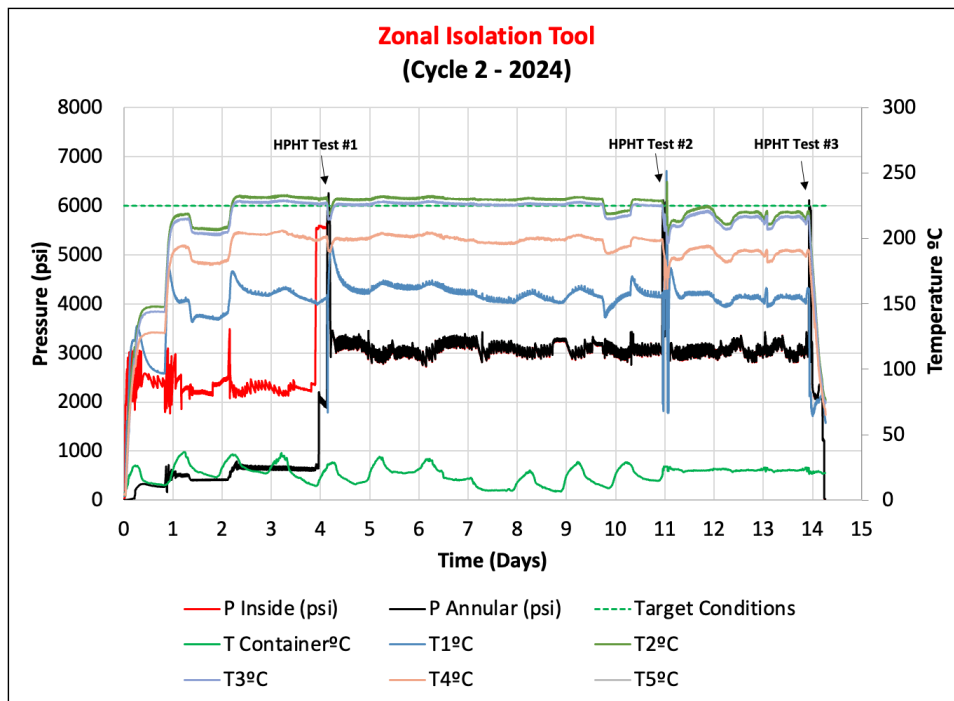
Modifications were made to the setup to achieve a higher injection flow rate and, therefore, increase the pressure in the system to the desired values (6,000 psi in both the annular and inside of the tool). This cycle lasted for 15 days, and 3 HPHT tests were done where the pressure of 6,000 psi was reached and held for one hour on each test. The temperature was held over 225°C during the whole cycle period; Figure 9 presents the pressure and temperature parameters during this cycle.

Figure 9 Testing Cycle 2 results

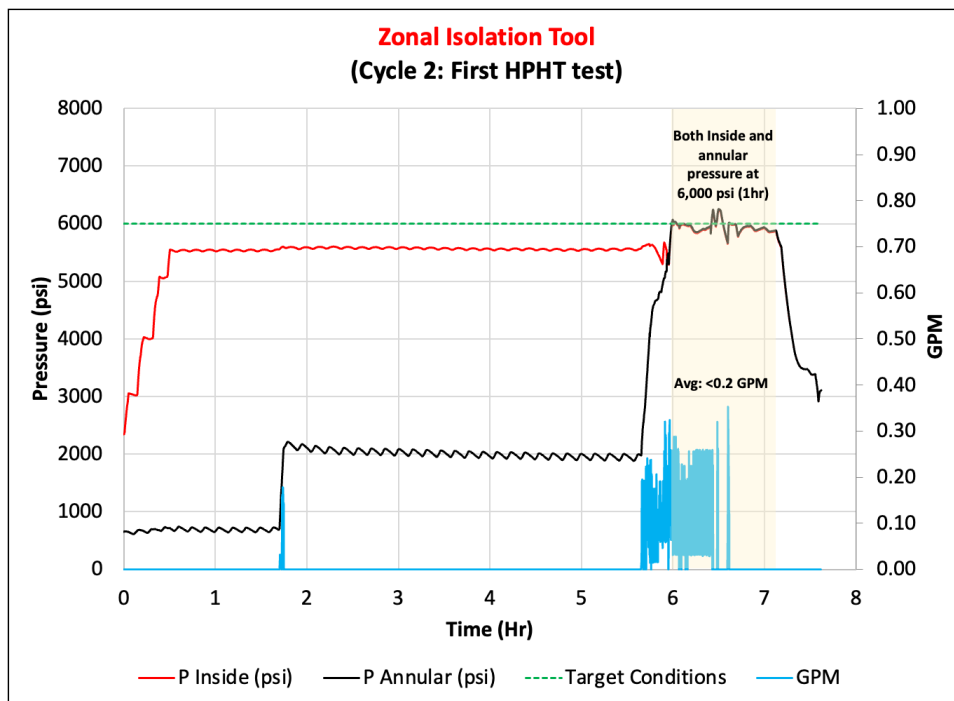
The pressure in both the annular and inlet spaces was increased to 6,000 psi, and with the new system modifications, it was possible to hold the pressure for one hour. The average leak during this test was less than 0.2 GPM, below the acceptable leak threshold of 0.5 GPM. The pressure and leak parameters are shown in Figure 10.

Figure 10 Result of the first HPHT test in Cycle 2

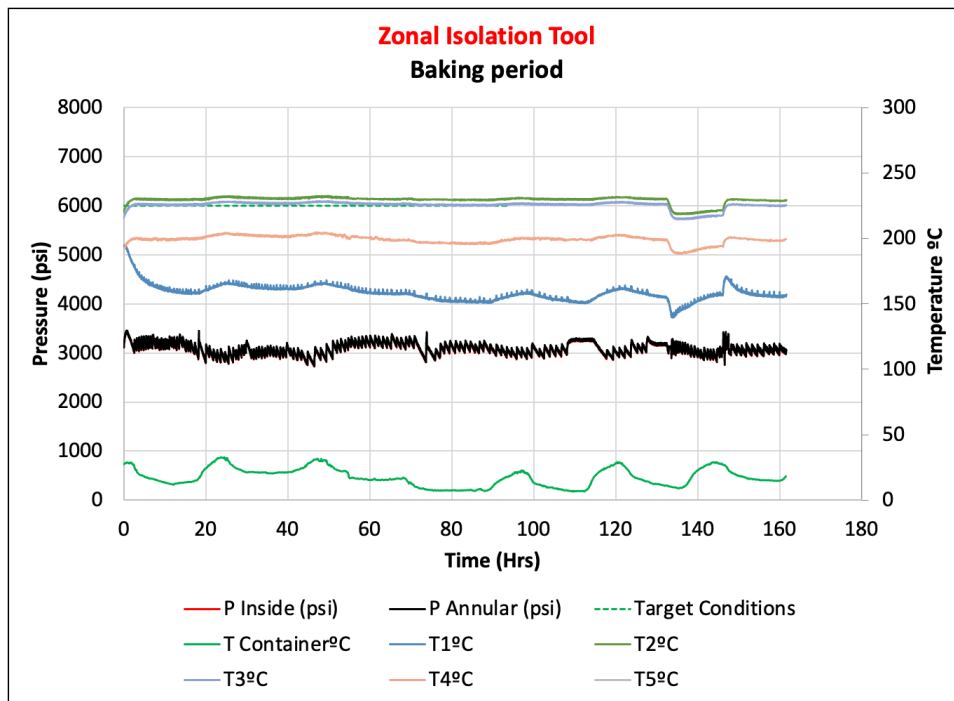
After each HPHT test, there was a baking period during which the pressure was held at 3,000 psi for both the inside and annular space, and the system's temperatures were kept around 225°C. The baking period lasted 160 hours (6.5 days), as shown in Figure 11.

Figure 11 Result of the first HPHT test in Cycle 2

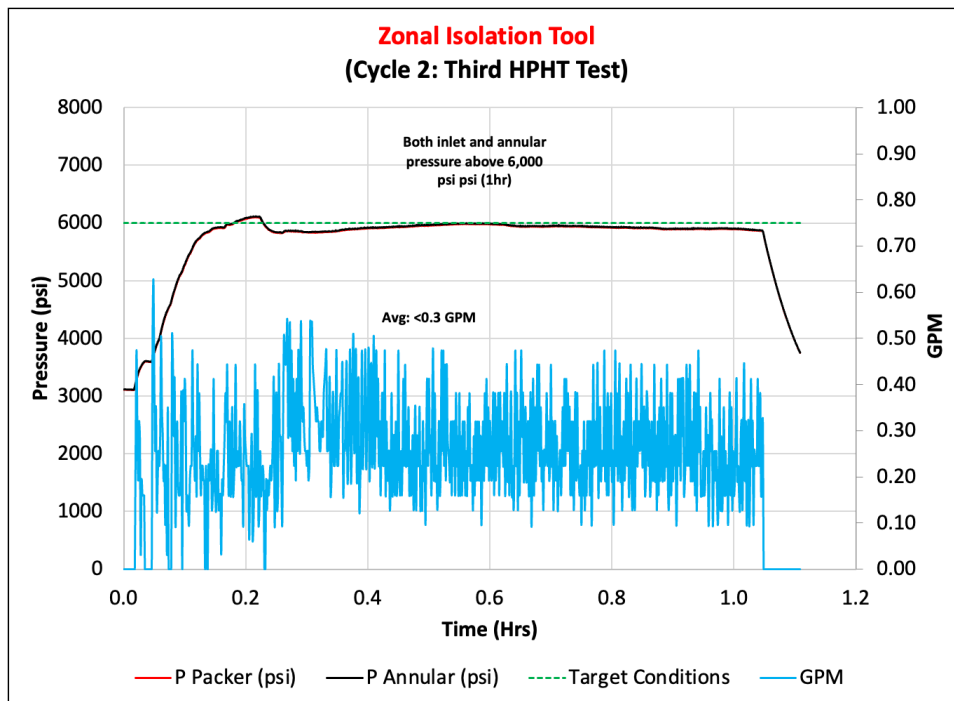
The third and last HPHT test of cycle two was performed without issues; the pressure was increased to 6,000 psi in the annular and inside the tool. The result of this test is presented in Figure 13.

Figure 13 Result of the third HPHT test in Cycle 2

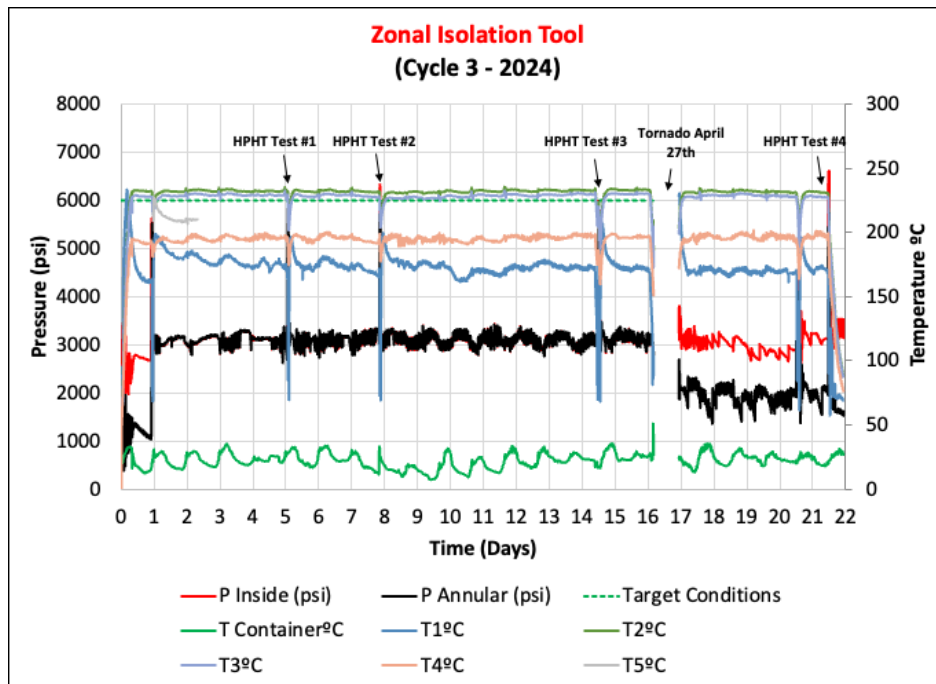
The tool was tested for 21 days for the third cycle, during which four HPHT cycles were performed. During this period, a tornado struck the area where the test was being conducted, and the data was lost, as shown in Figure 14. The heating was turned off to prevent damage to the unit and protect the personnel involved in the 24-hour testing.

Figure 14 Testing Cycle 3 results

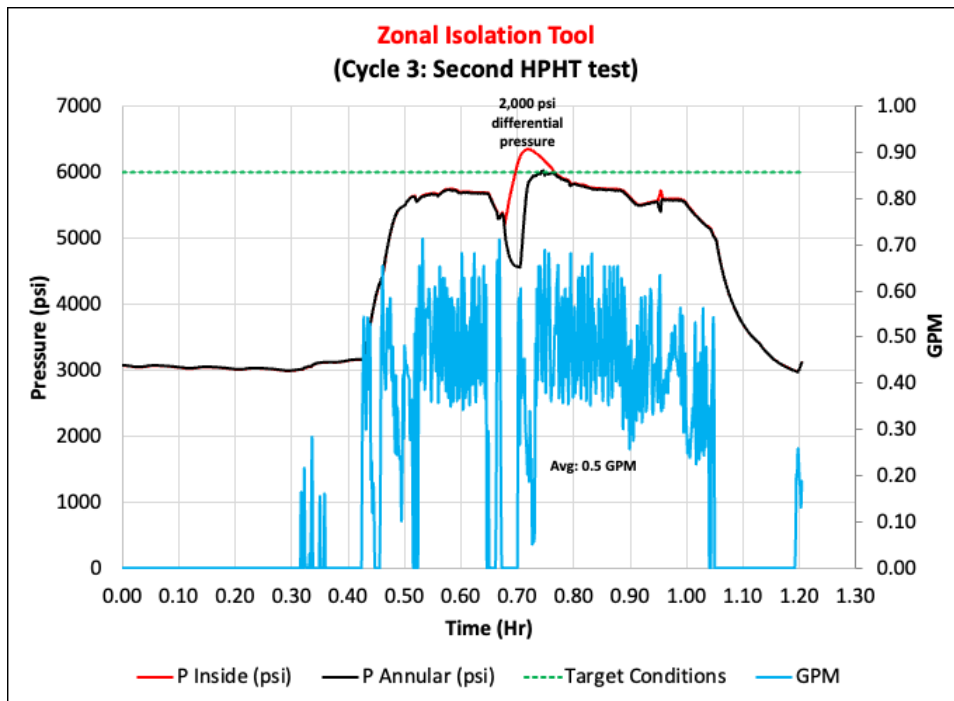
As in the previous test, the maximum pressure achieved for the second HPHT test was around 5,900 psi. During this second test, a 2,000 differential pressure was applied to the tool to increase the inside pressure above 6,000 psi and observe whether the system could maintain the pressure. As can be observed in Figure 16, once the pressures were equalized, the pressure dropped to values around 5,500 psi (both inlet and annular pressure), and during this period, the average leak was also around 0.5 GPM, which means it is impossible to increase the pump rate due to the tool’s maximum allowed leakage (0.5 GPM). Once the second test was finished, the tool was allowed to bake for 7 days to check if, with a more extended baking period, different results could be attained in the subsequent tests.

Figure 16 Result of the second HPHT test in Cycle 3

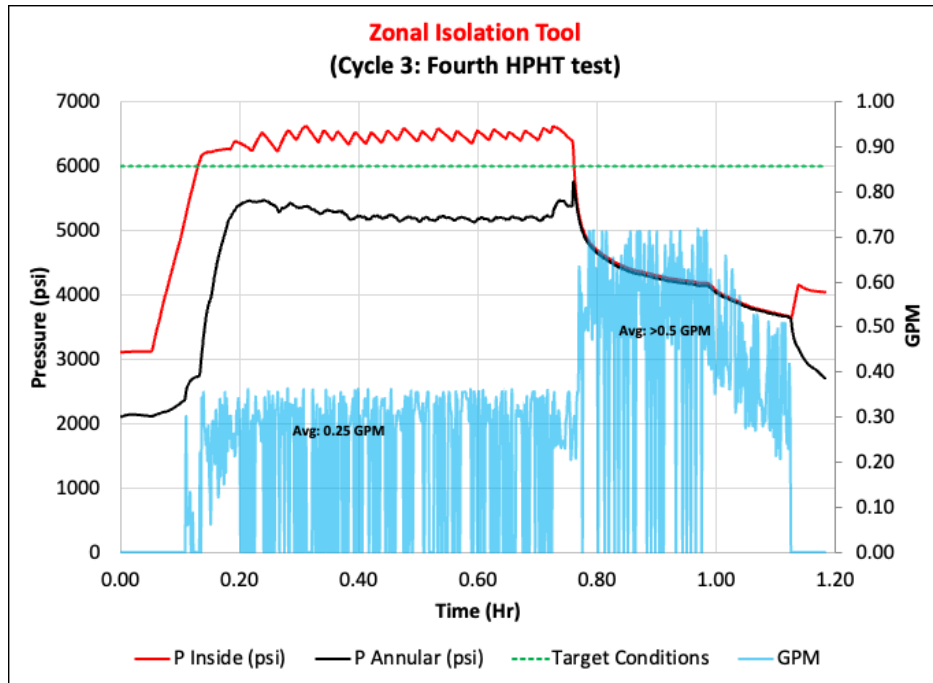
Figure 18 shows the pressure and temperature conditions during the fourth HPHT test of cycle 3. The tool was tested for one hour during this test, but the inlet and the annular pressure were not equalized in the first half hour. Therefore, it was observed that the differential pressure of only 1000 psi was maintained, and once the pressures were equalized, the pressure dropped to below 5,000 psi. After finishing this test, the tool was cooled down, and the results were analyzed to decide the best options for the next cycle.

Figure 18 Result of the fourth HPHT test in Cycle 3

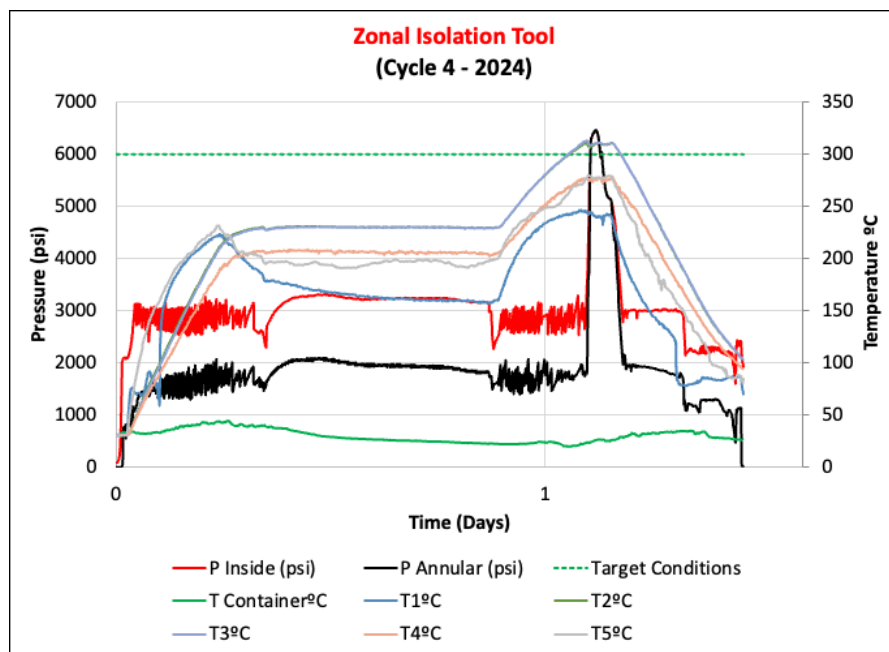
To evaluate a higher temperature impact on the system during the HPHT test, the temperature was raised to 310°C for this cycle. Figure 19 shows the pressure and temperature conditions during this cycle, with a temperature increase of 310°C noted during the HPHT test.

Figure 19 Testing Cycle 4 results
